**REPUBLIC OF NAMIBIA
MINISTRY OF WORKS AND TRANSPORT**

**Aircraft Accident Investigation Preliminary
Report**

DESCRIPTION OF OCCURRENCE: Collision with terrain during low-level flight.

AIRCRAFT TYPE: Windlass |Aquila (ZU-FIW)

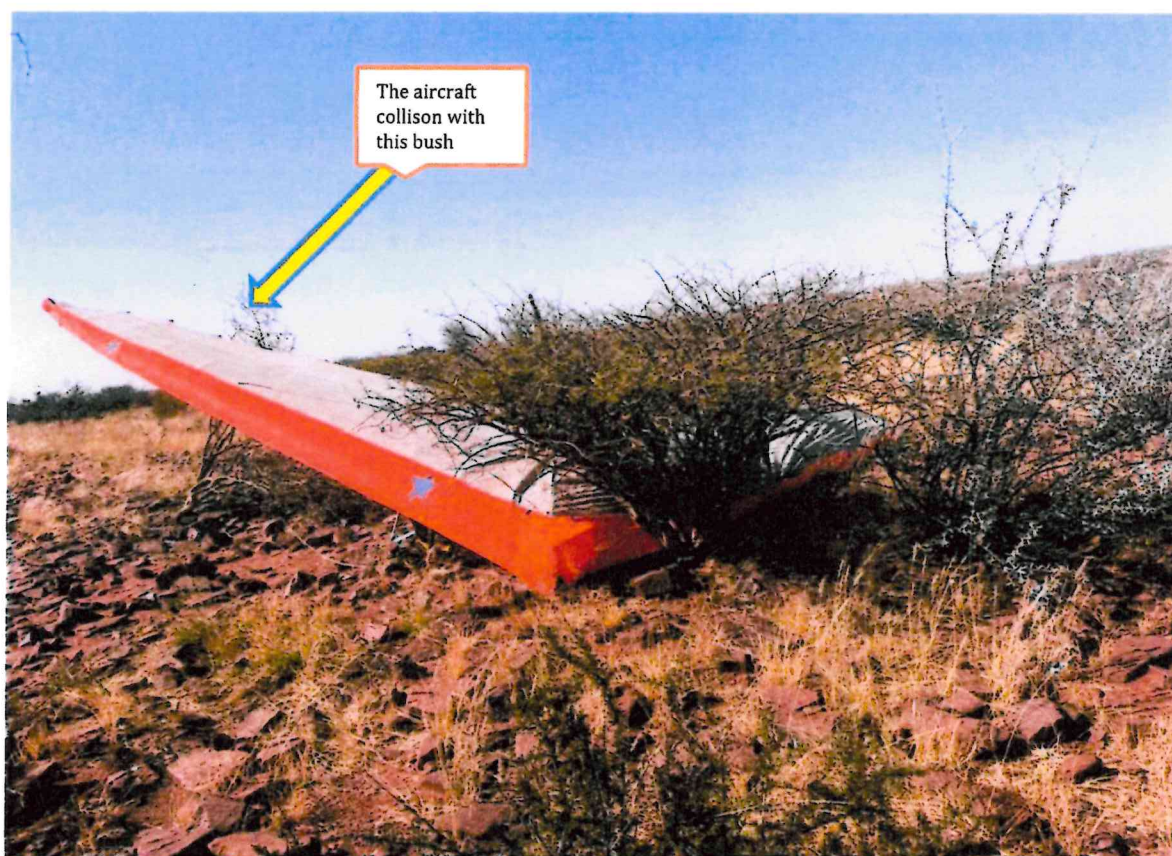
Photo 2 The Aquilla ultra light after collision into the bushes.

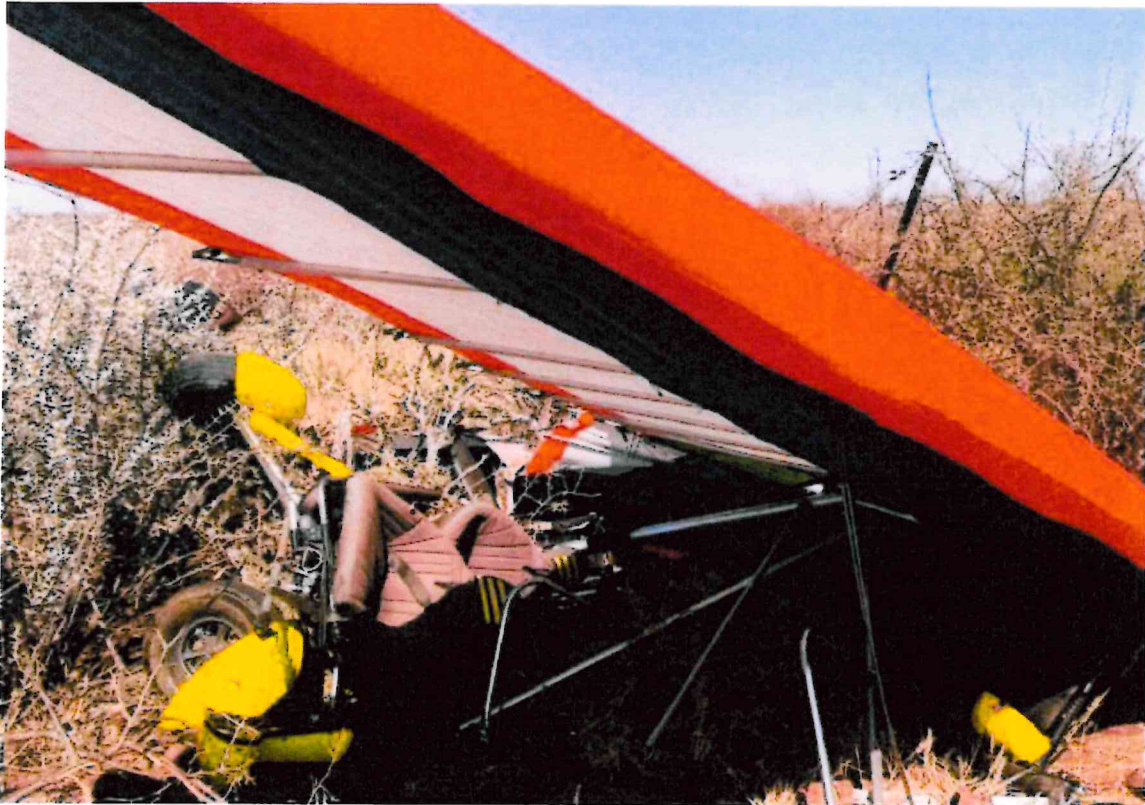
- Ground impact evidence showed that the aircraft initially impacted terrain in a forward rolling motion, followed by a secondary collision with surrounding vegetation (bushes). The aircraft then rotated approximately 340 degrees, coming to rest on its left lateral side.

- The pylon-mounted airfoil (wing support structure) fractured approximately at mid-span, resulting in the trapeze wing being displaced and rotated approximately 270 degrees relative to the aircraft's longitudinal axis.

- The nose gear assembly was found separated and only partially connected by cables to the main wreckage, consistent with forward and downward impact loads.

Photo 3 Depicting the aircraft final orientation
