**Directorate of Aircraft Accident and Incident  
Investigations**

Occurrence Reference: ACCID08042025/08-01

**Aircraft Accident Investigation Preliminary  
Report**

**AUTOGYRO MTO SPORT (Y024), V5-UVG**

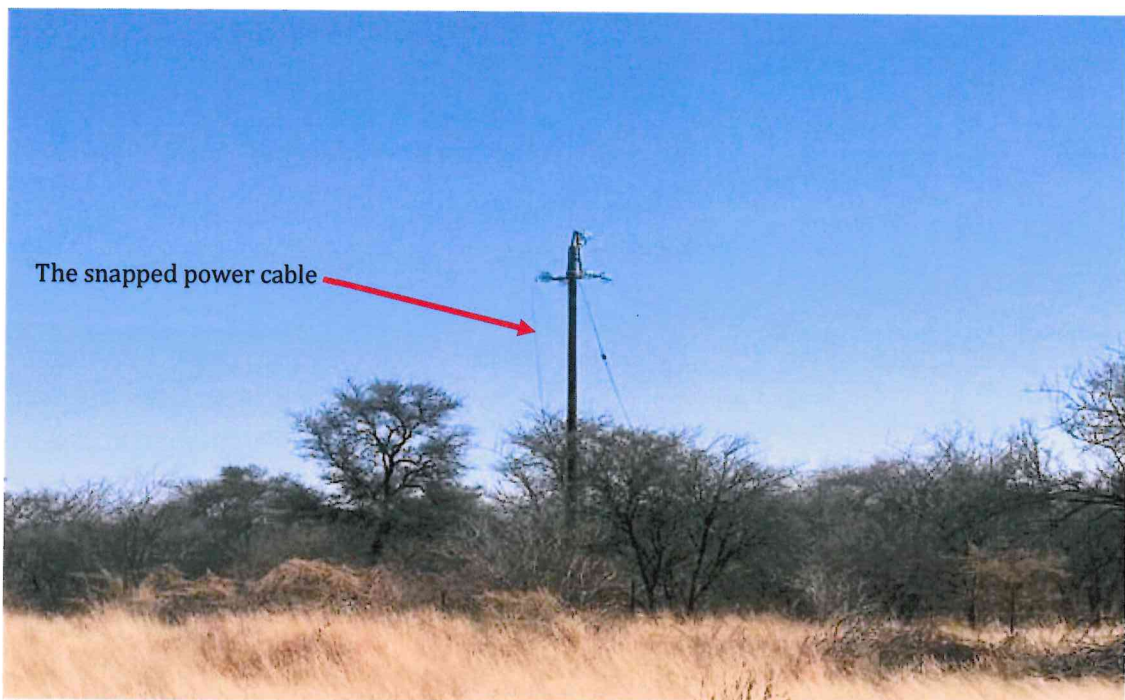
1.1.1. On the 04<sup>th</sup> of August 2025 a Namibian Registered Gyroplane, V5-UVG, took off from Omaruru (FYOM) airfield at 15:47 UTC for a short local flight. The flight was in preparation of the Pilot's skills test the next day. According to the Pilot, who was the only occupant, he did two touch-and-go's (landing and taking off without stopping on the Runway) and then turned to the North-East and climbed to between 700 and 900 feet above ground level (AGL), he then set course to the North of a hill, known as the "Omaruru-Koppie", he practiced several maneuvers. He also practiced two engine-out maneuvers. After feeling satisfied with his performance, he decided to head back to the airfield at about 800 feet AGL. Enroute to the Airfield the pilot decided to do another engine-out maneuver. He selected a gravel road that runs parallel with the Omaruru river. The road is on the left bank of the river. According to him, he lowered the nose, checked for people, vehicles and obstacles on the road, after observing that it was all clear he determined the aiming point on the road and went through the procedures. A slight cross wind was prevailing from the right as he prepared for the landing. When the landing was assured, he rounded out and kicked in the throttle and at that moment he collided with a power line.

Figure 2: Picture showing the snapped power line.

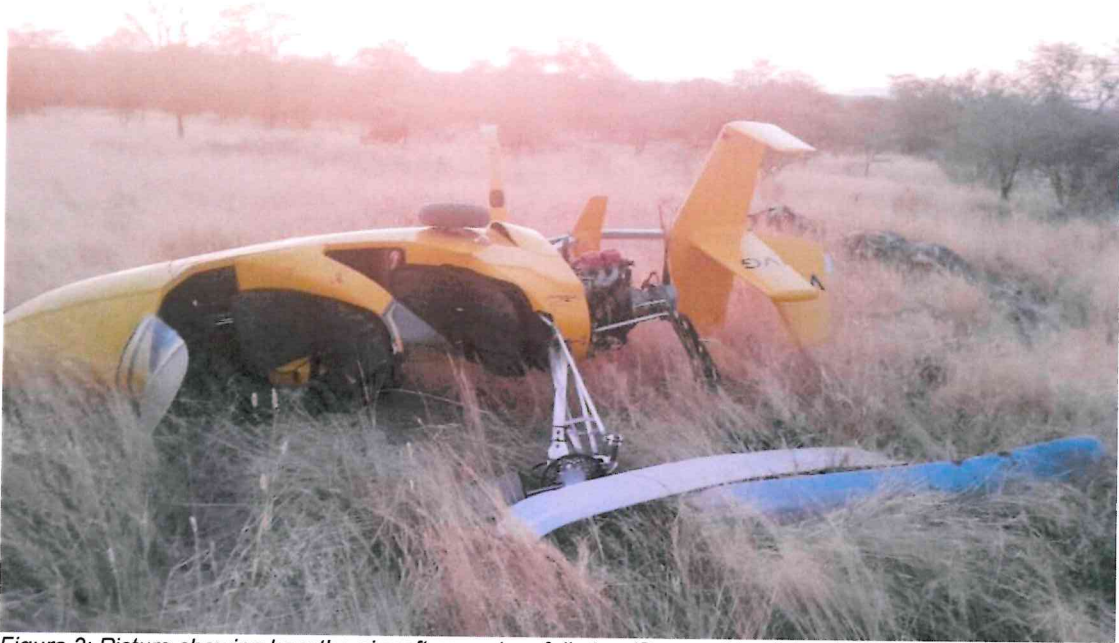
- 1.1.2. After the collision with the power line the Gyroplane remained airborne for a while and touch down in the centre of the gravel road, however the landing was very hard causing the nose and the right wheel to broke off, thereafter the Gyroplane veered off to the right and finally came to a full stop in the grass and fell on its side.

Figure 3: Picture showing how the aircraft came to a full stop (Source: Namibian Police).

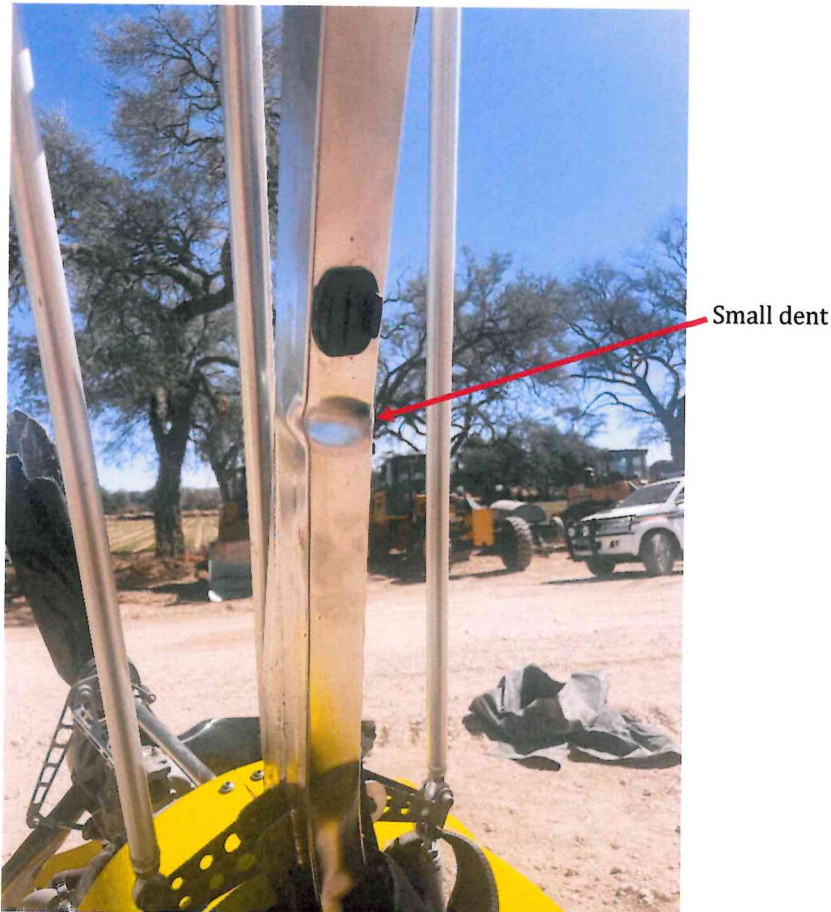
The power line consists of a three high tension cable system, with two cables at the bottom and one at the top. The aircraft passed through the middle, between the bottom two and the top one, however the nose section followed by the windshield and the main rotor mast struck the top cable and it snapped. A small dent is visible on the main rotor mast where the cable made contact. The two bottom cables remained intact.

Figure 4: Picture showing small dent on the main rotor mast where the cable made contact.

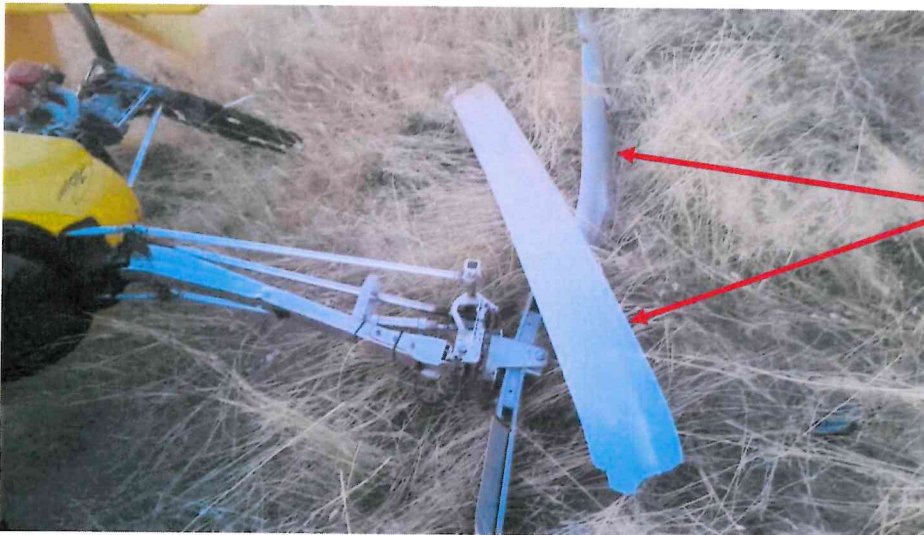
The aircraft was substantially damaged when the Gyroplane impacted the gravel road causing the nose wheel and right main wheel to broke off. More damage was caused when the Gyroplane fell on its side, the spinning main rotor blades stroke the ground causing the aluminum blades to break. The pusher propeller at the back of the engine also impacted the ground causing the propeller blades to broke as well. The fuselage (fiberglass) and the front windshield were also damaged.

Broken main rotor

Figure 5: Picture showing the damage to the main rotor. (Source: Namibian Police)

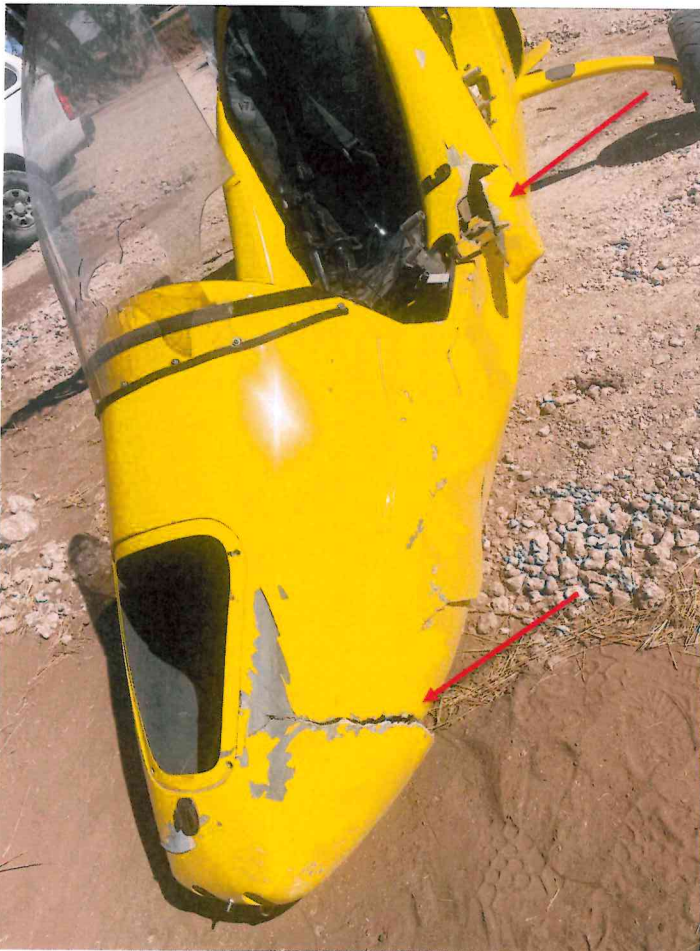
Figure 6: Picture showing the damage to the fuselage (Red Arrows)

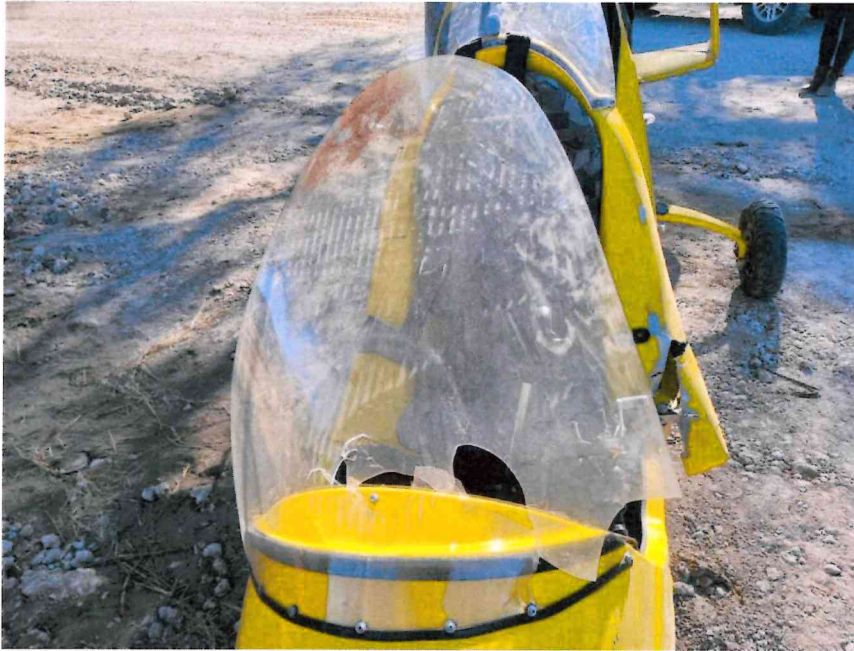
Figure 7: Picture showing the damage to the windshield.

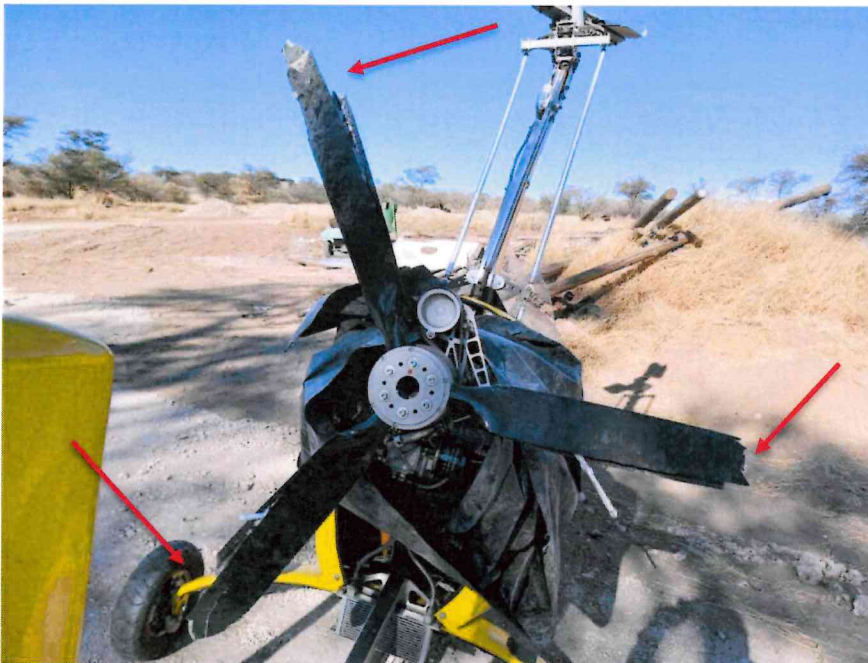
Figure 8: Picture showing the damage to the pusher propeller at the back of the engine (Red Arrows).
