Occurrence Reference: INCID/02262025/02-02

Serious Incident Preliminary Report

Embraer ERJ 190 - 100 (E190): ZS-YAF

DESCRIPTION OF OCCURRENCE: Runway Excursion

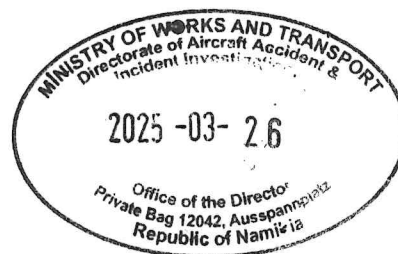
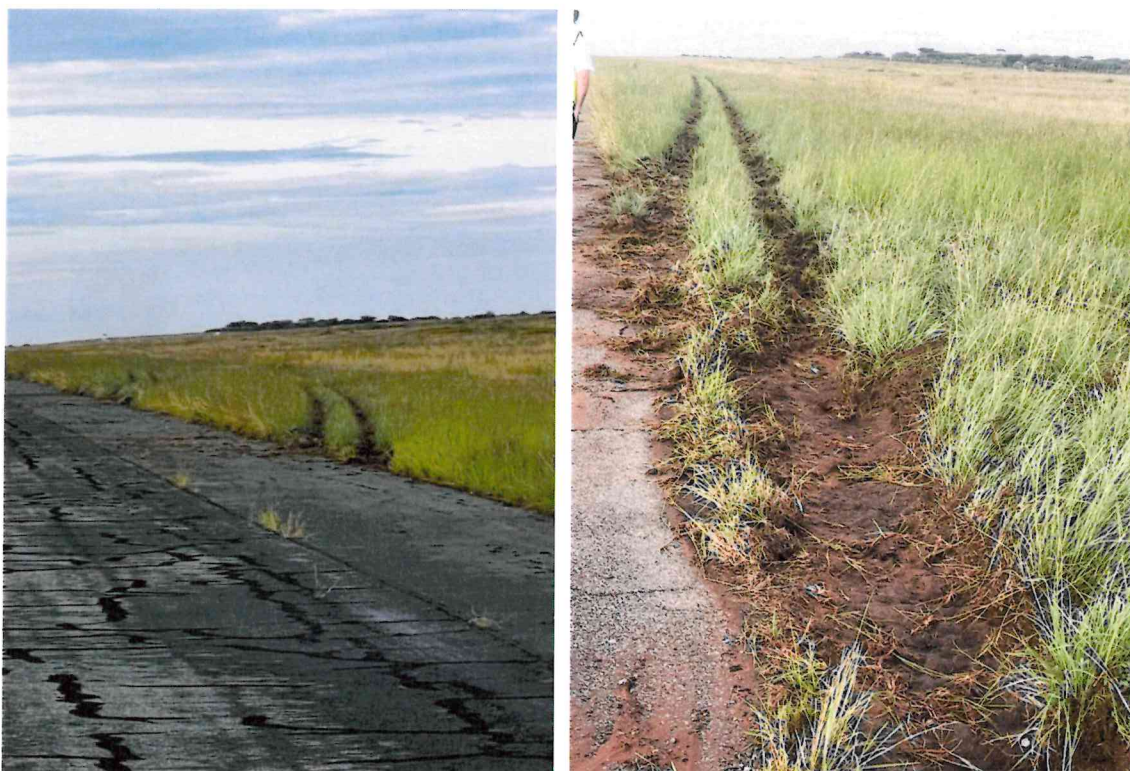
- 1.1.9. The aircraft touched down to the right of the centreline and veered to the right. The main landing gear hit two runway edge lights and thereafter veered off the RWY while the nose wheel was still not down. The nose wheel only came down while aircraft was already on the grass. The aircraft remained on the grass for approximately 490 meters (m) before it re-entered the runway and completing the landing roll. The aircraft vacated the RWY via intersection Charlie to the parking bay.

- 1.1.12. The PIC reported a possible RWY excursion and possible damage to the RWY edge lights to the Tower controller. The ATC then sent out a vehicle ("FC") to inspect. FC reported that 2 RWY edge lights were hit and confirmed the RWY excursion to the ATC.

Figure 2 and 3: Pictures showing the tracks of the main landing gear.

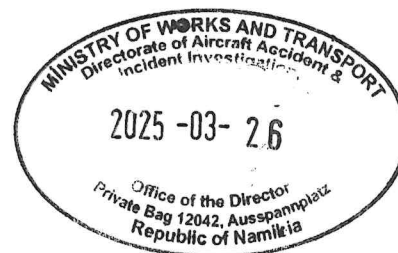
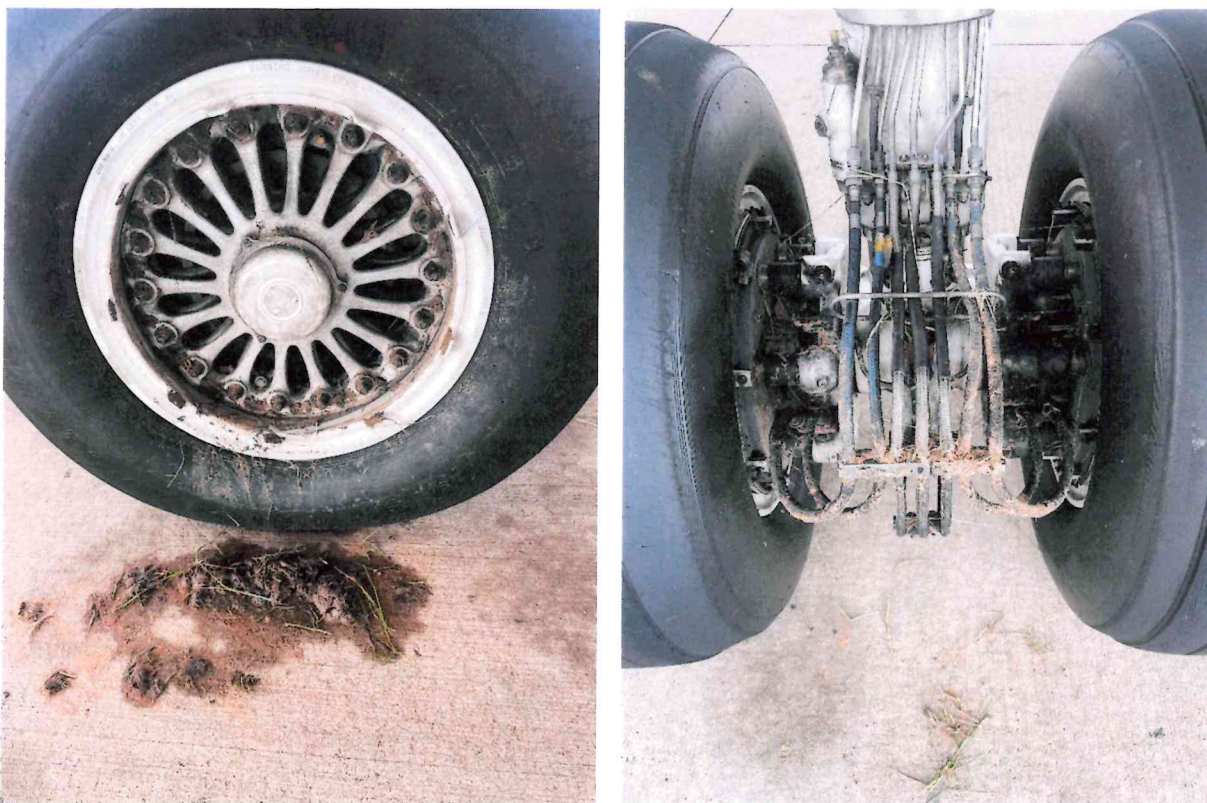
- 1.1.13. During the post flight inspection, the PIC noticed grass and mud residue on the landing gear. No noticeable damage was observed.

The Aircraft did not sustain any damage. The next day, 27 February 2025, Maintenance personnel from the operator arrived from Cape Town to inspect the aircraft and no noticeable damage was observed. They also noticed the grass and mud residue on the landing gear (see photos below). The Aircraft was then ferried to Johannesburg with landing gear down and locked. More inspections were carried out and the completed inspections did not reveal any damage to the aircraft.

Figure 4 and 5: Pictures showing grass and mud residue on the landing gear.
