**Accident Investigation Preliminary Report**

DESCRIPTION OF OCCURRENCE: Catastrophic Engine Failure and Forced Landing.

AIRCRAFT TYPE: GippsAero GA8 Airvan

DATE AND TIME: 16 October 2025, 15H10 UTC

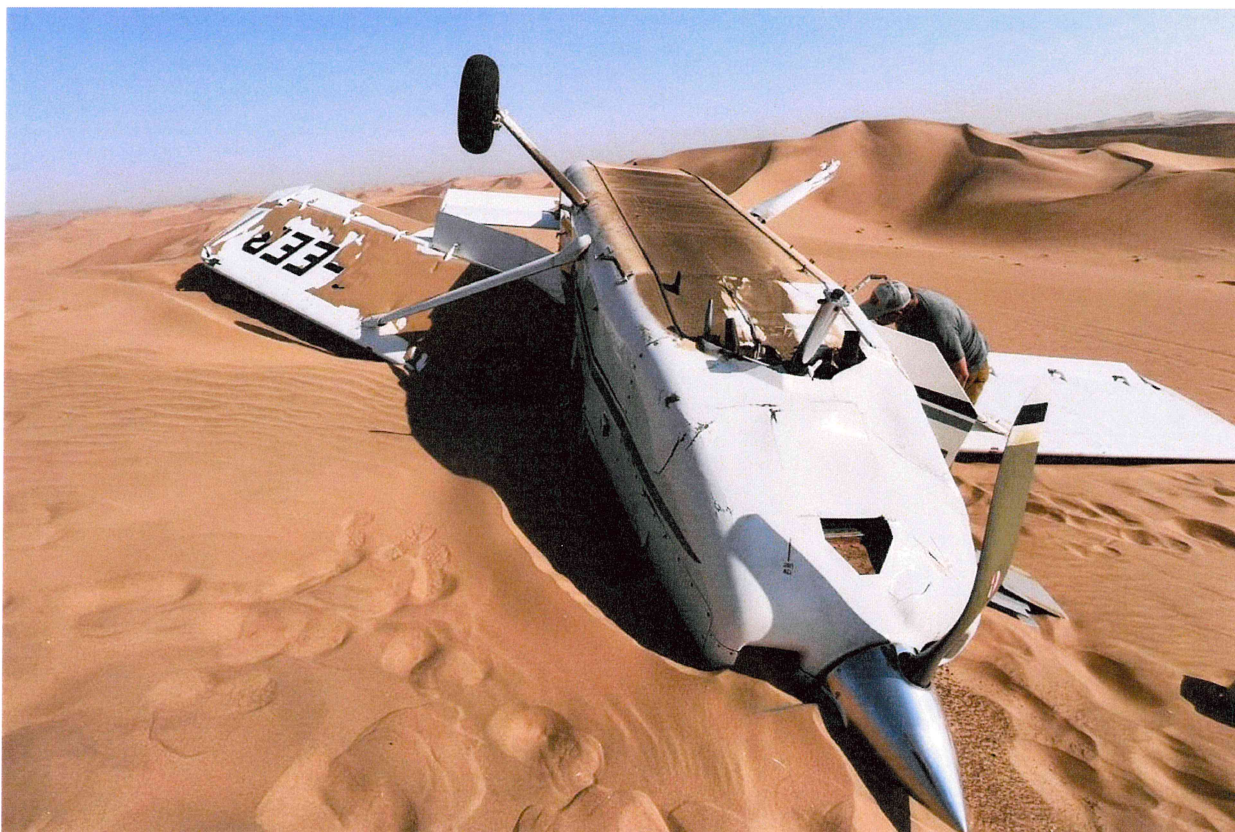
- I. The aircraft descended at a shallow angle, impacting soft sand.
- II. Upon initial contact, the nose wheel broke off.
- III. The aircraft then catapulted forward and subsequently came to a rest in an inverted position.
- IV. The right main wheel also broke off.

*Photo 1 : The Aircraft hit the soft sand and flipped forward.*

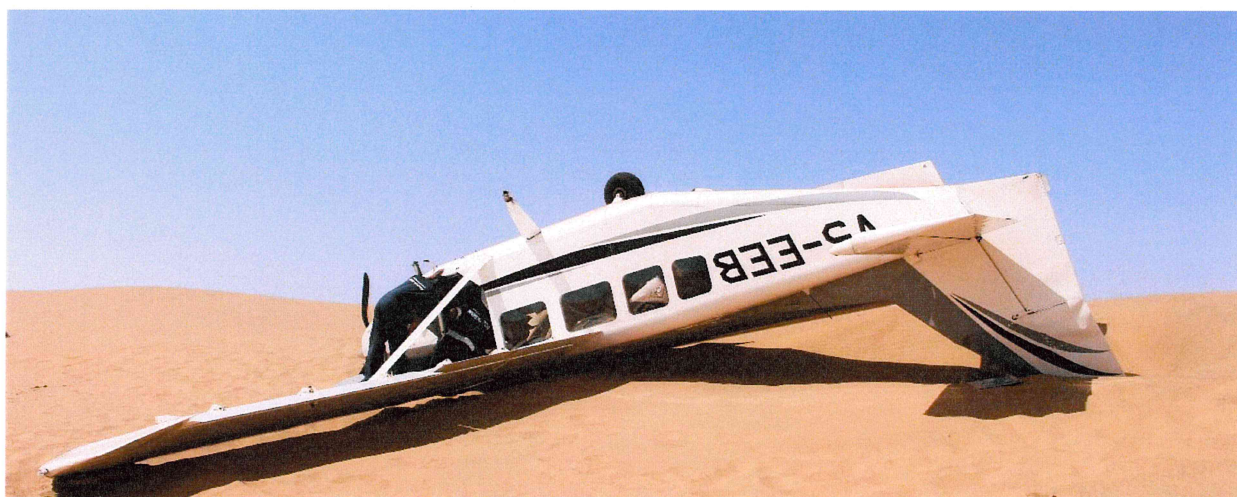
The fuselage structure, particularly the rear sliding door frame, was compromised. The specific extent of the damage to the engine, propeller, and wings is subject to further detailed wreckage examination and is currently unknown..

*Photo 2 : The side view of inverted aircraft.*

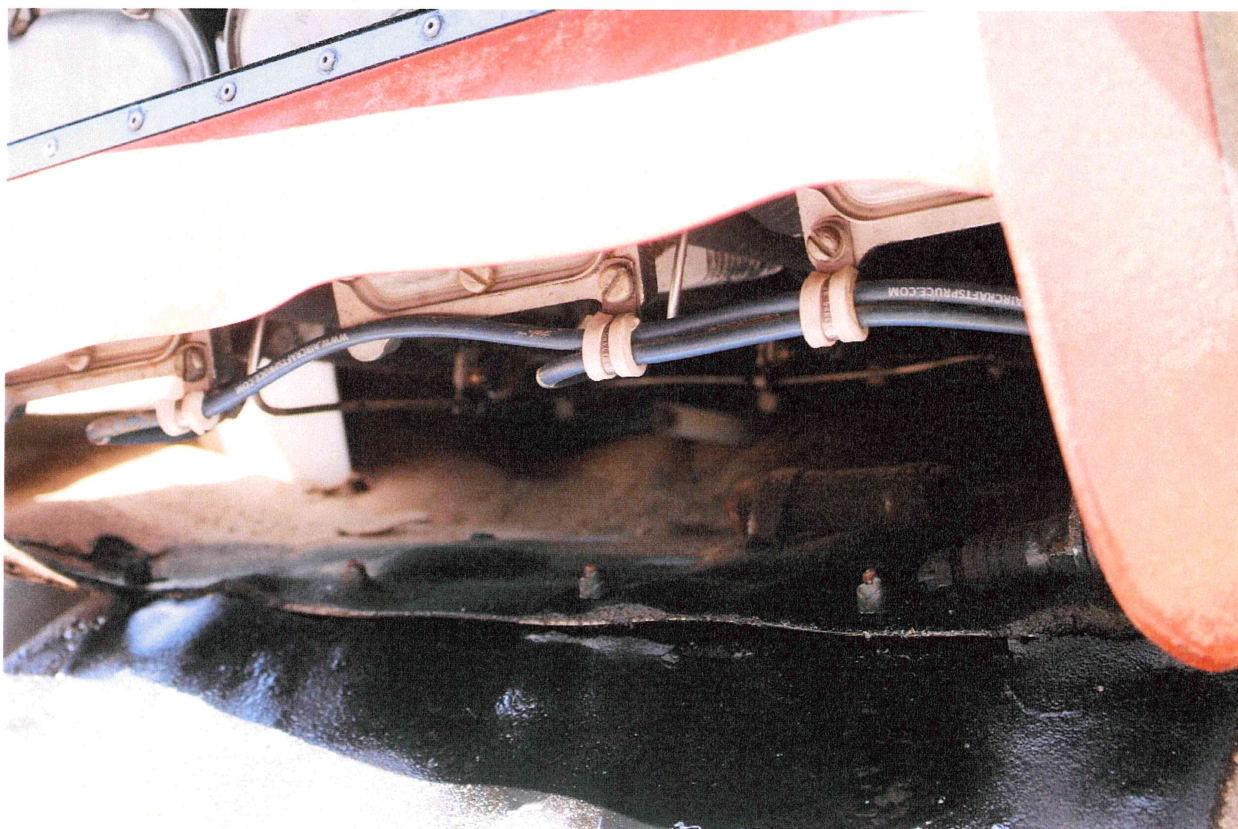
Approximately 12 nautical miles inbound to Charlottenfelder, the pilot reported a sudden, aggressive, loud, and distinct vibration from the engine. Following the initial shock, the pilot immediately attempted to control the engine, noting that manual inputs to both the Mixture Control Lever and the Manifold Pressure (throttle) control had zero effect on the engine's behaviour. The engine performance was uncommanded and uncontrollable. They also noticed that there was a deformation on the top of the engine cowl, and oil was being pushed out of the cowl into the airstream.

*Photo 3: Loss of engine oil.*

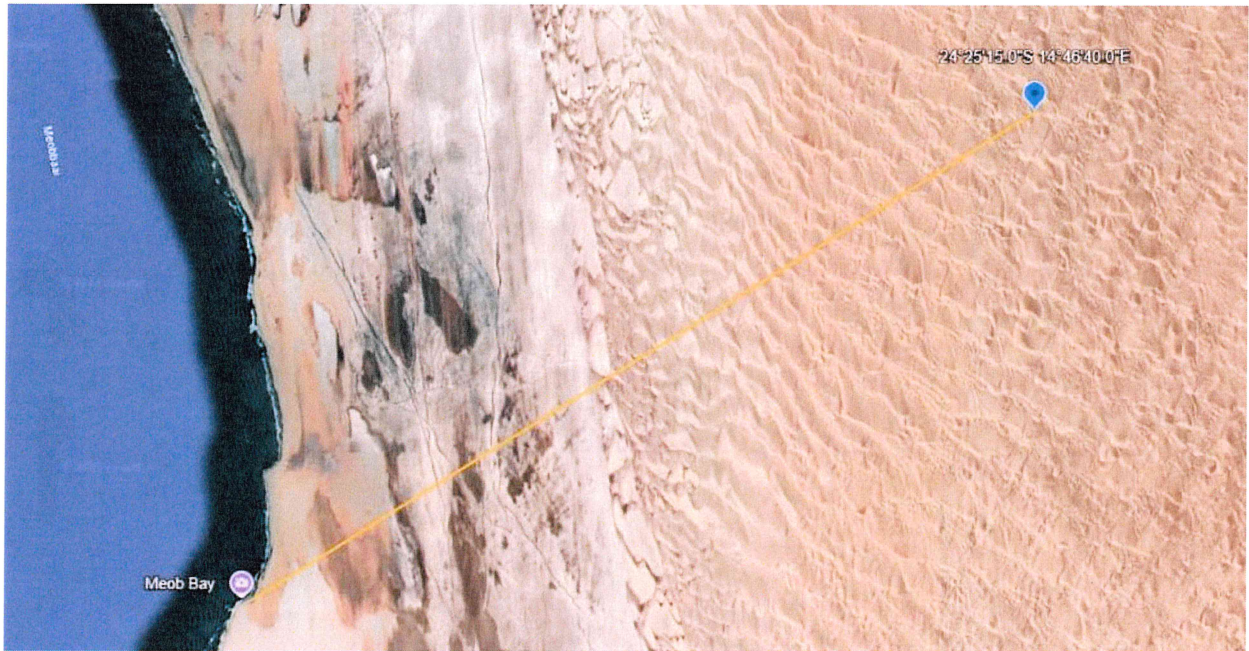
*Photo 2: location of the wreckage.*

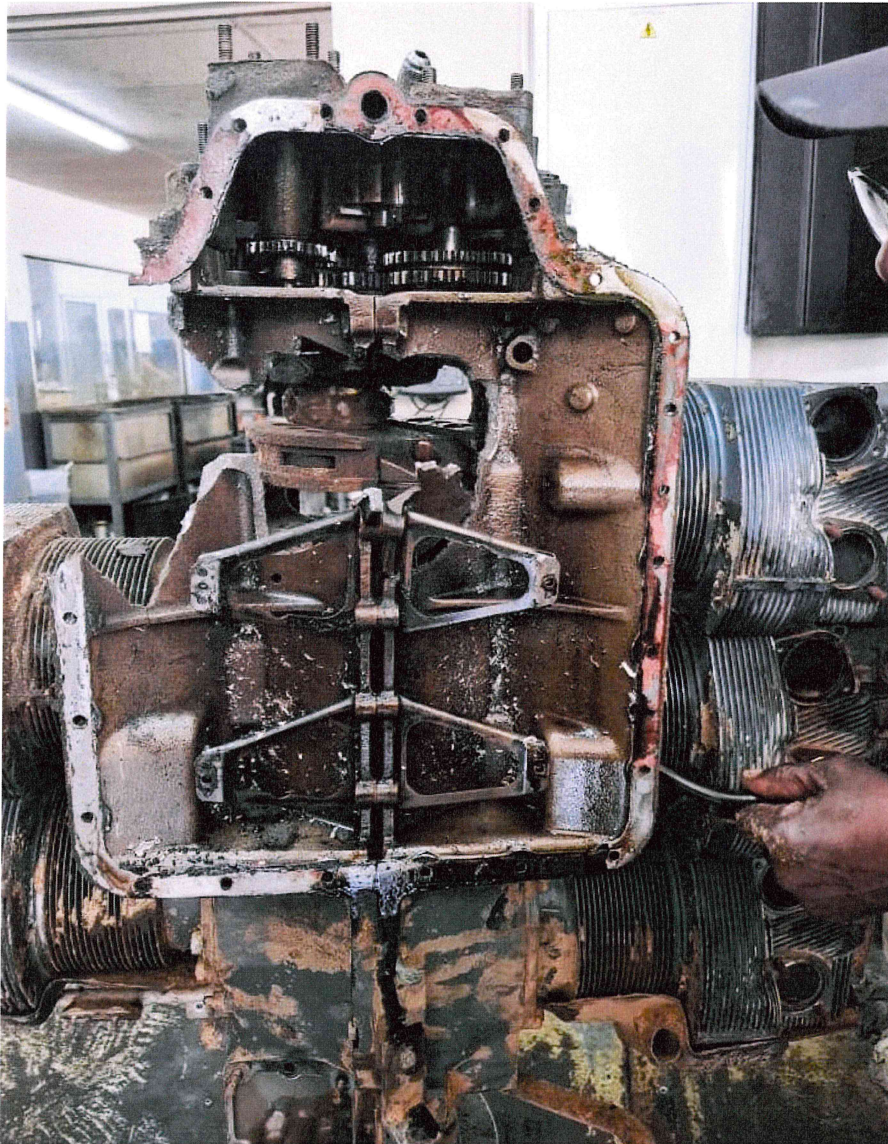
1. Wreckage Examination: Detailed recovery and examination of the engine and propeller assembly to determine the exact component failure that led to the aggressive vibration and loss of control.
2. Engine Records: Review of the aircraft and engine logbooks, maintenance history, and parts traceability records.
3. Performance Analysis: Calculation of aircraft performance parameters at the time of the incident.
4. Engine teardown: The engine was removed and sent to a maintenance and repair facility in South Africa for detailed examination.

Photo 3 : Engine teardown
