**Serious Incident Investigation Preliminary  
Report**

DESCRIPTION OF OCCURRENCE: Loss of Control (LOC-G).  
TYPE OF OPERATION: Post Maintenance Flight.  
AIRCRAFT TYPE: EMBRAER, ERJ145 (C9-MEK)  
LOCATION: FYWE (EROS AIRPORT)  
DATE AND TIME: 2025/09/15 (18:20 local time).

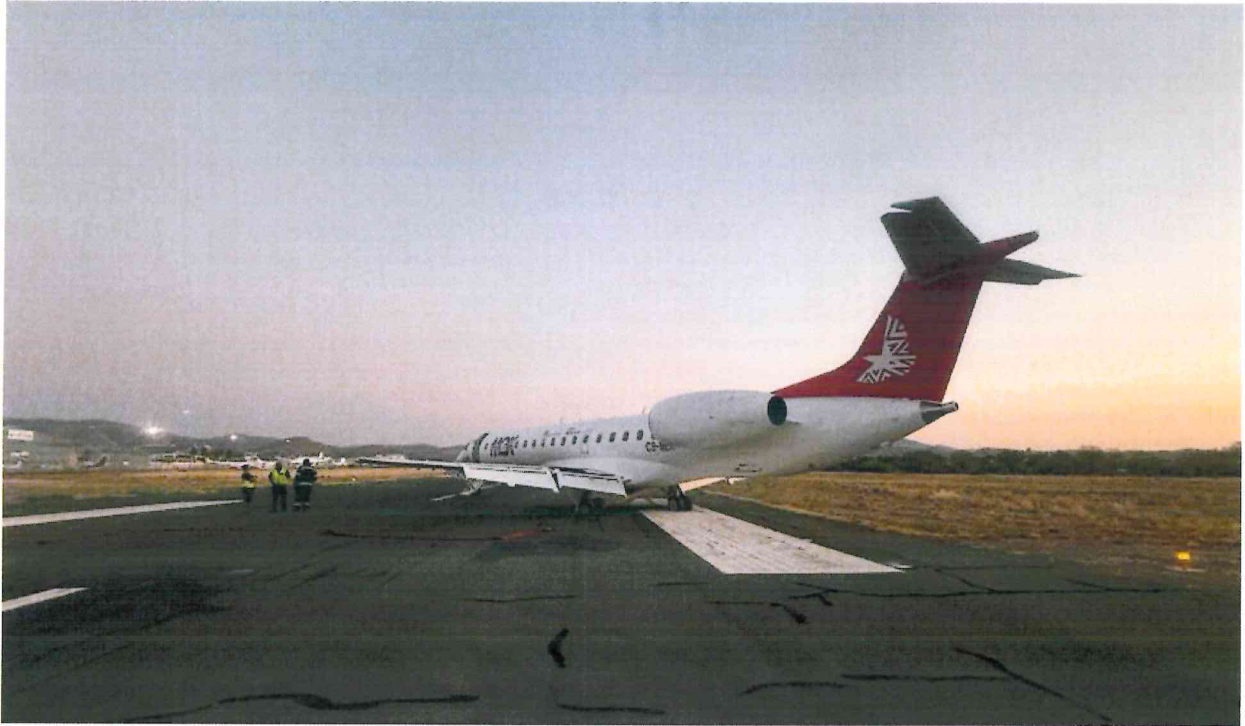
*Photo 1. The aircraft after coming to a stop near the runway threshold.*

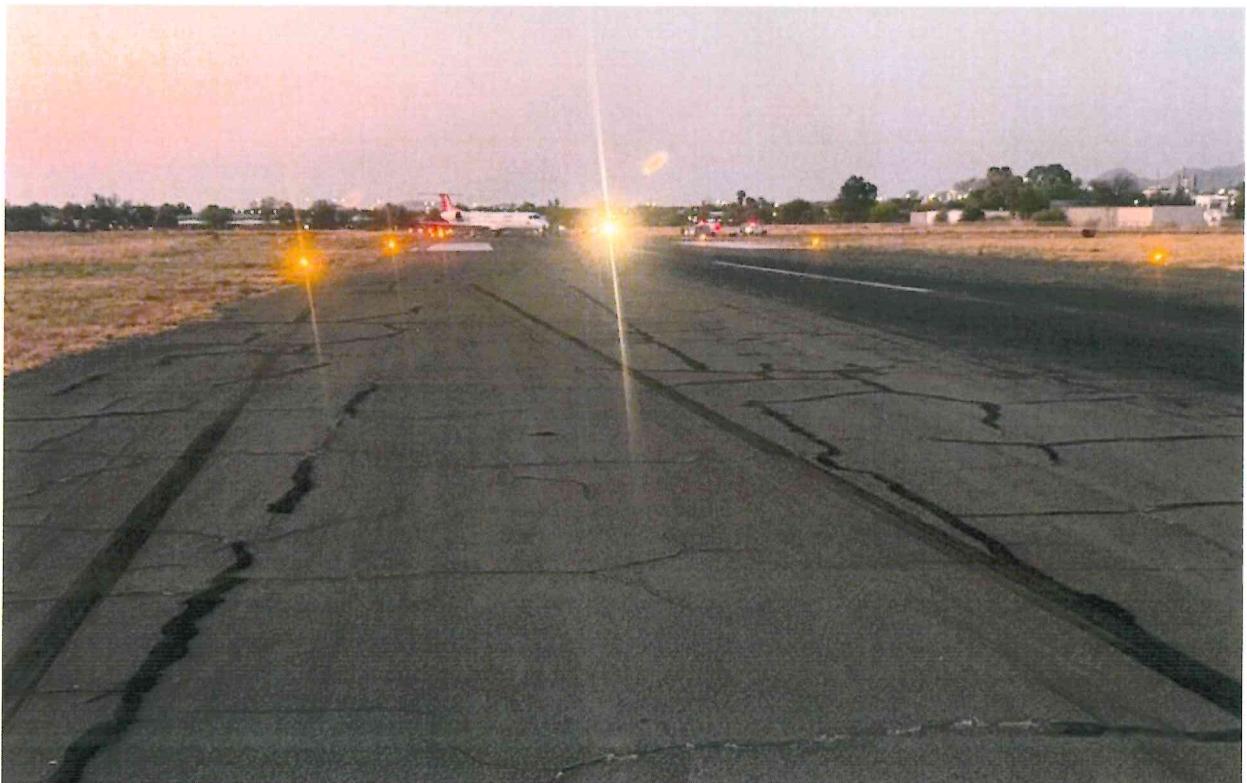
*Photo 2. Photo depicting the aircraft as it veered to the left..*
