REPUBLIC OF NAMIBIA
MINISTRY OF WORKS AND TRANSPORT

Accident Reference: ACCID/05032024-01-01

Aircraft Accident Investigation Interim Report

Reims Cessna F406 Caravan II aircraft: V5-ASB

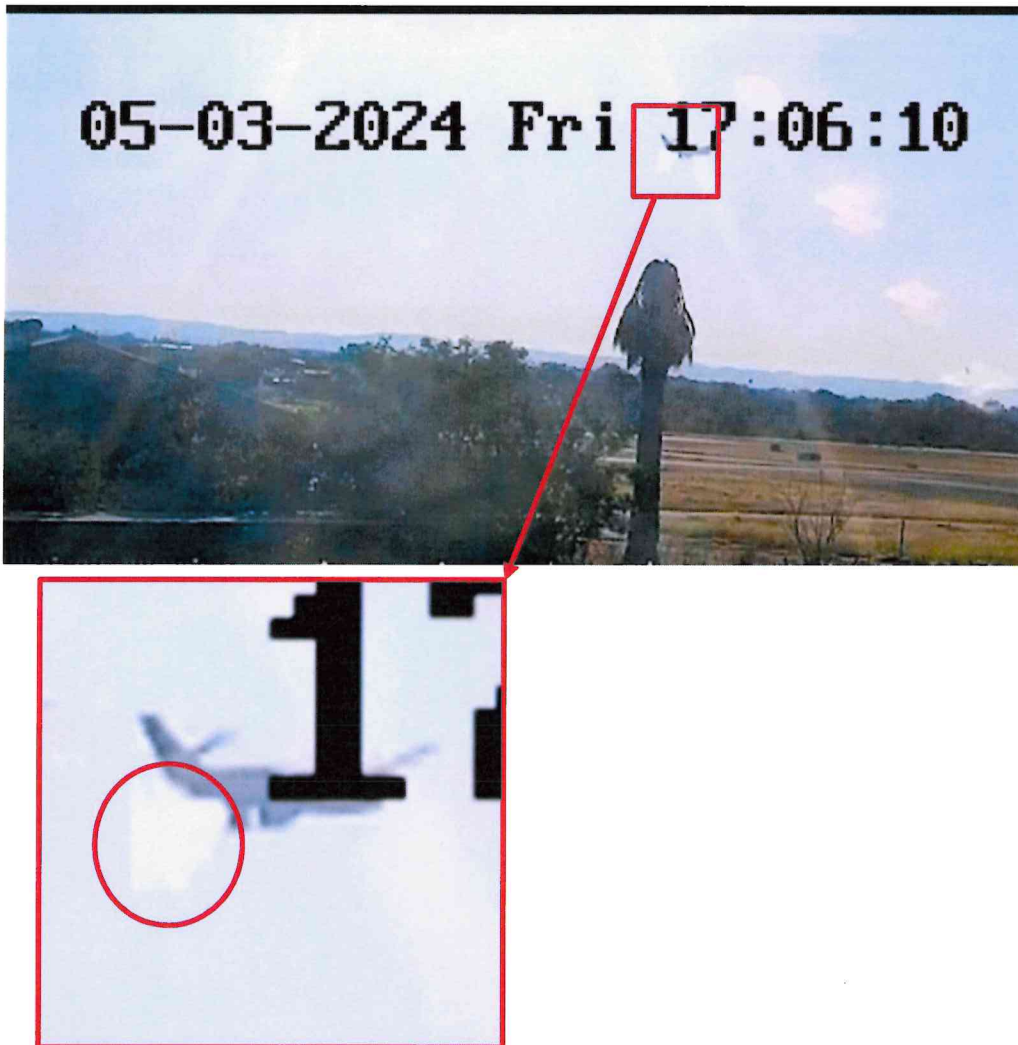
According to CCTV camera footage, shortly after take-off a cloud of smoke could be observed around the left engine, consistent with a malfunction in the left engine. As soon as the smoke around the left engine was observed, the aircraft banked sharply to the left and crashed.

Figure 2: Image shows a cloud of smoke observed around the left engine. (CCTV Footage courtesy of the Operator)

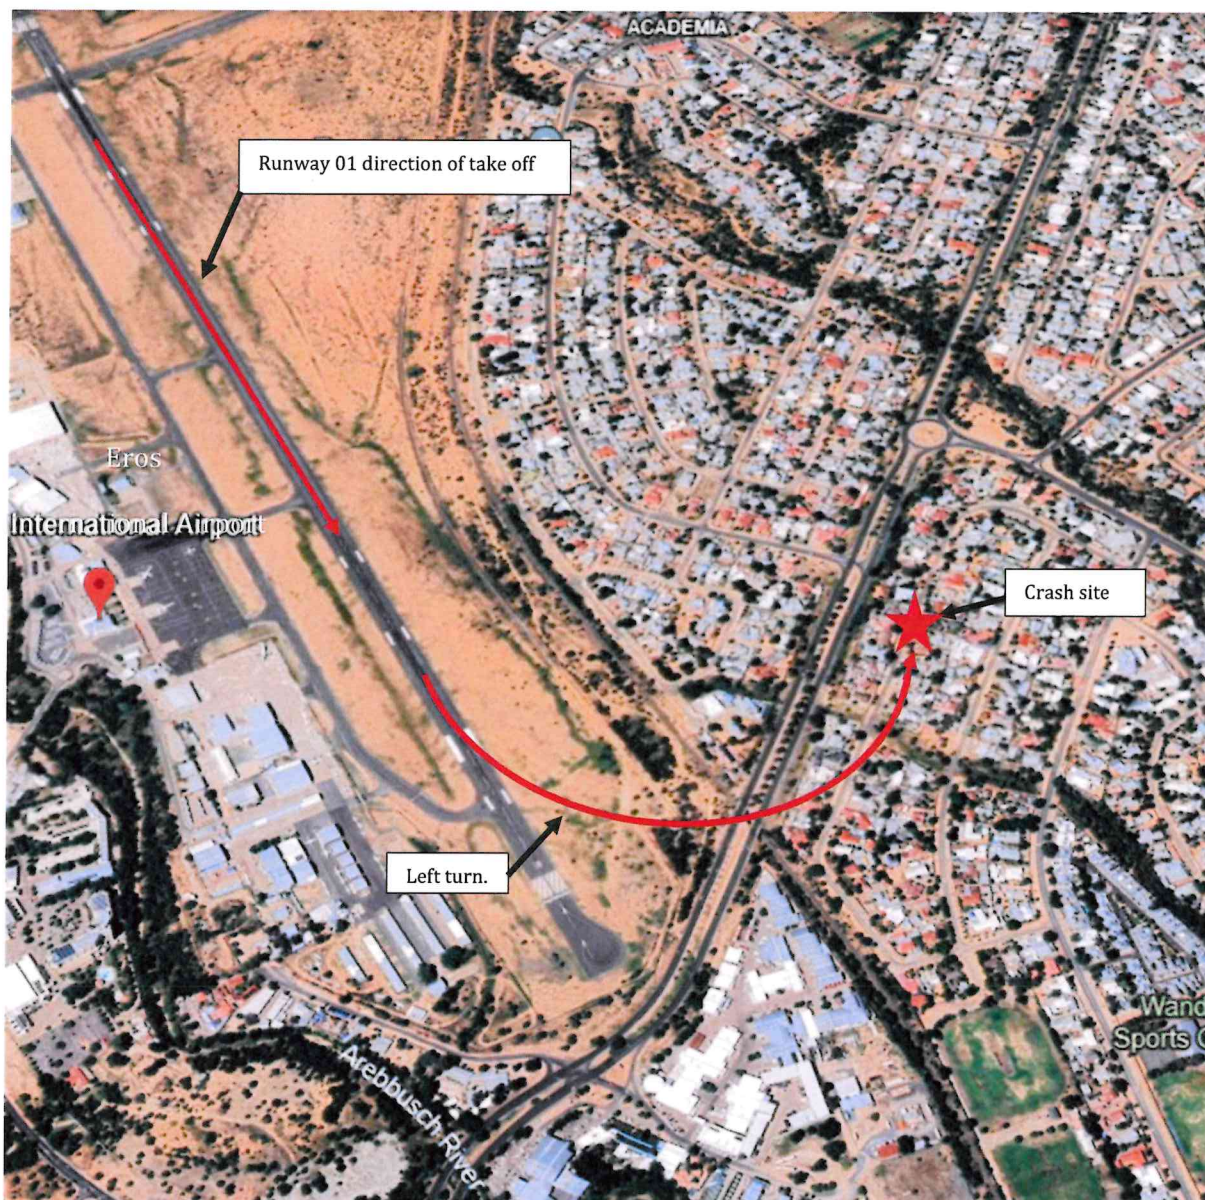
Figure 3: Picture showing where the Aircraft crashed (Image: Google Earth).

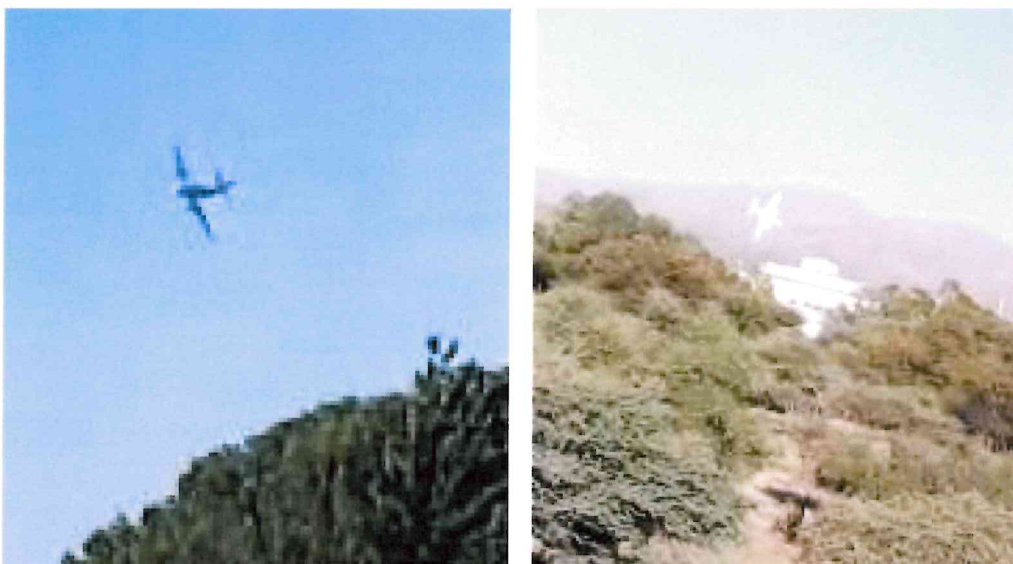
The aircraft was observed in a steep nose-down attitude with the left wing oriented approximately 90 degrees downward (left bank) prior to impacting the ground within a residential area.

Figure 4 and 5: Pictures showing the aircraft banking sharply to the left, shortly before it crashed (CCTV Footage)

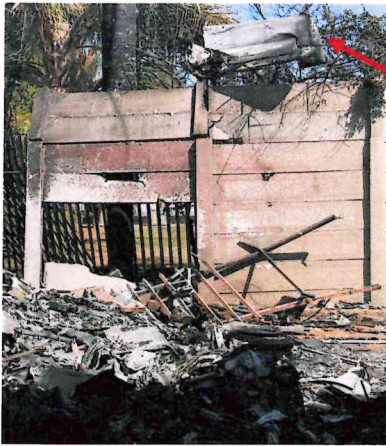
Horizontal stabilizer and elevator

Figure 6: Picture showing where the left horizontal stabilizer and elevator came to rest.

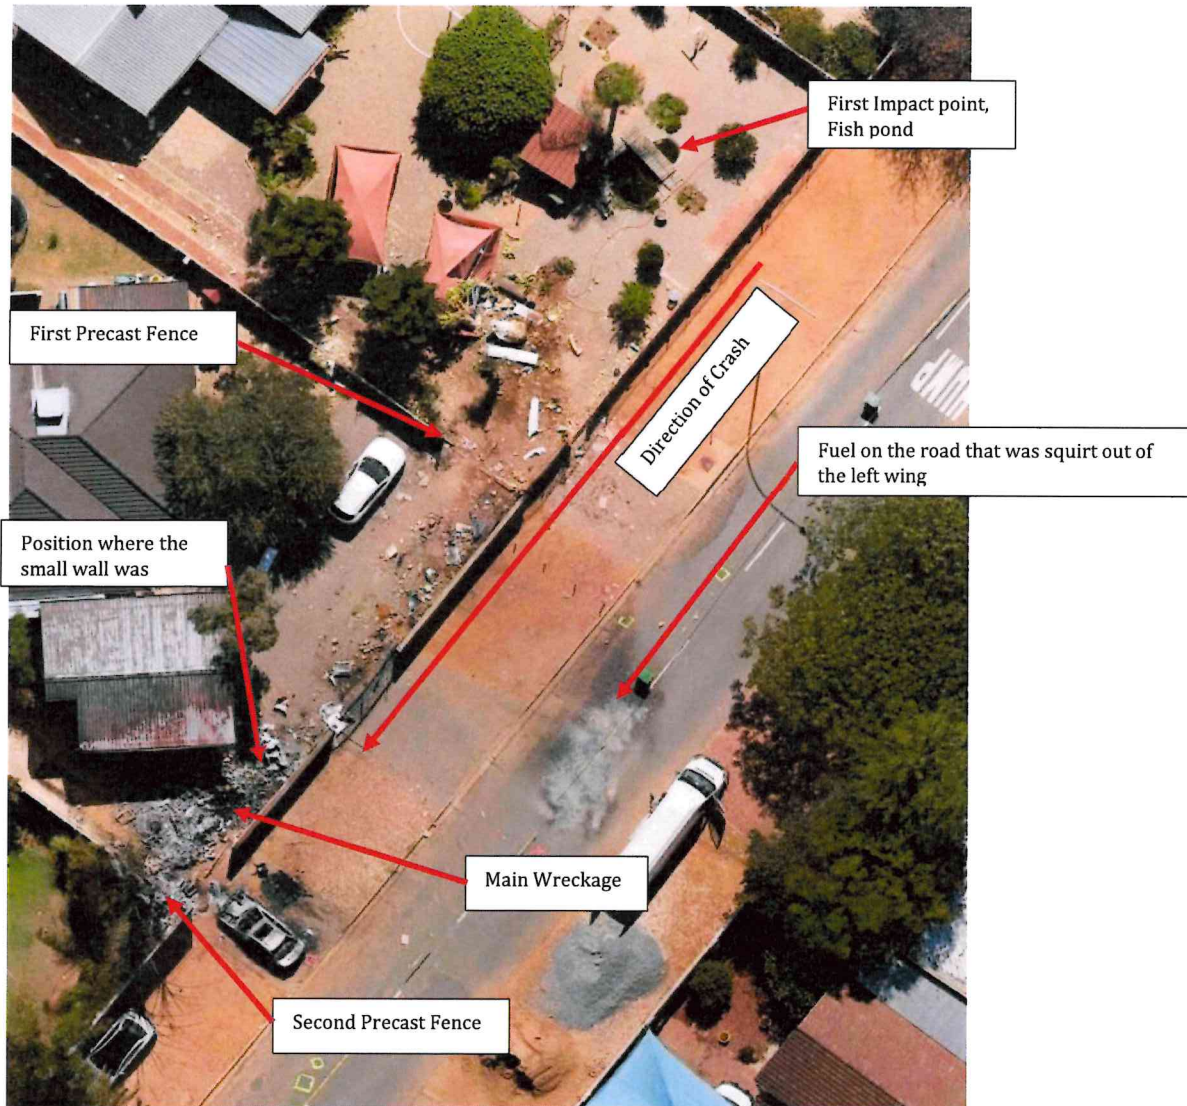
The left wing impacted the ground first followed by the left engine and then the nose section of the aircraft, hitting trees in the first yard. The impact caused the aircraft to flip sideways breaking through two precast fences and a small wall. It came to rest in the corner of the second yard with the right horizontal stabilizer and elevator ended up on top of the precast fence. The impact resulted in fuel discharge from the left wing onto the adjacent street. One of the left engine's propeller blades was separated during the impact sequence and was found approximately 200 meters from the main wreckage, having come to rest in a separate residential yard. Post-impact, the aircraft breached a precast perimeter fence, after which a fire ensued.

Figure 7: Picture showing the impact sequence (drone footage).
