**REPUBLIC OF NAMIBIA
MINISTRY OF WORKS AND TRANSPORT**

**Directorate of Aircraft Accident and Incident
Investigations**

Accident Reference: ACCID/09202024/09-01

Aero Commander- 695B (AC95): V5-DAM

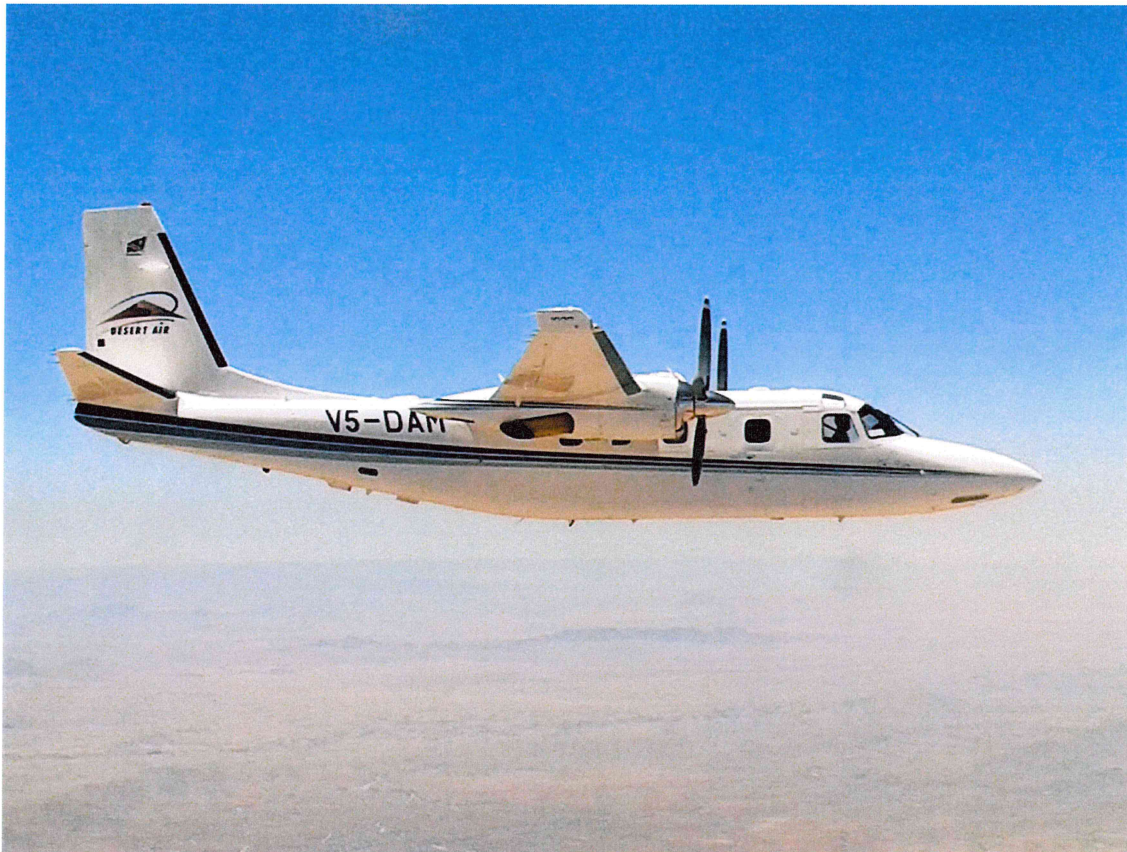
Figure 1: The Aero Commander- 695B, V5- DAM, accident aircraft (Source: Operator)

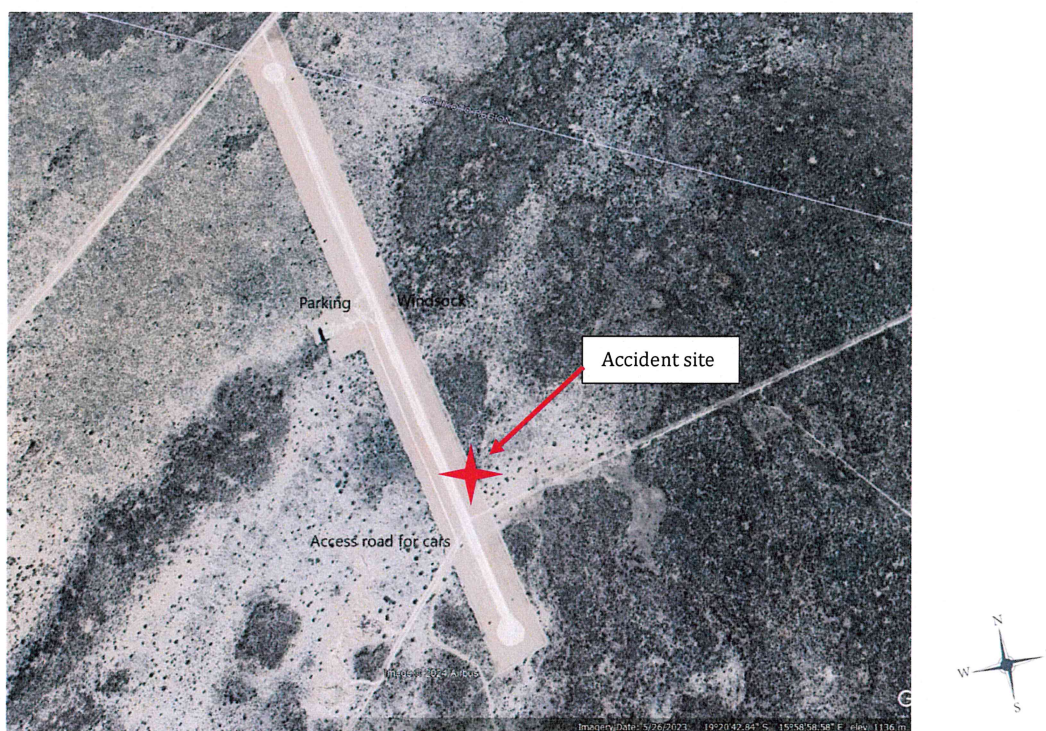
The Aircraft left the RWY and continued towards the parameter fence until it collided with the fence. The distance from the point where the aircraft left the RWY until the point where it collided with the parameter fence was 171 meters.

Figure 2: Picture showing where the aircraft collided with the fence.

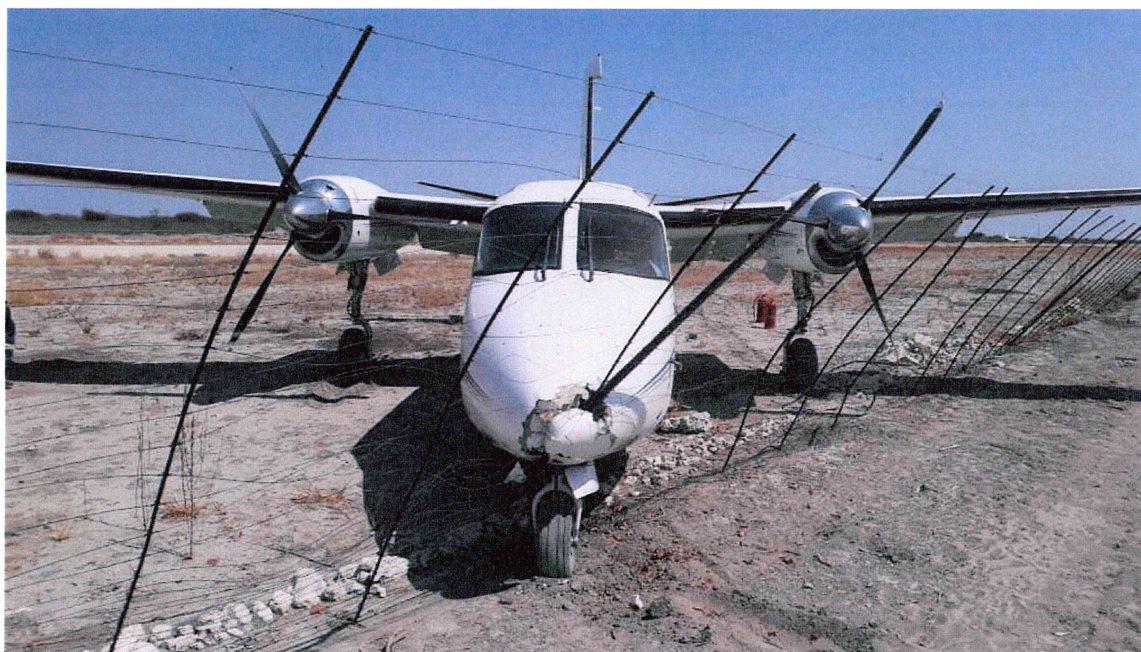
The Aircraft sustained substantial damage, when it collided with the parameter fence. The Radome (Nosecone) hit an iron pole, which caused the nose section of the aircraft to lift almost one meter off the ground, before the aircraft came to full stop. The iron pole caused substantial damage to the nosecone. The left propeller was also damaged when it stroke the fence and smaller iron poles. The left wing of the aircraft also made

Figure 3: Picture showing the damage to the nosecone.

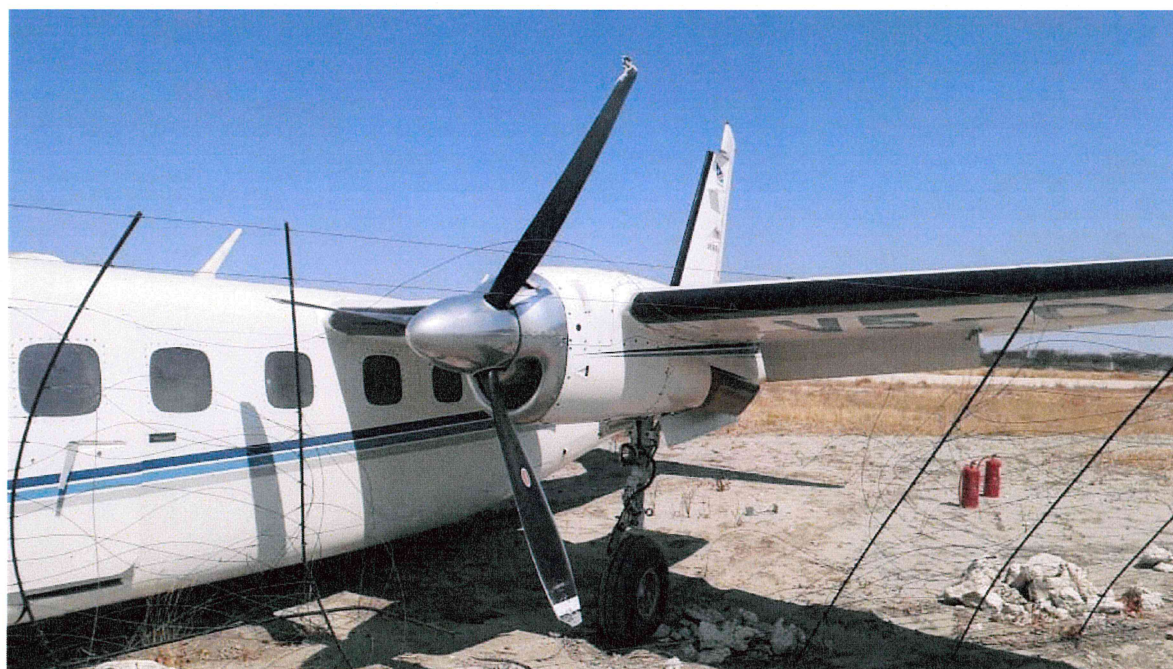
Figure 3: Picture showing the damage to the left propeller
