**Directorate of Aircraft Accident and Incident
Investigations**

Occurrence Reference: ACCID/02082026/02-01

Accident Preliminary Report

Tecnam P-2004 Bravo (BRAV): V5-UTD

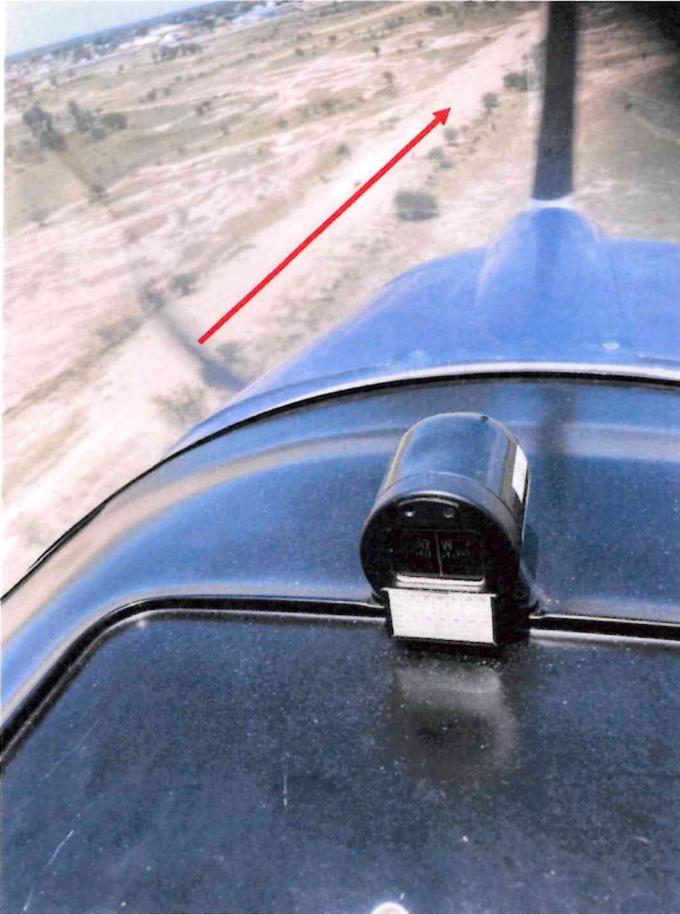
Figure 2: Image shows the RWY to left (Red Arrow) of the aircraft (Source: Passenger, picture was taken moments before the crash)

- 1.1.3. While doing the RWY inspection the passenger alerted the PIC of a bird concentrations ahead. To avoid a bird strike the PIC started to climb and according to him, when he was about to retract the flaps the wings were rocking, the aircraft then suddenly banked left. The PIC then applied full right rudder, but his input did not have any effect, he lost control of the aircraft and the aircraft crashed next to the RWY.
- 1.1.4. The aircraft hit a thorn bush, nose first, the left wing stroked the ground before the aircraft came to full stop. The engine stopped during the collision with the thorn bush.
- 1.1.5. According to the PIC, he then turned the main switch off and closed the tank taps before he and his passenger disembarked from the aircraft. The passenger suffered a minor injury while the PIC was unharmed.

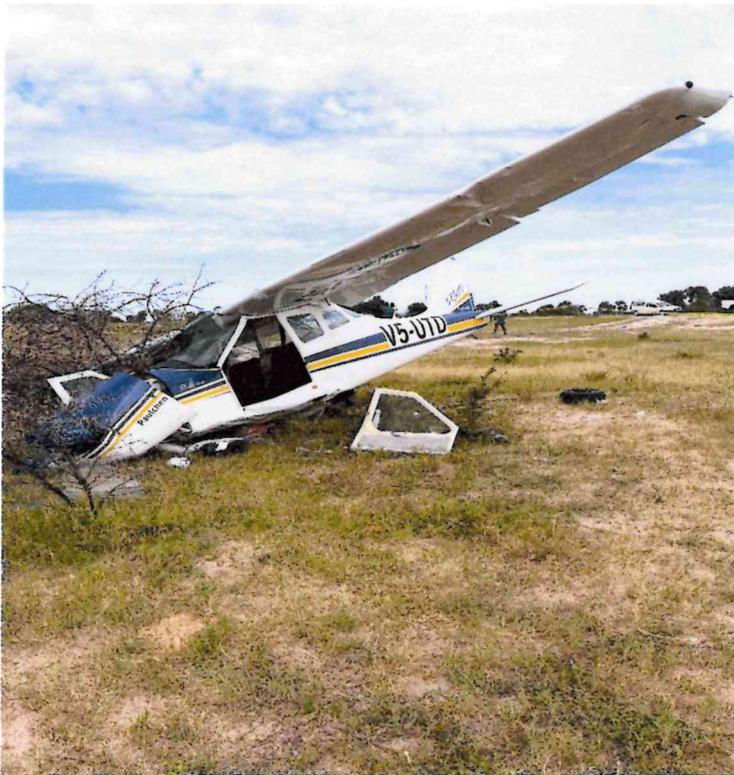
Figure 3: Image showing how the aircraft came to a full stop.

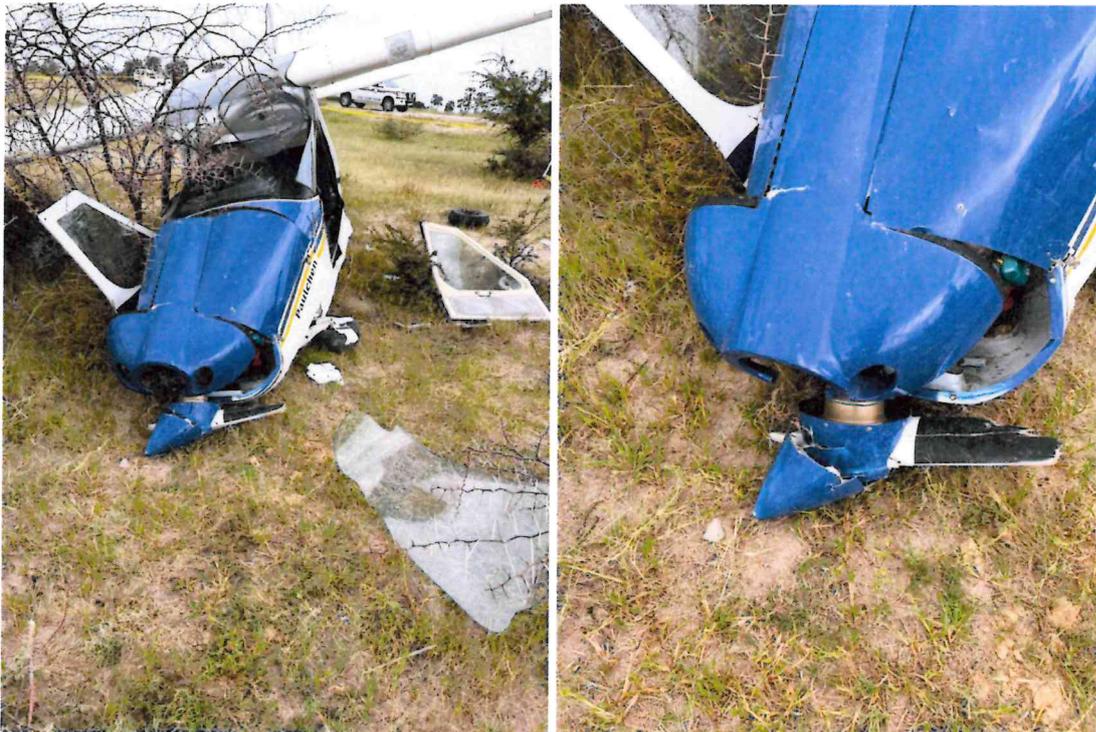
The aircraft was substantially damaged. The aircraft sustained damage to the fuselage, both Left and Right hand wings as well as the nose section including the wooden propeller. The undercarriage was also destroyed during the impact sequence.

Figure 4 and 5: Pictures shows the extend of the damage to the nose section.
