**REPUBLIC OF NAMIBIA
MINISTRY OF WORKS AND TRANSPORT**

**Directorate of Aircraft Accident and Incidents
Investigations**

**Aircraft Accident Investigation Interim
Report**

16th July 2020
Mc. Donnell Douglas, 1997 MD 600N Helicopter
V5-HVD
near Heja lodge, Windhoek NAMIBIA

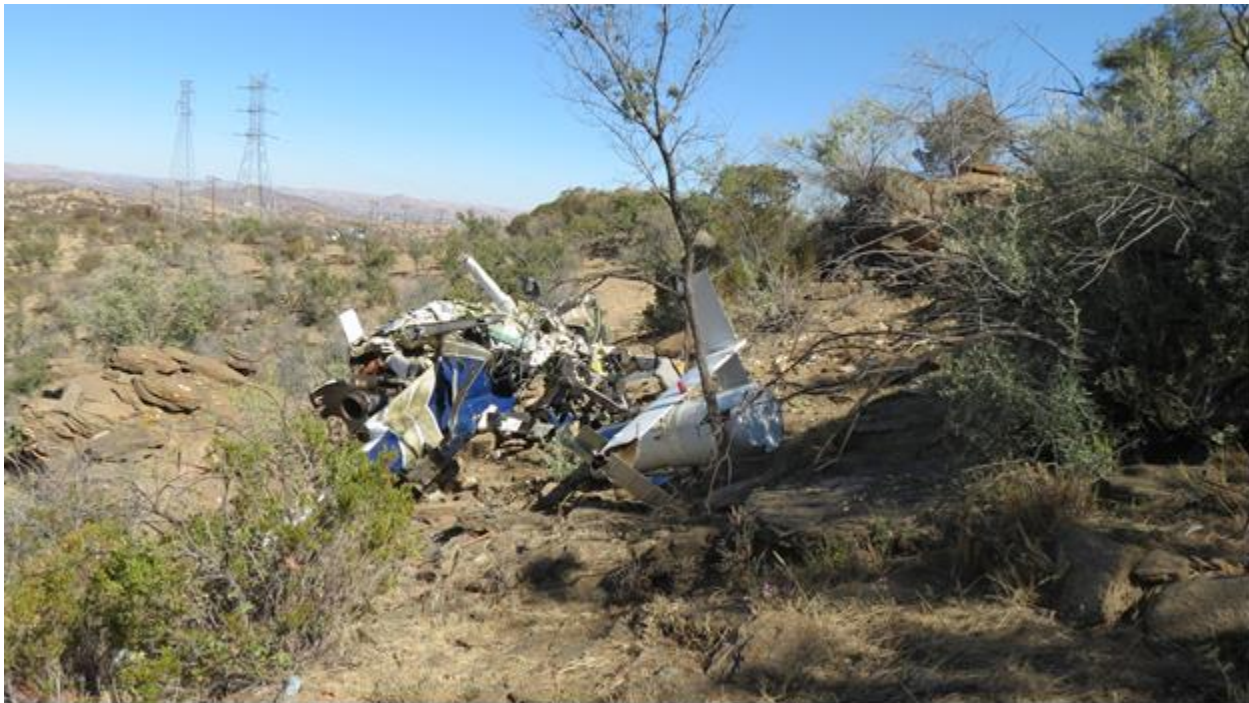
The pilot searched for an area to quickly land using the auto-rotation procedure. He veered between some hills and found a relatively level area while trying to avoid high voltage power lines straight ahead. He lost control and hit the ground at a shallow angle, the aircraft hit the ground and tumbled down a ravine and came to rest halfway the cliff.

The helicopter was destroyed. The pilot and one passenger were seriously injured, the other two passengers sustained minor injuries.

Figure 1. Photo depicting the final resting position with visible high voltage power lines ahead.

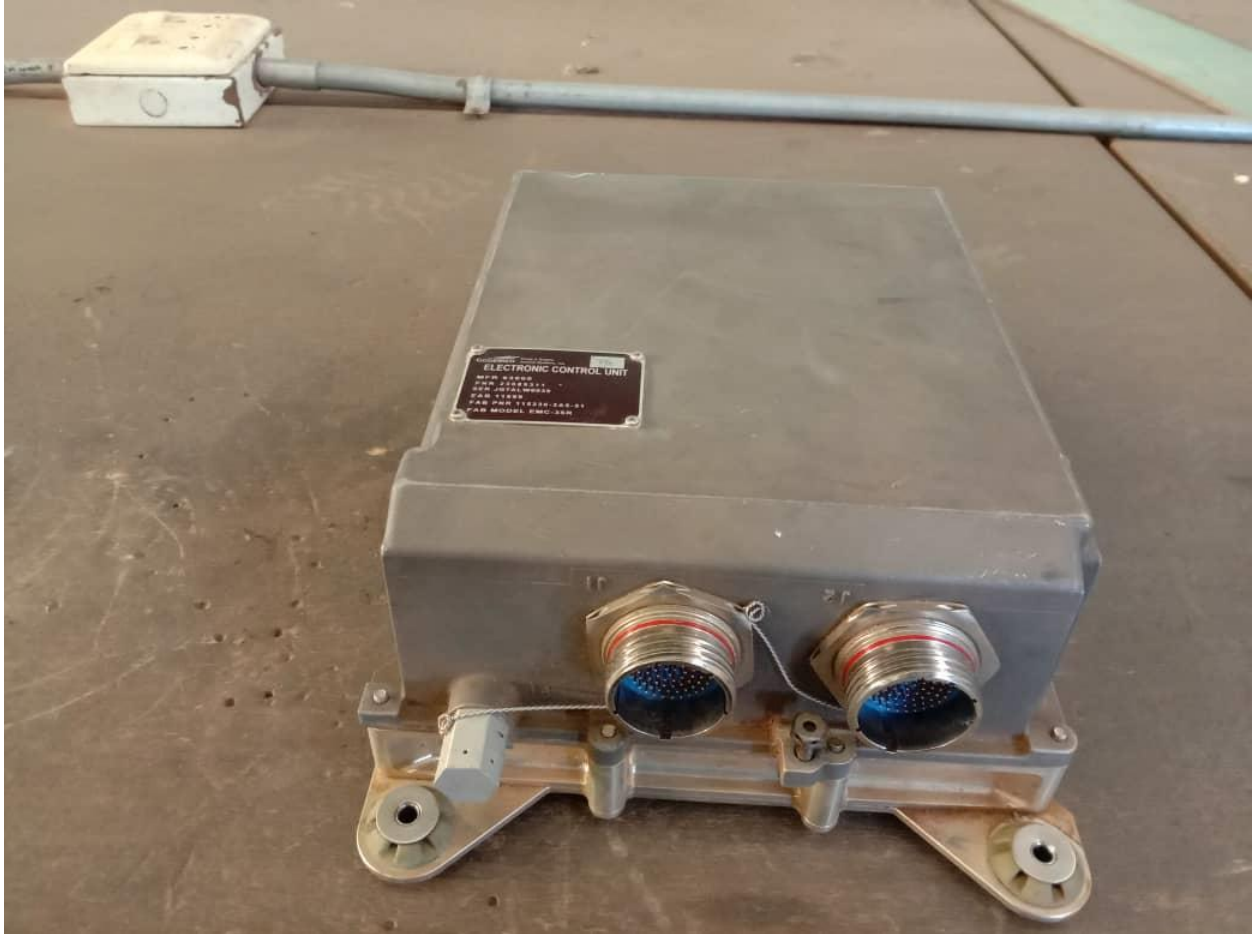
The engine was extensively damaged and could not be function tested. However several components were inspected and tests are ongoing. It was important to establish if fuel was being delivered to the engine. The ECU unit was dismantled from the wreckage and sent for download in a facility approved by the Manufacturer in South Africa under the supervision of the South African Civil Aviation Authority's Accident and Incident Investigation Division (SACAA AIID).

Figure 3. Electronic Control Unit
