**CIVIL AIRCRAFT FINAL ACCIDENT REPORT**

**ACCID/112721/02-05**

**AIRCRAFT : V5-ELZ  
REGISTRATION**

Belly landing at Eros Airport RWY 19  
Private Flight  
Beech A36, 1972 Aircraft,  
V5-ELZ Eros Airport, Windhoek  
27<sup>th</sup> November, 2021

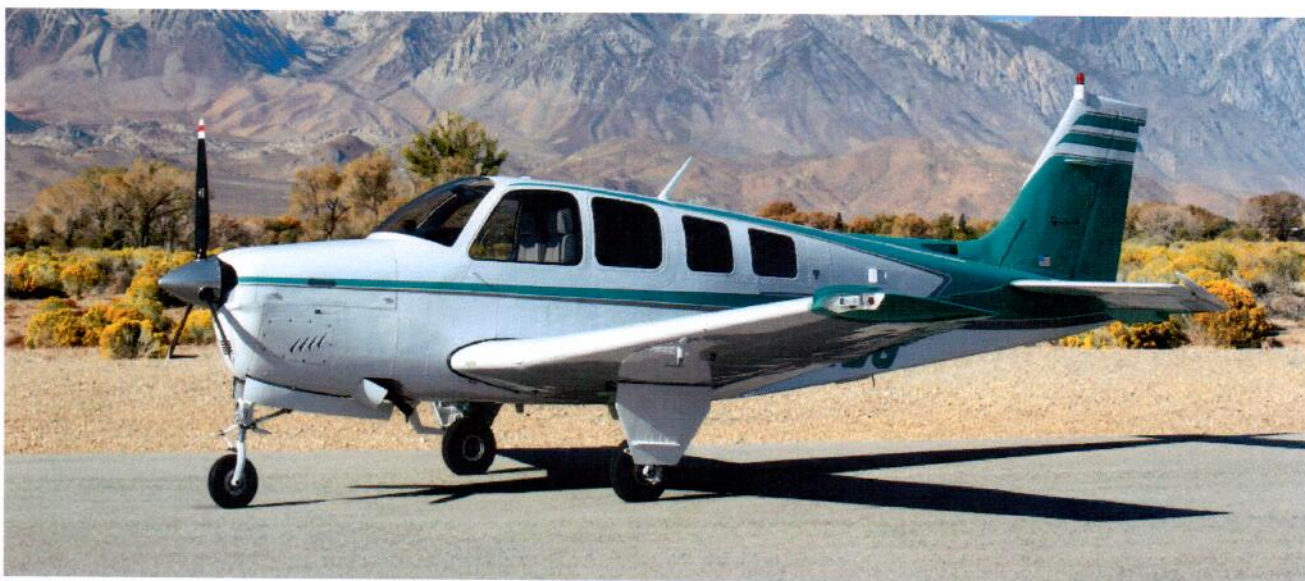
1.3.2 Figure 1: Photo of the aircraft before the accident. Photo for illustration purpose.
