**CIVIL AIRCRAFT ACCIDENT REPORT**

**ACCID/011108/01-12**

<b>OPERATION</b>	<b>:</b>	<b>COMMERCIAL</b>
<b>AIRCRAFT</b>	<b>:</b>	<b>V5-GWH</b>
<b>LOCATION</b>	<b>:</b>	<b>WINDHOEK</b>
<b>DATE</b>	<b>:</b>	<b>11 JANUARY 2008</b>

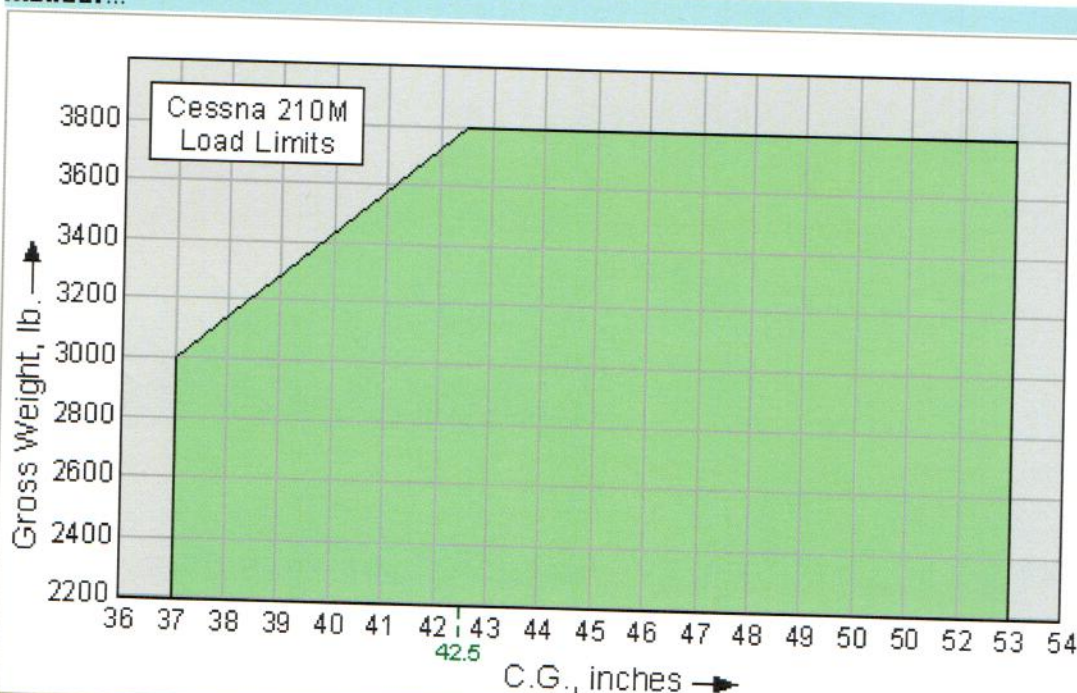
## 12 Calculation and chart – Actual values

Therefore, the C.G. was found **1.35** in. (**minimal**), **3.05** in. (**actual**) or **3.11** in. (**maximal**) out of the aircraft aft limit.

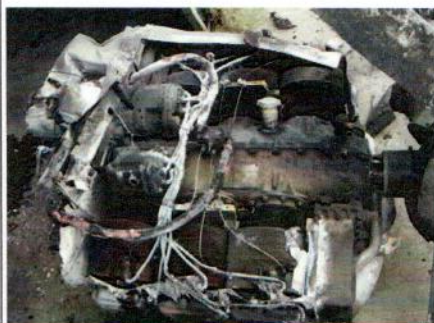
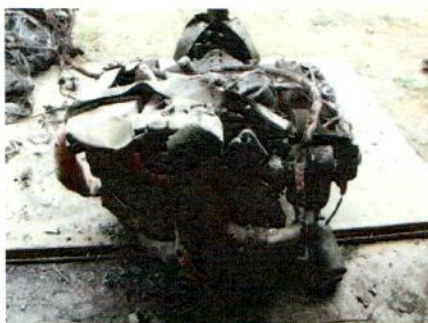
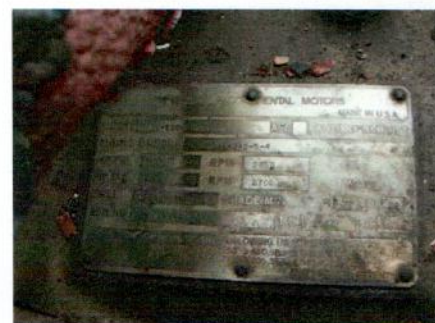
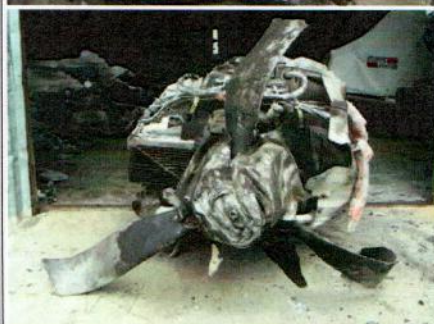
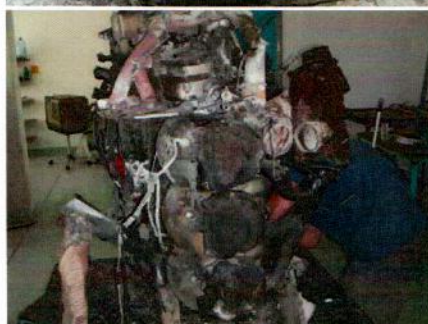
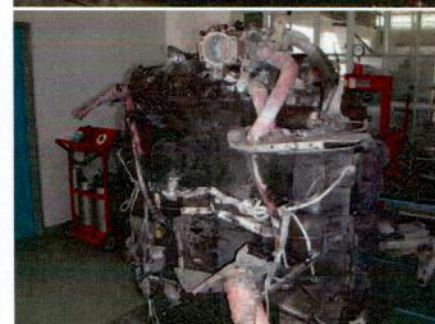
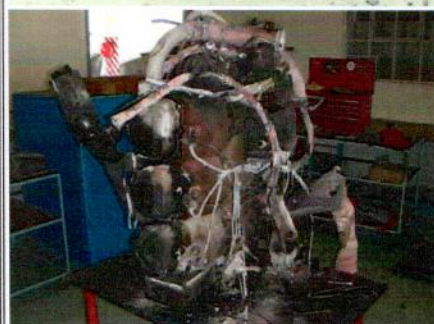
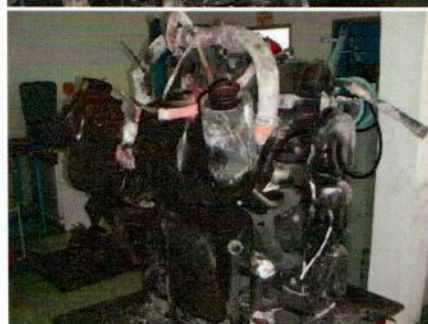
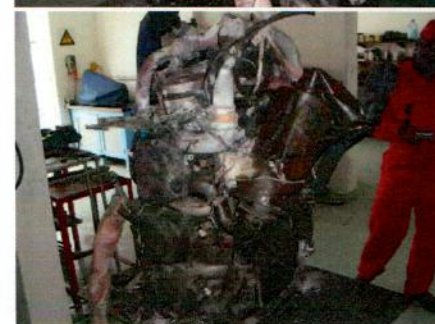
**EXTERNAL INSPECTION OF ENGINE:** There was thermal damage to the engine and all external components. The inspection occurred at the Aviation Center Ltd. facility. The engine was initially viewed on the ground in a hangar with the firewall and instrument panel section attached. The engine was removed via a forklift and taken to a secure and sterile environment for further inspection and disassembly.

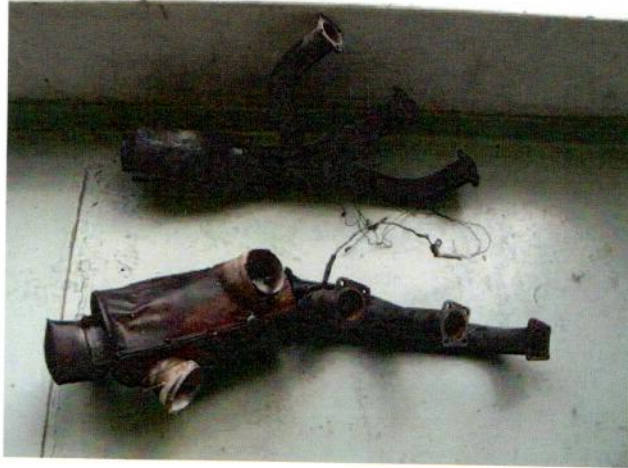
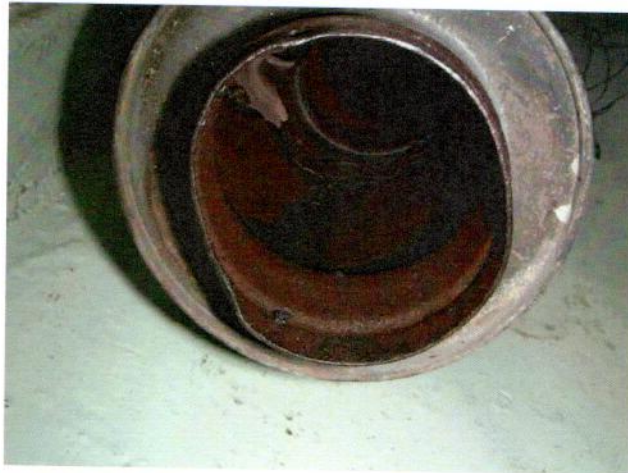
#### Exhaust System

The exhaust system remained attached to the engine. The exhaust pipes and exhaust muffler assembly were bent and deformed and exhibited thermal damage. Corrosion was observed at the muffler. Deformation was observed to the exhaust pipe.

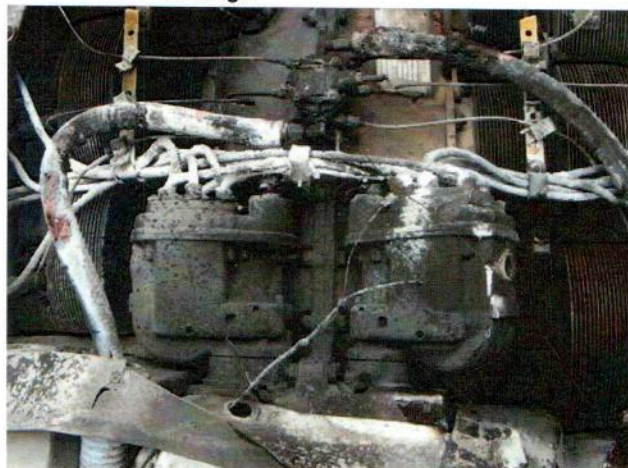
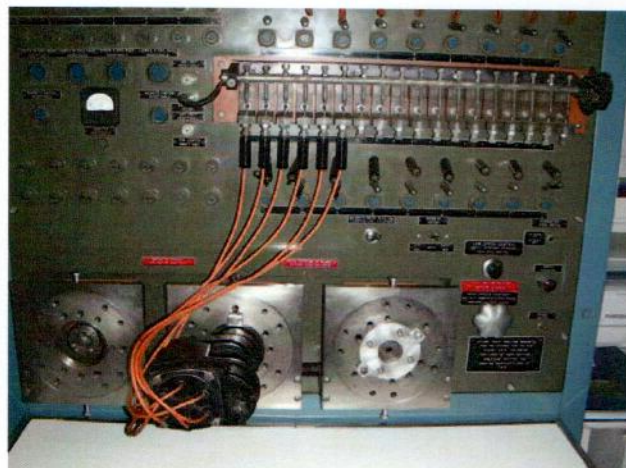
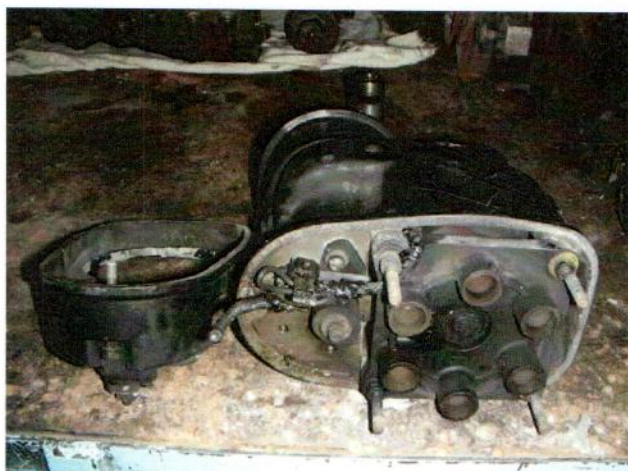
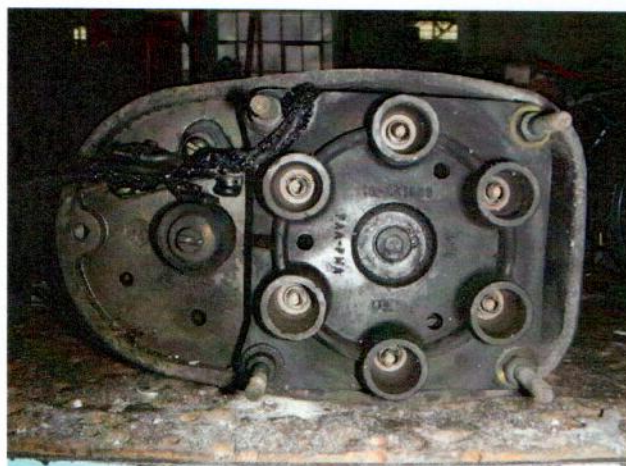
Condition: The magneto was intact and remained attached to the engine mounting pad. Internal and external thermal damage was observed. During the bench test, coupling engagement was noted, although spark was not observed. The harness assembly could not be used during the test due to thermal damage.

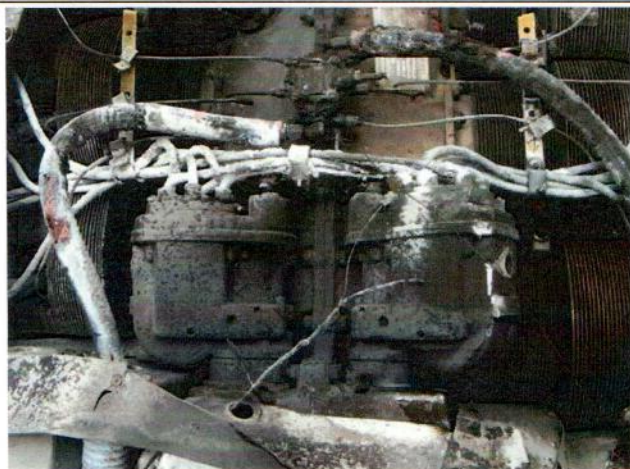
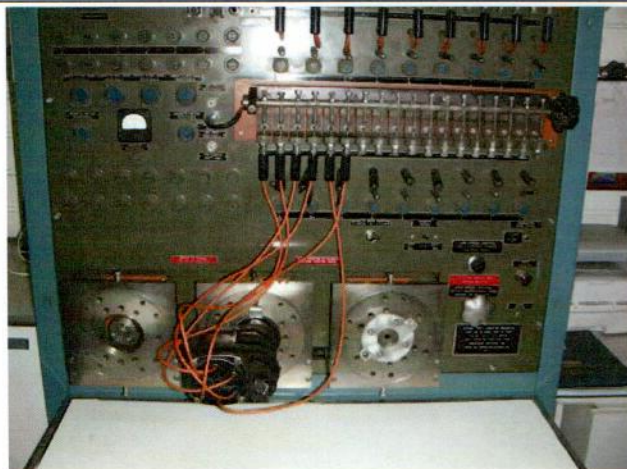
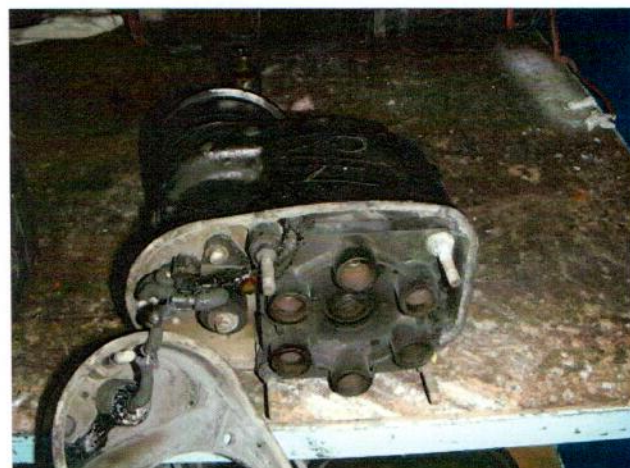
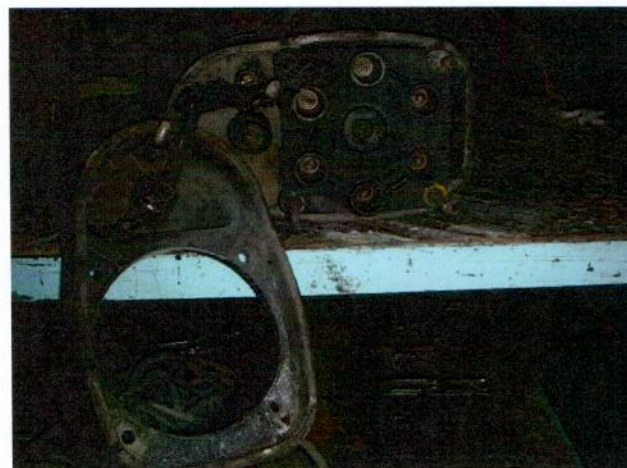
L/H Magneto

Condition: The magneto was intact and remained attached to the engine mounting pad. Internal and external thermal damage was observed. During the bench test, coupling engagement was noted, although spark was not observed. The harness assembly could not be used during the test due to thermal damage.

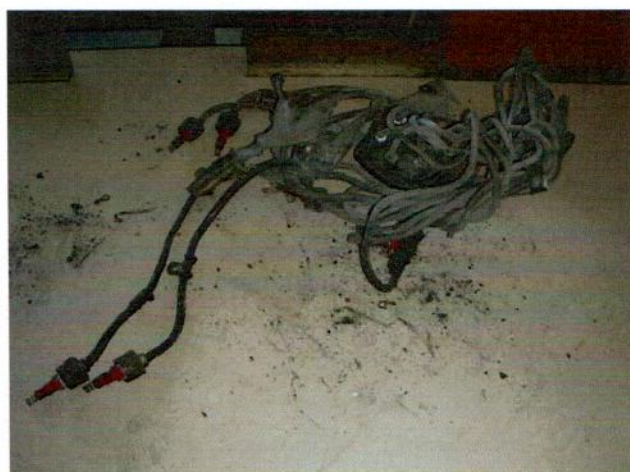
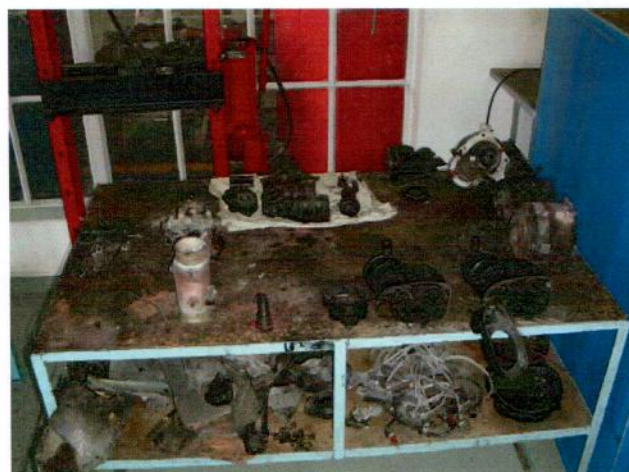
#### Ignition Harness

Condition: The ignition harness was attached and thermally damaged. No sparks to any lead was observed.

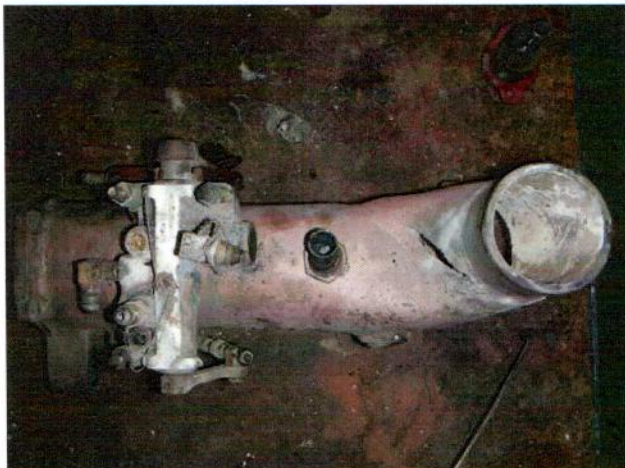
#### Throttle Body Fuel Control

Condition: The throttle body fuel control was intact, although, it was cracked. There was also thermal damage observed to the unit. The throttle plate was stuck open ¼ travel. The throttle and mixture controls were bent and could not move. The screen was clear and thermally damaged.

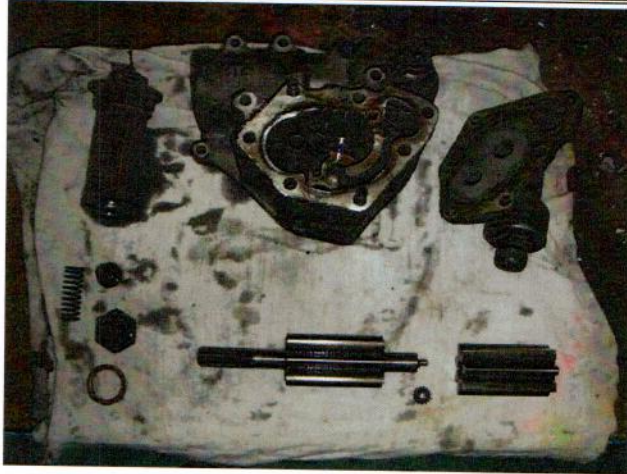
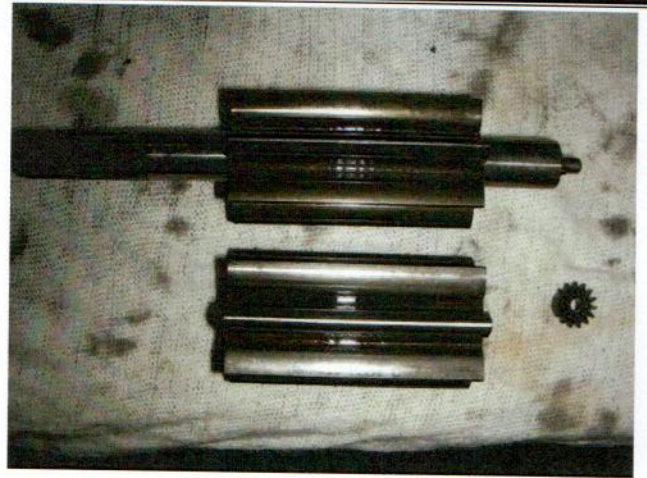
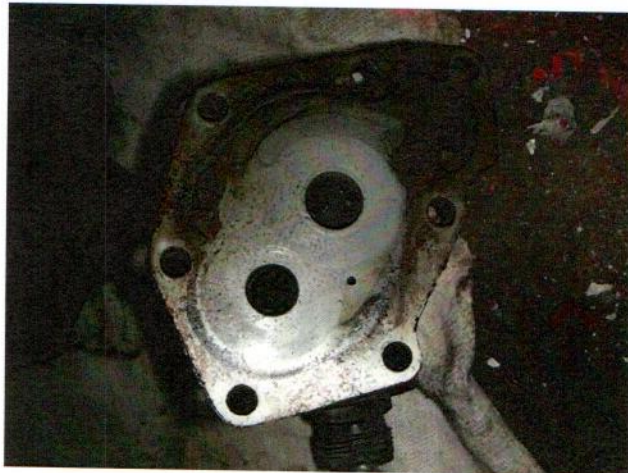
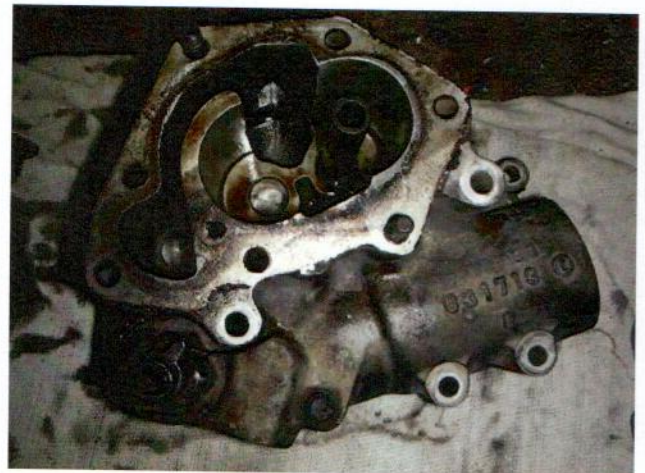
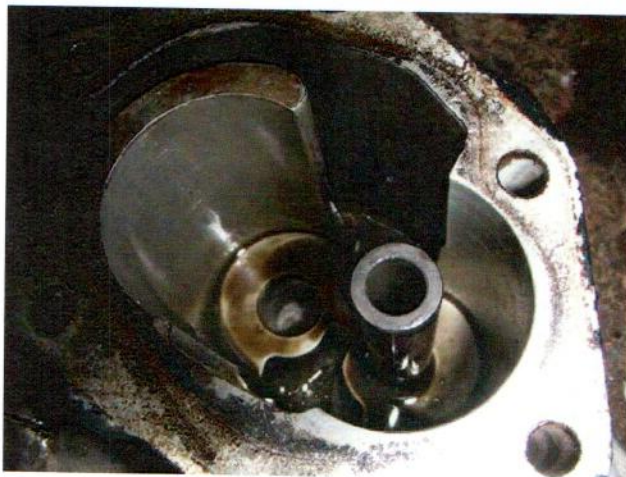
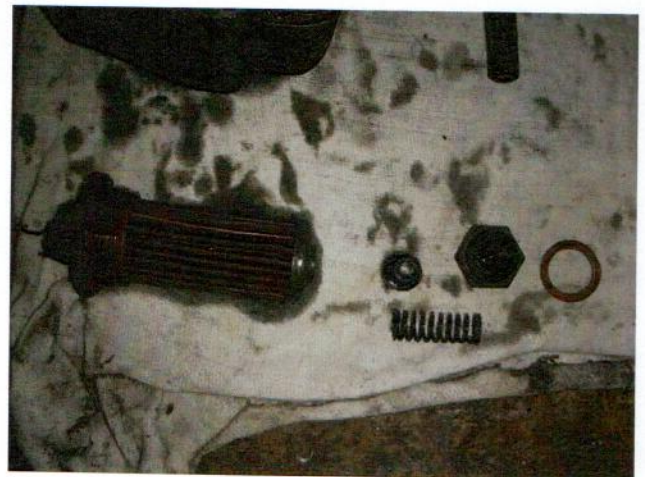
### Oil Pump

The oil pump was intact. The pump assembly was disassembled. Oil was observed within the pump assembly. The internal gears rotated and were intact. Rotational scoring signatures were noted to the pump internal housing walls. The relief valve spring was intact. The filter screen was intact and no metal contaminants were observed.

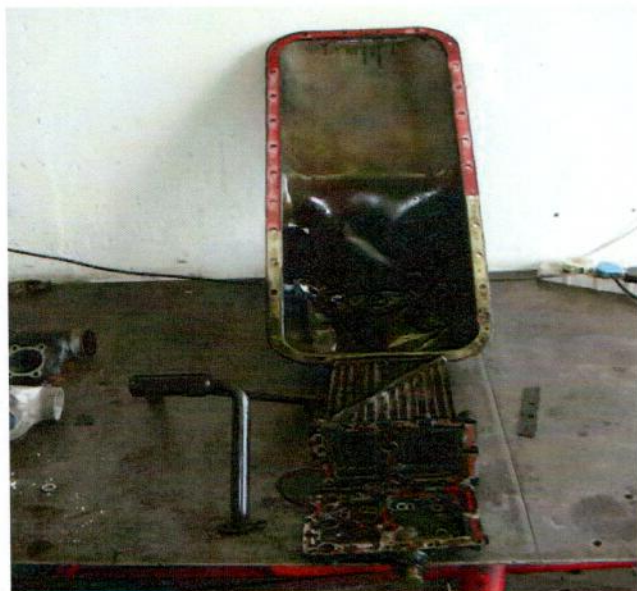
Oil Pick-up Tube & Screen

The pickup tube and screen were intact and secured. The screen and tube assembly was clear of debris and contaminants.

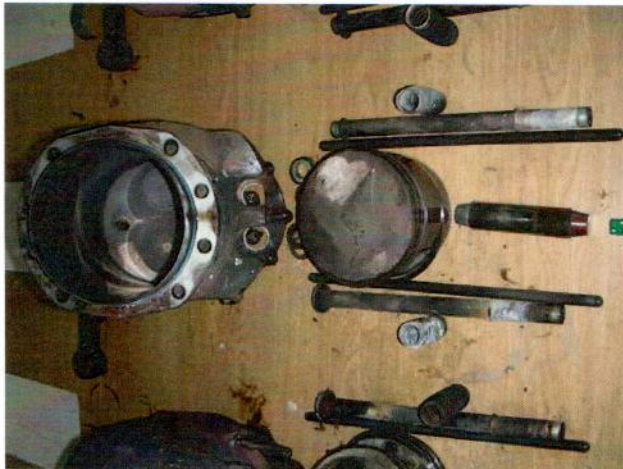
Cylinder #2 Part Number: 649166P

Condition: The cylinder was intact and secured to the engine. There was external thermal discoloration to the barrel and head assembly. The cylinder stud nuts were. Torque putty was not observed on any of the cylinder nuts. The combustion chamber was lightly lubricated and contained light brown deposits. The valves were not removed. The valve faces exhibited light combustion deposits.

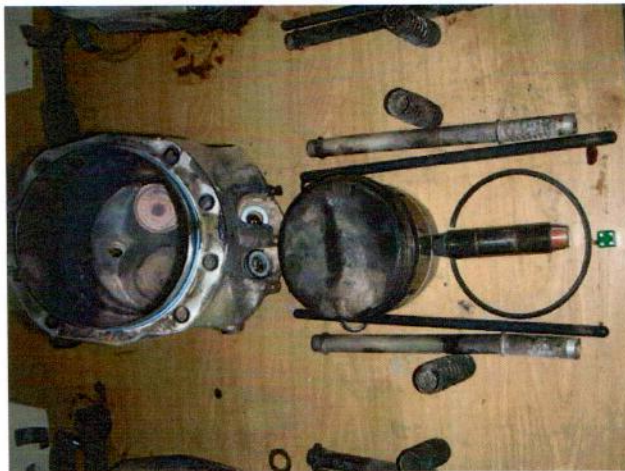
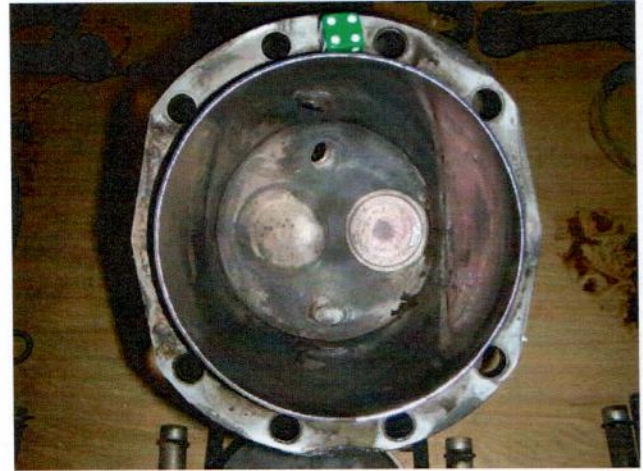
Cylinder #4 Part Number: 649166P

Condition: The cylinder was intact and secured to the engine. There was external thermal discoloration to the barrel and head assembly. The cylinder stud nuts were. Torque putty was not observed on any of the cylinder nuts. The combustion chamber was lightly lubricated and contained light brown deposits. The valves were not removed. The valve faces exhibited light combustion deposits.

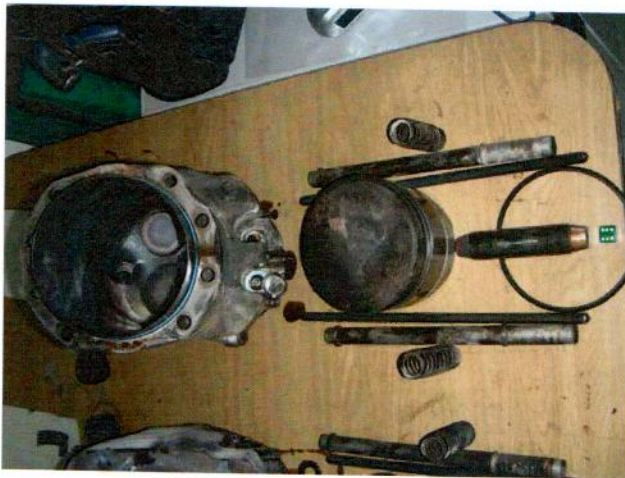
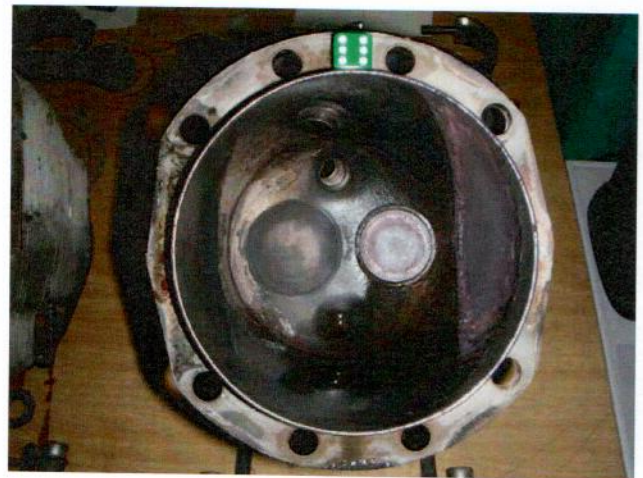
Cylinder #6 Part Number: 649166P

Condition: The cylinder was intact and secured to the engine. There was external thermal discoloration to the barrel and head assembly. The cylinder stud nuts were. Torque putty was not observed on any of the cylinder nuts. The combustion chamber was lightly lubricated and contained light brown deposits. The valves were not removed. The valve faces exhibited light combustion deposits.

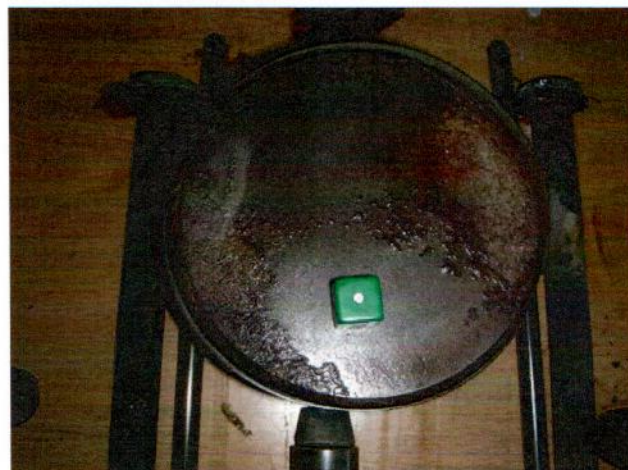
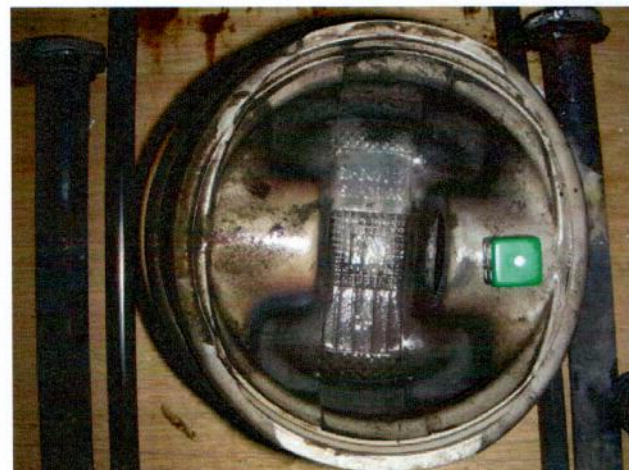
#### #1 Piston, Rings and Pin

Condition: The piston, pin and rings were intact. The piston exhibited light combustion deposits. The piston skirt visually appeared to have thermal discoloration. The rings were properly offset. The pin was intact and not scored.

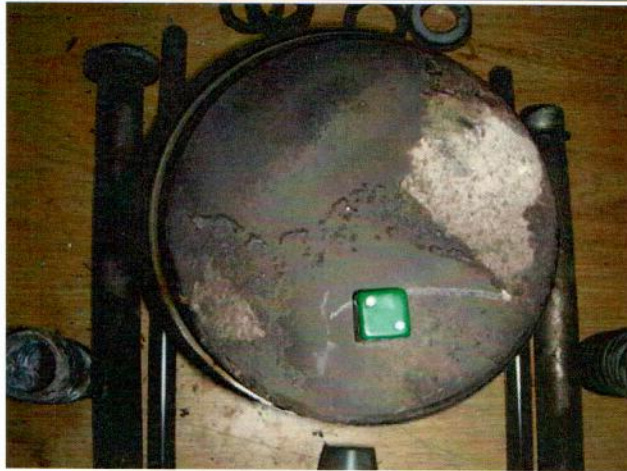
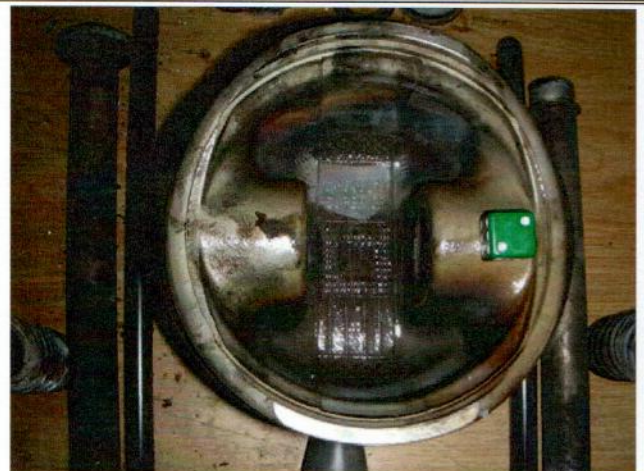
#### #2 Piston, Rings and Pin

Condition: The piston, pin and rings were intact. The piston exhibited light combustion deposits. The piston skirt visually appeared to have thermal discoloration. The rings were properly offset. The pin was intact and not scored.

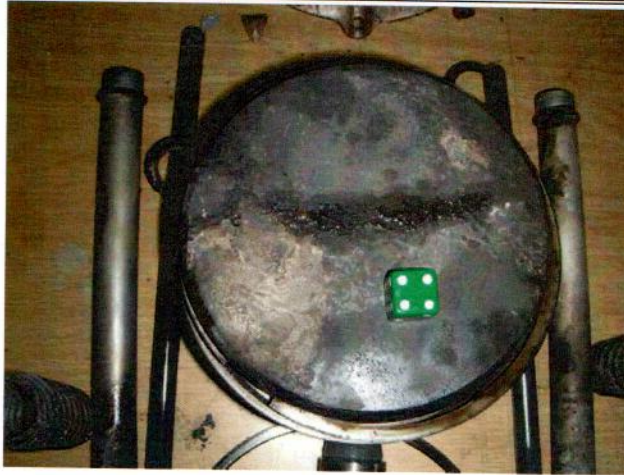
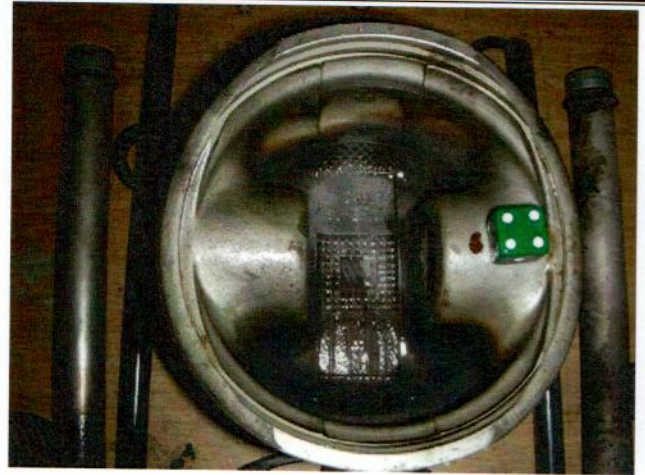
#### #4 Piston, Rings and Pin

Condition: The piston, pin and rings were intact. The piston exhibited light combustion deposits. The piston skirt visually appeared to have thermal discoloration. The rings were properly offset. The pin was intact and not scored.

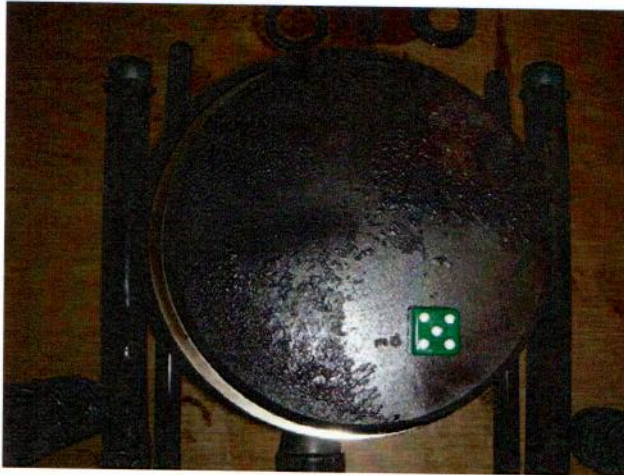
#### #5 Piston, Rings and Pin

Condition: The piston, pin and rings were intact. The piston exhibited light combustion deposits. The piston skirt visually appeared to have thermal discoloration. The rings were properly offset. The pin was intact and not scored.

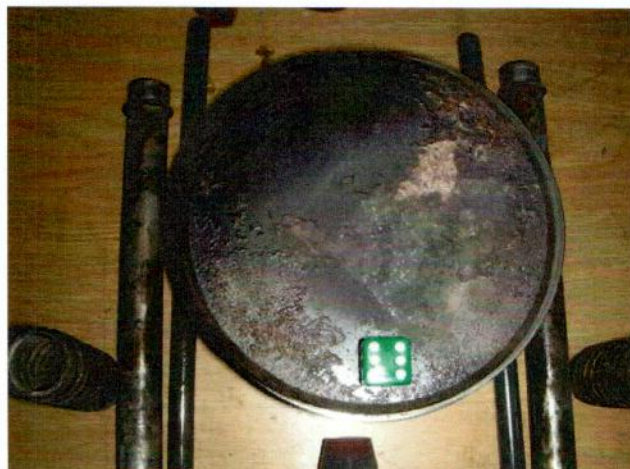
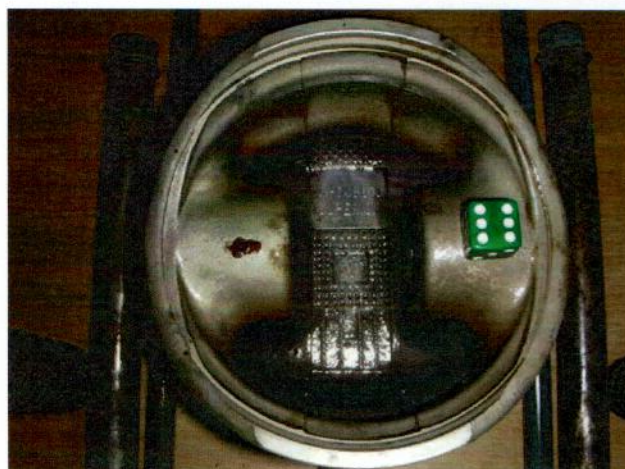
#### #6 Piston, Rings and Pin

Condition: The piston, pin and rings were intact. The piston exhibited light combustion deposits. The piston skirt visually appeared to have thermal discoloration. The rings were properly offset. The pin was intact and not scored.

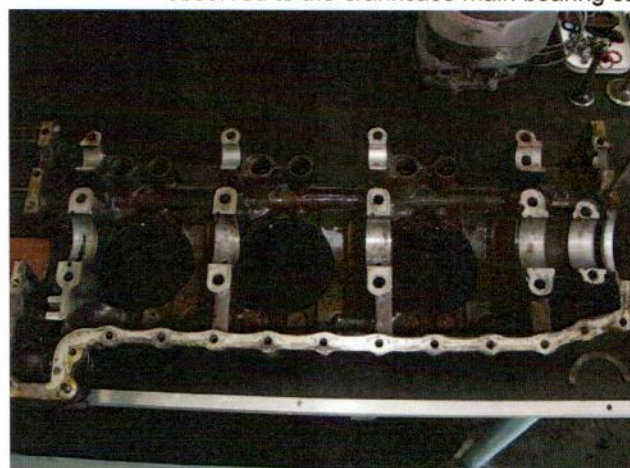
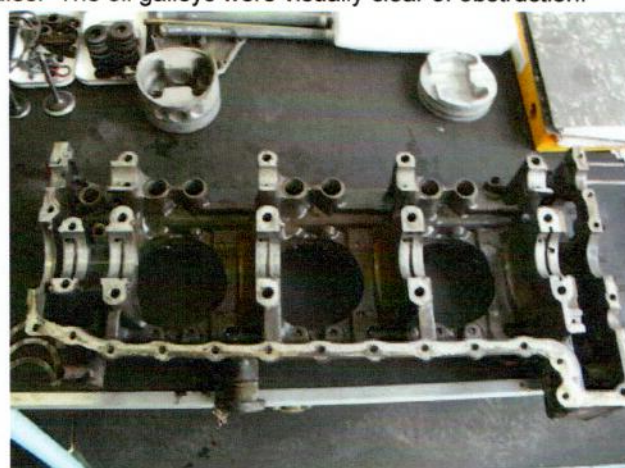
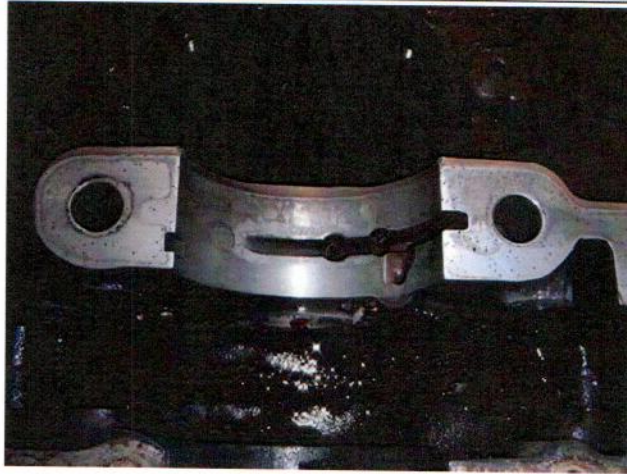
## CRANKCASE ASSEMBLY:

Condition: The crankcase halves were intact with thermal discoloration to the outside surfaces. Pitting was observed to the crankcase main bearing saddles. The oil galleries were visually clear of obstruction.

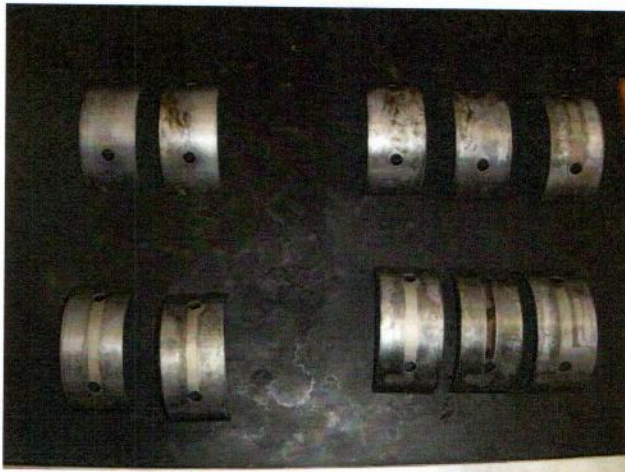
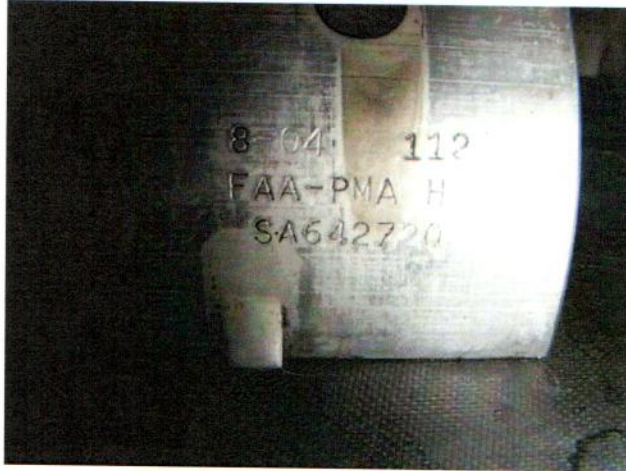
Main Bearing Part Number	Rear	Intermediate	Front
	SA642720	SA642720	SA642720
Condition	DATE CODE: 8-04 The bearings were all intact and light scoring signatures were observed to the bearing surfaces.

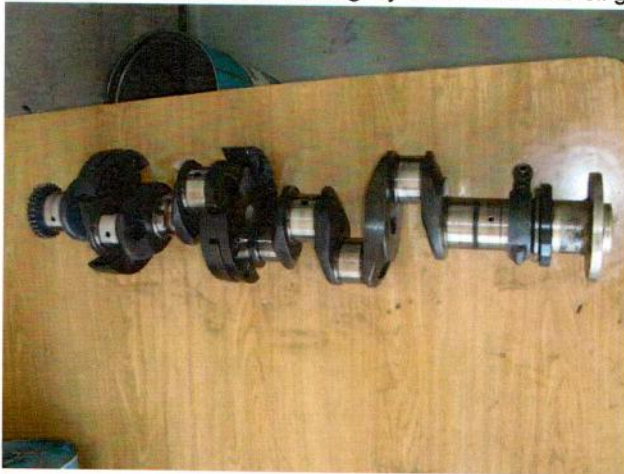
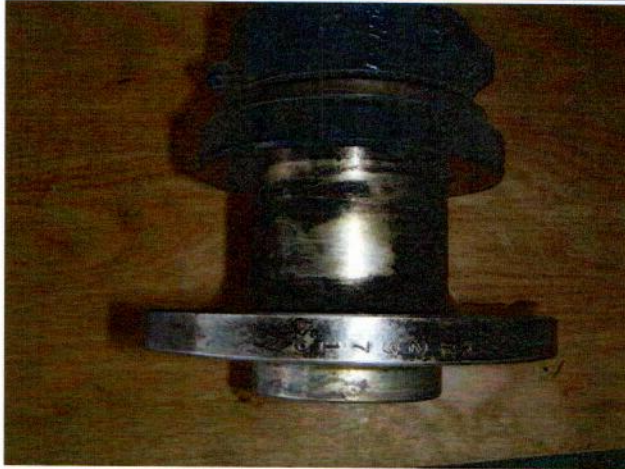
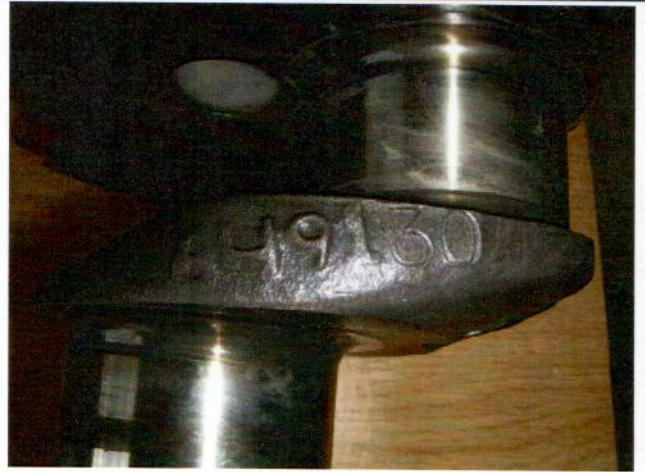
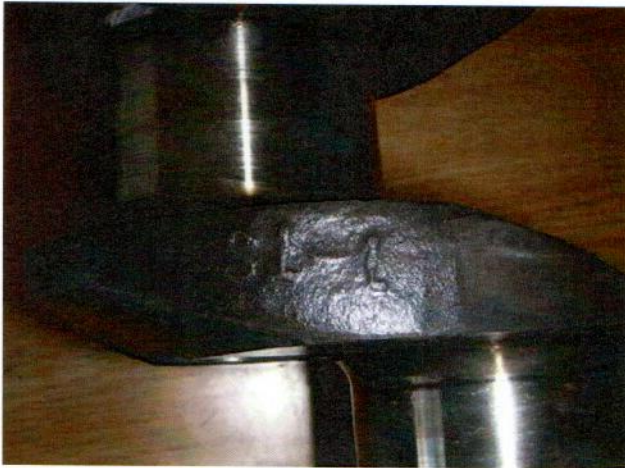
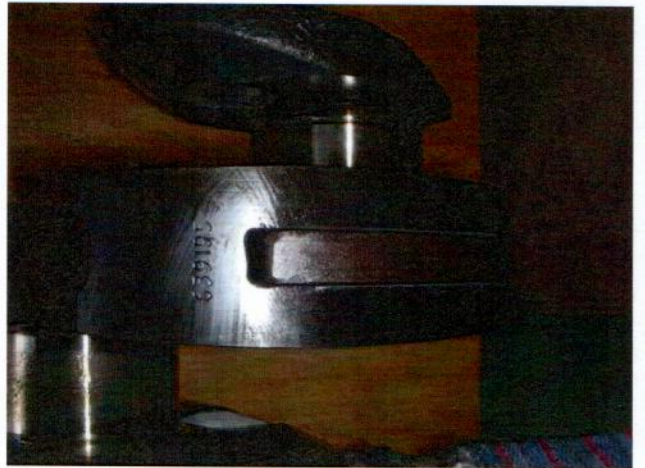
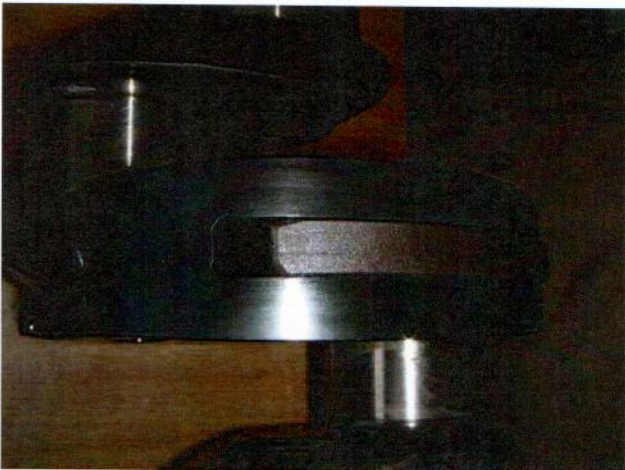
## CRANKSHAFT ASSEMBLY:

Condition: The crankshaft was intact and exhibited lubrication. The main journals and rod journals were lubricated and slightly discolored. The oil galleries were visually free of obstruction.

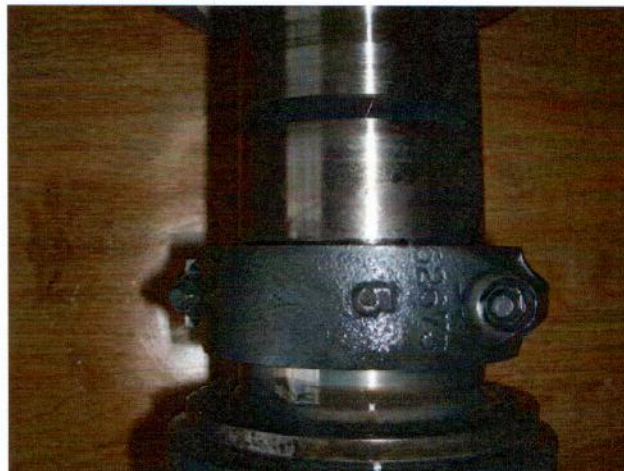
Transfer Collar: P/N: 626737

The transfer collar was intact and no binding was observed.

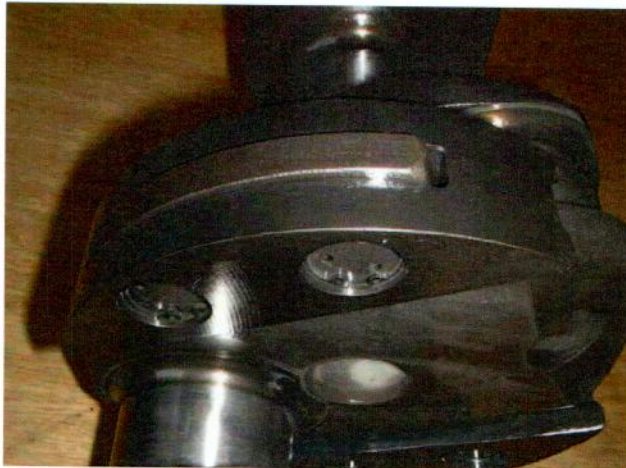
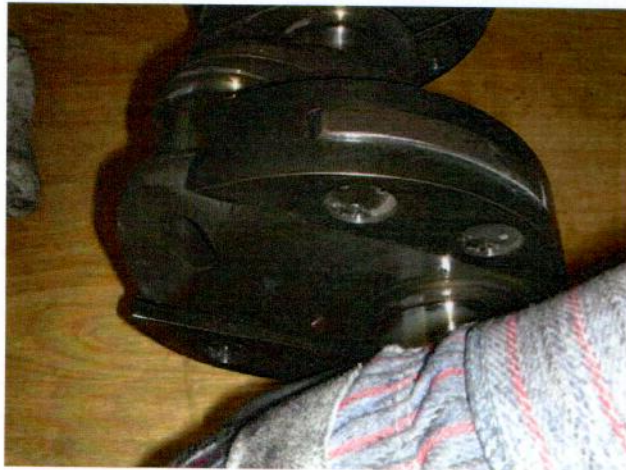
#### Counter Weights:

P/N: 639196 (pair) and 639195 (Pair) The counterweights were intact and the snap rings were correctly installed and intact. Movement of each counter weight was noted over the hangars.

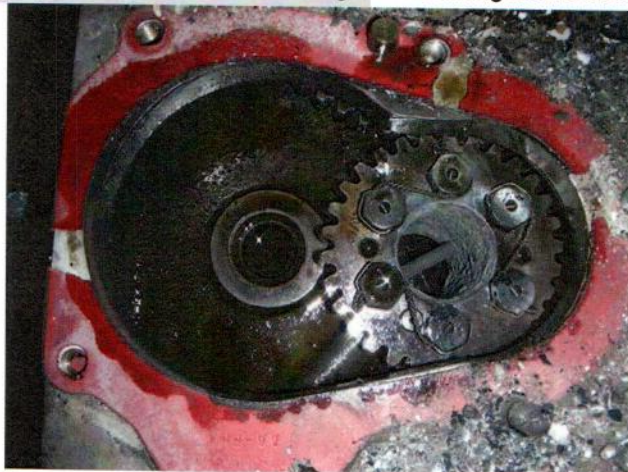
#### Crankshaft to Camshaft Timing

The timing marks were observed in alignment.

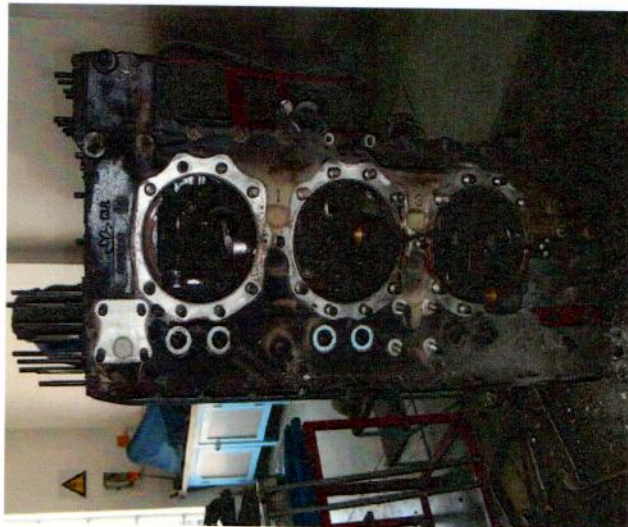
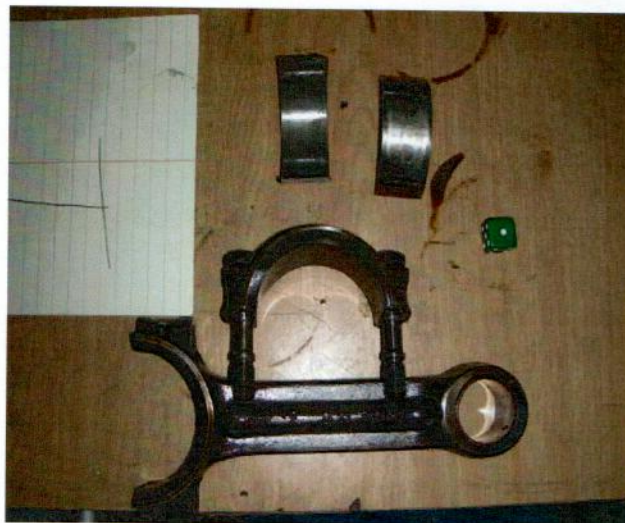
#### #1 Connecting Rod

Condition: The connecting rod was intact and secure. The rod was able to move freely on the crankshaft.

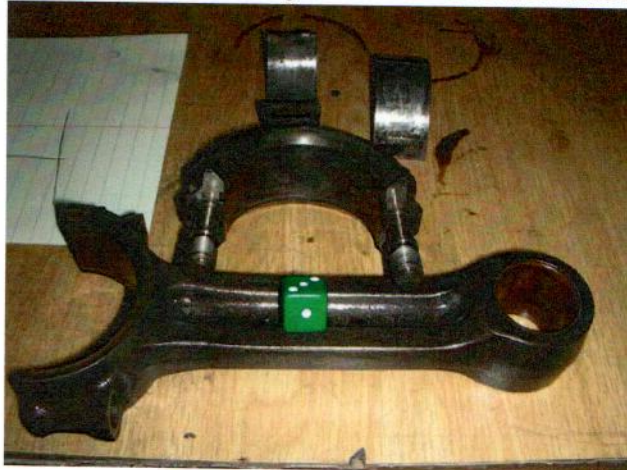
#1 Connecting Rod Bearing

Condition: The bearing was intact and no anomalies were visually observed.

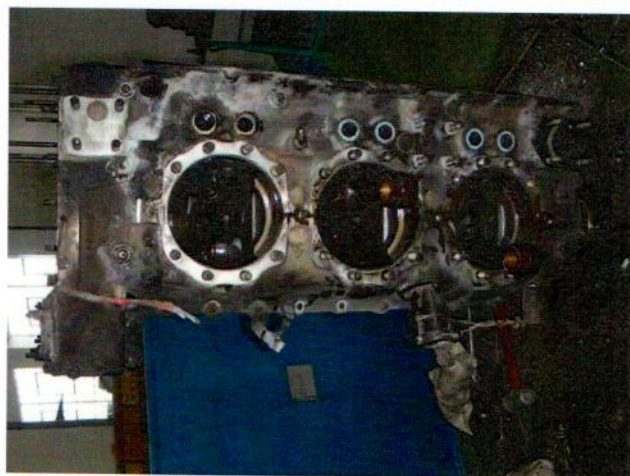
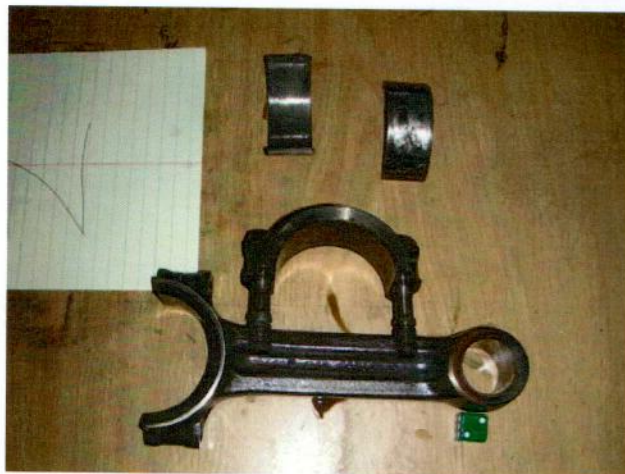
#2 Connecting Rod

Condition: The connecting rod was intact and secure. The rod was able to move freely on the crankshaft.

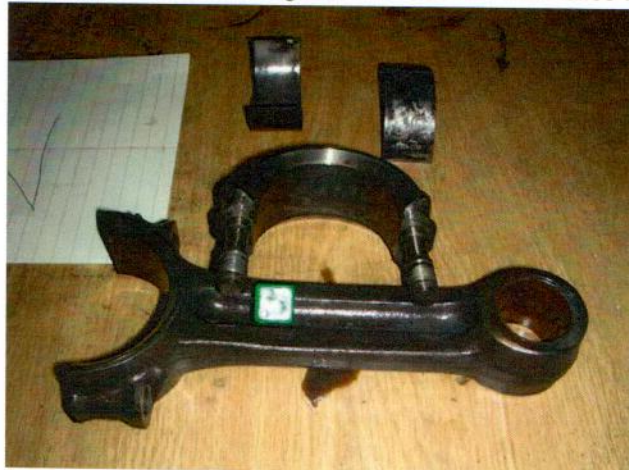
#2 Connecting Rod Bearing

Condition: The bearing was intact and no anomalies were visually observed.

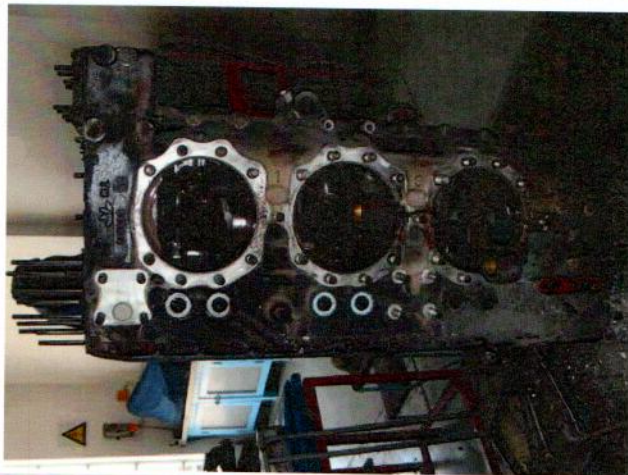
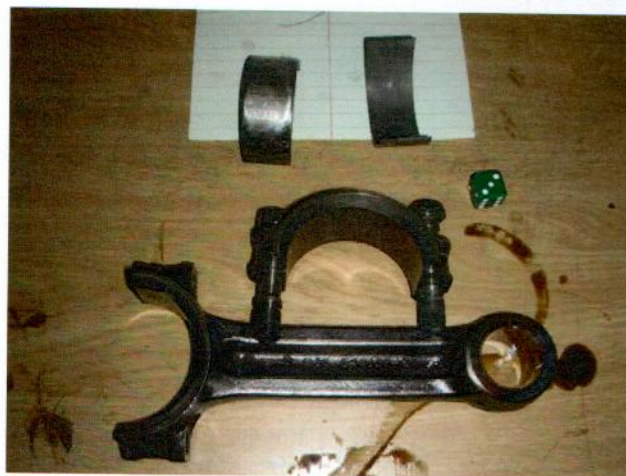
#3 Connecting Rod

Condition: The connecting rod was intact and secure. The rod was able to move freely on the crankshaft.

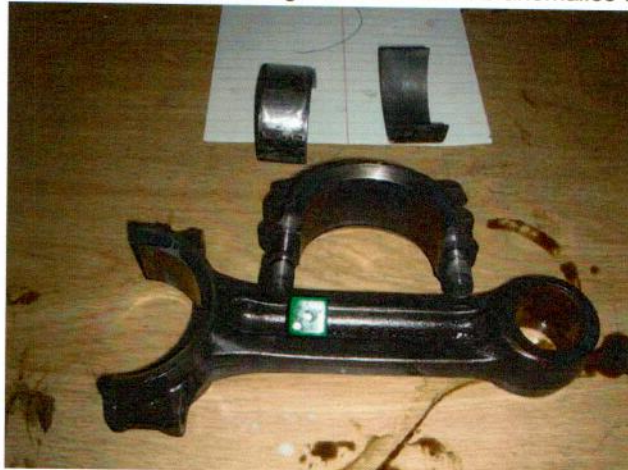
#3 Connecting Rod Bearing

Condition: The bearing was intact and no anomalies were visually observed.

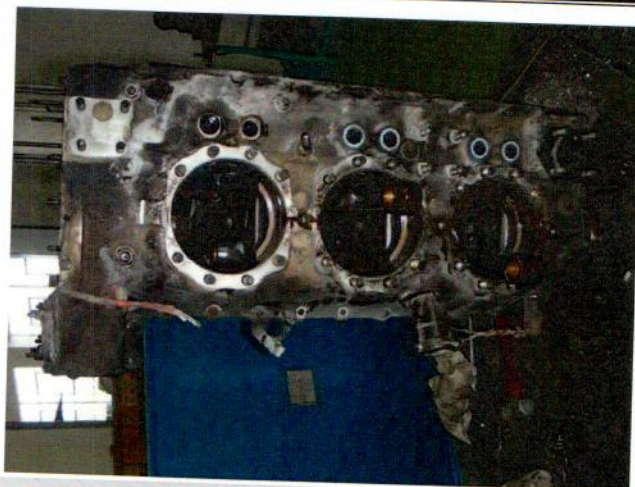
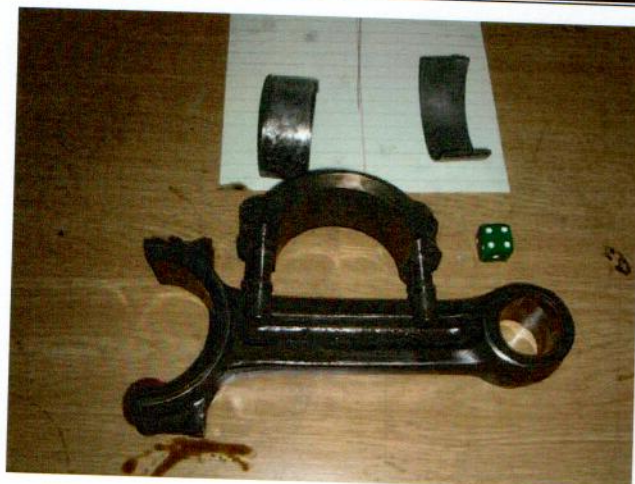
#4 Connecting Rod

Condition: The connecting rod was intact and secure. The rod was able to move freely on the crankshaft.

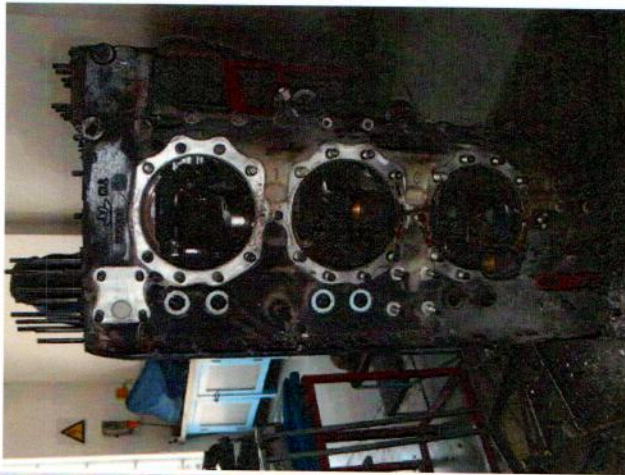
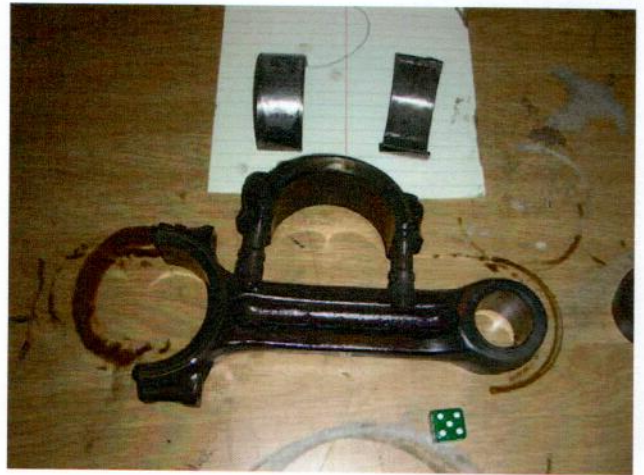
Condition: The connecting rod was intact and secure. The rod was able to move freely on the crankshaft.

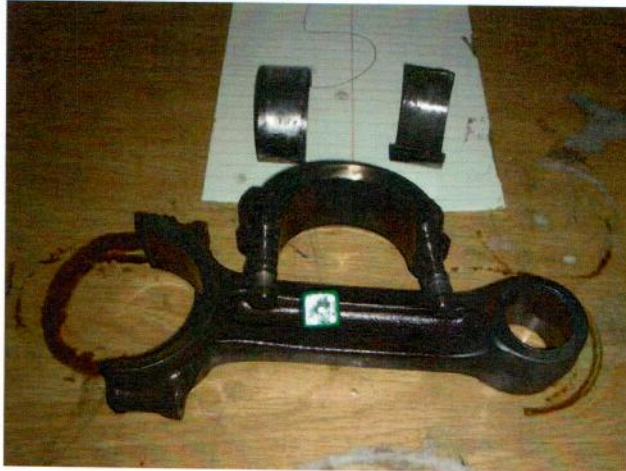
#5 Connecting Rod Bearing

Condition: The bearing was intact and no anomalies were visually observed.
