**CIVIL AIRCRAFT ACCIDENT REPORT**

**ACCID/011108/01-12**

<b>OPERATION</b>	<b>:</b>	<b>COMMERCIAL</b>
<b>AIRCRAFT</b>	<b>:</b>	<b>V5-GWH</b>
<b>LOCATION</b>	<b>:</b>	<b>WINDHOEK</b>
<b>DATE</b>	<b>:</b>	<b>11 JANUARY 2008</b>

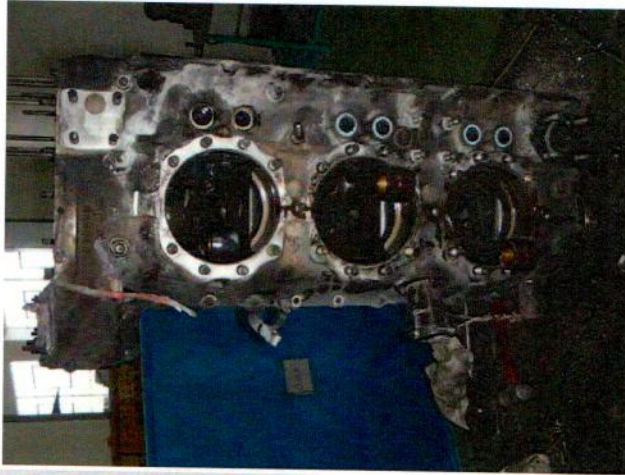
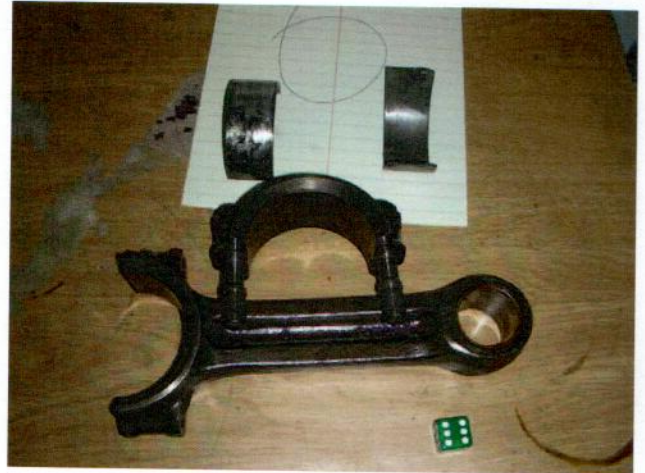
Condition: The connecting rod was intact and secure. The rod was able to move freely on the crankshaft.

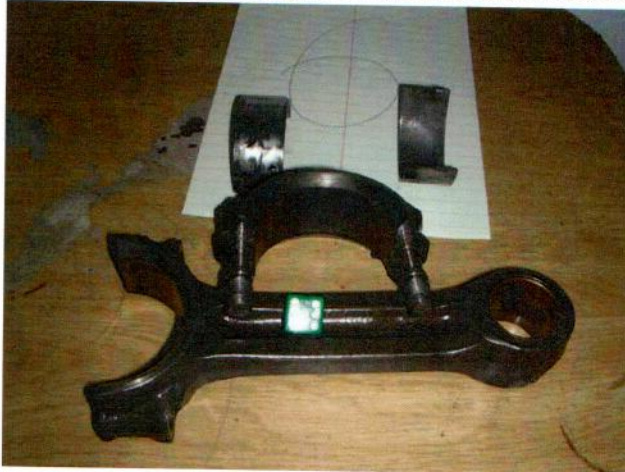
#6 Connecting Rod  
Bearing

Condition: The bearing was intact and no anomalies were visually observed.

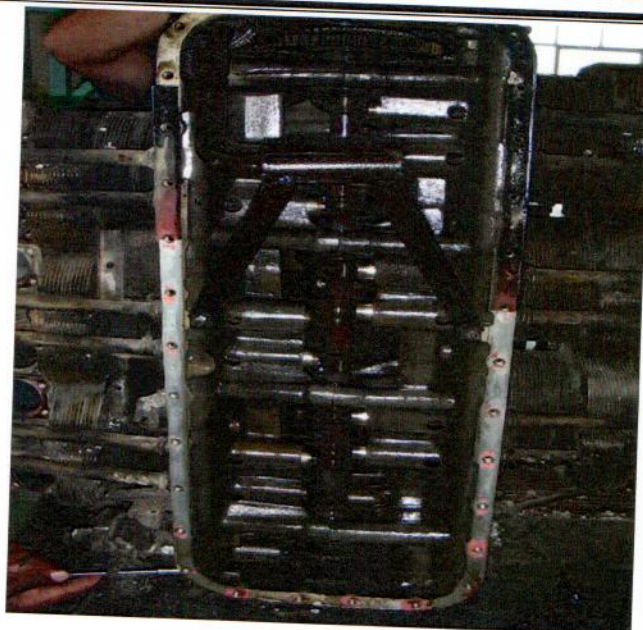
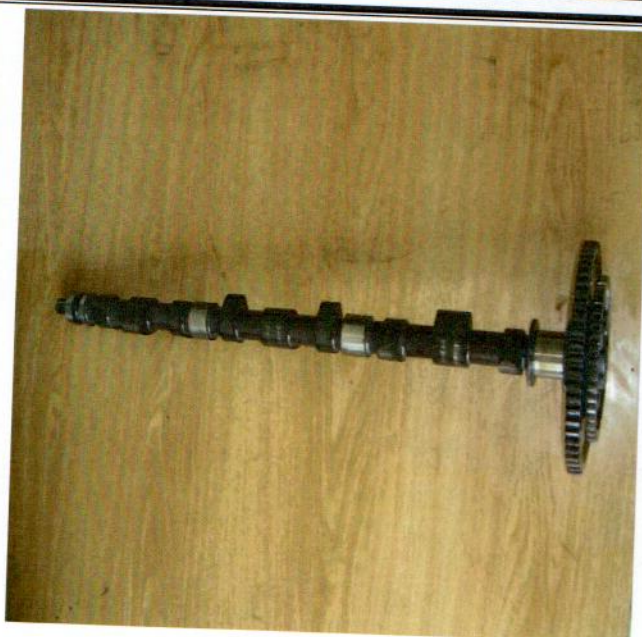
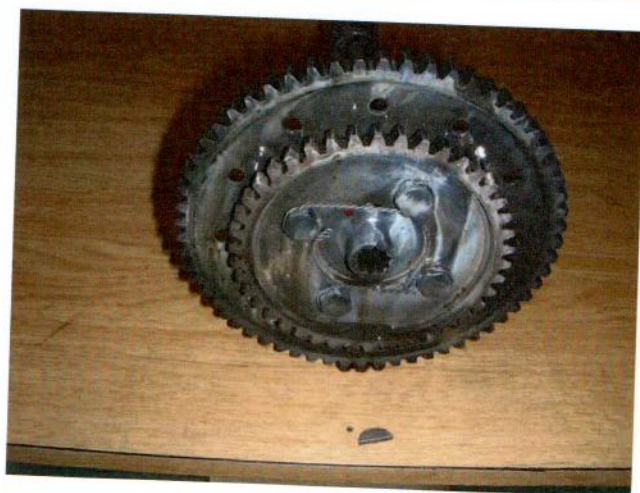
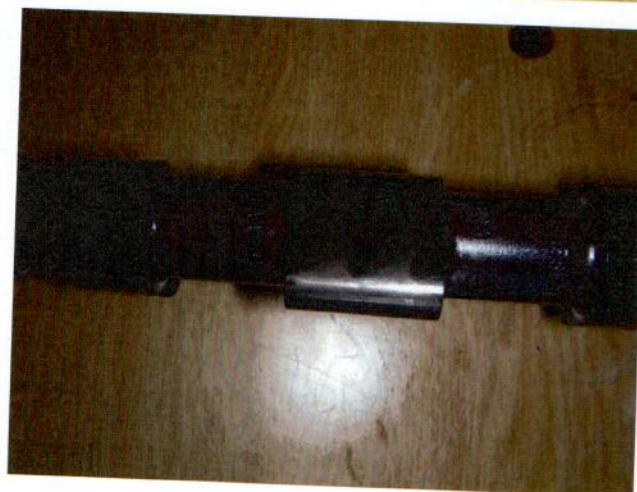
## CAMSHAFT:

Condition The camshaft was intact and no anomalies were visually observed. The woodruff key was observed in place and intact.

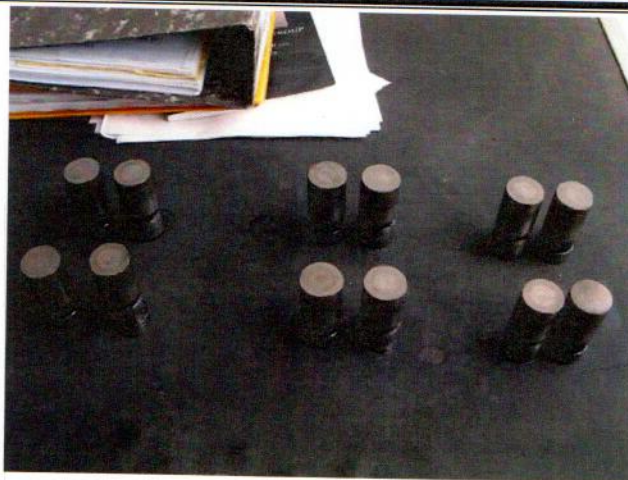
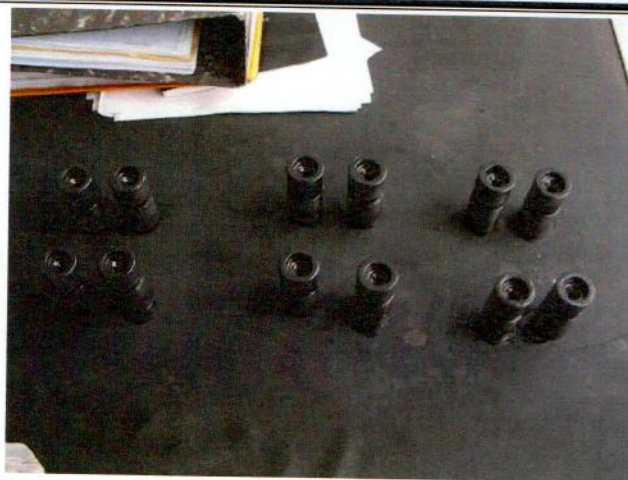
## LIFTERS:

Condition: All the lifters were intact and no visual anomalies were observed. The lifters exhibited lubrication.

The lifter pistons had full travel up and down within the lifter body.

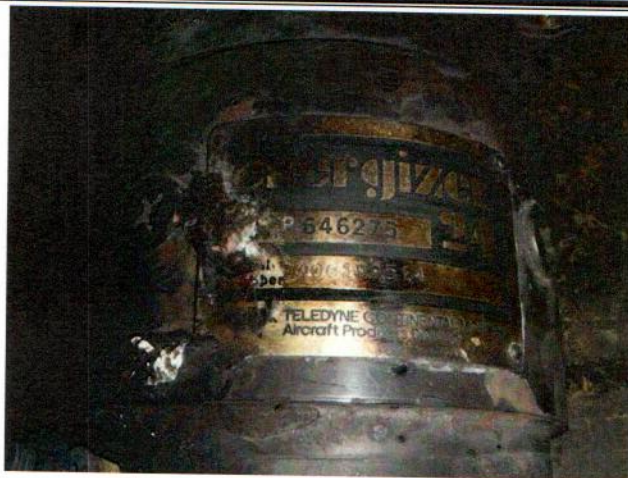
Condition: The starter was intact, although some case damage was observed and exterior thermal damage was observed. The starter shaft rotated without any binding. The wires were melted.

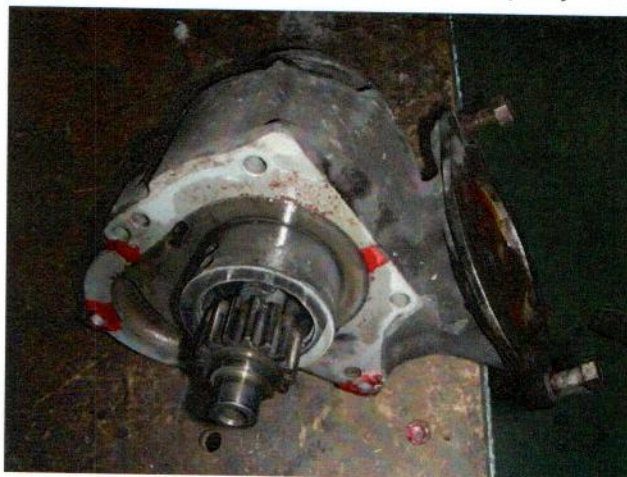
**Starter Adapter** Part Number: Illegible.

**Condition:** The adapter was intact. The internal gear and clutch was intact and the shaft rotated. Signatures of lubrication was observed. The pulley was damaged.

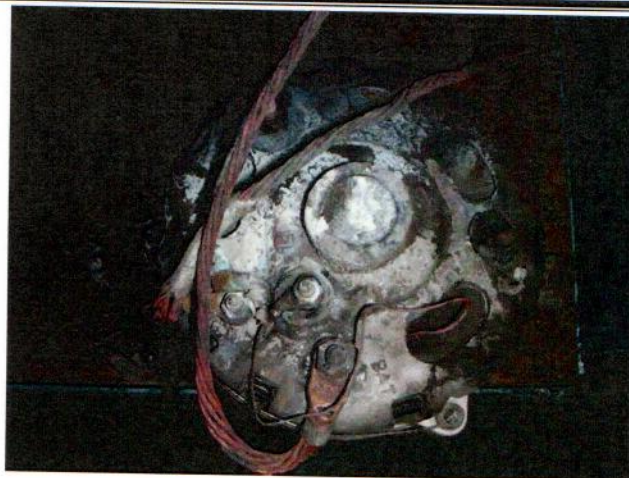
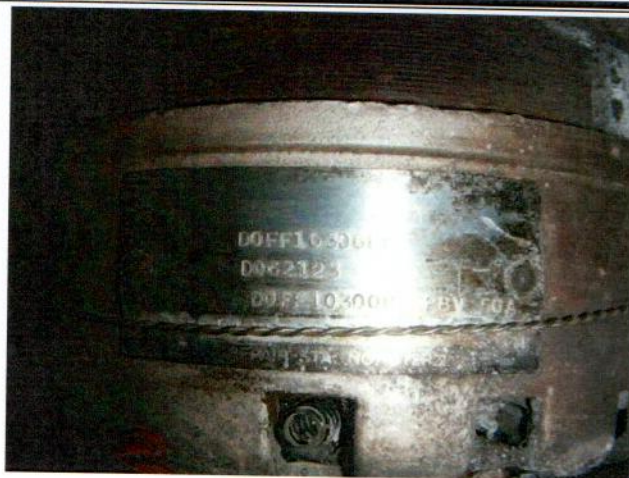
Condition: The alternator was intact. Thermal damage and corrosion was observed to the exterior. The pulley would not rotate. The wires were melted and damaged.

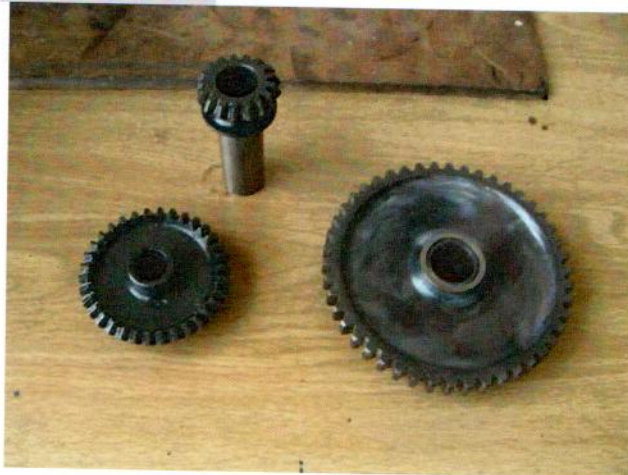
**Accessory Gears** All accessory gears were observed intact and all gear teeth were observed intact.

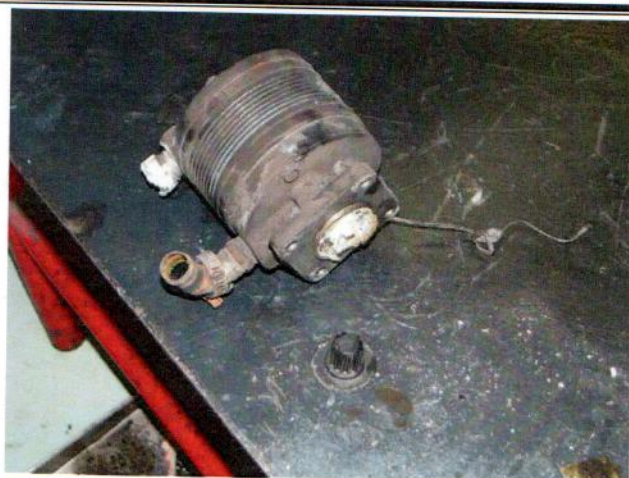
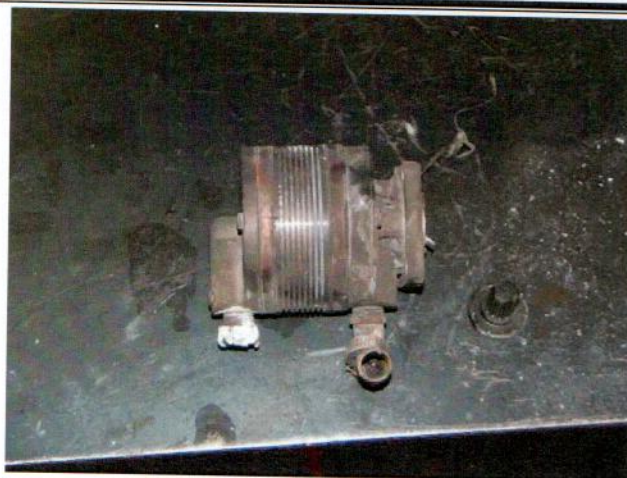
**Condition:** The vacuum pump was intact. Thermal damage was observed to the exterior. The coupling was separated and melted.
