**DIRECTORATE OF AIRCRAFT ACCIDENT  
INVESTIGATION**

**CIVIL AIRCRAFT ACCIDENT REPORT**

**ACCID / 040816 / 1-04**

<b>OPERATION</b>	<b>:</b>	<b>PRIVATE</b>
<b>AIRCRAFT</b>	<b>:</b>	<b>V5-HFW</b>
<b>LOCATION</b>	<b>:</b>	<b>8.7 NM SE OF EROS AIRPORT</b>
<b>DATE</b>	<b>:</b>	<b>08 APRIL 2016</b>

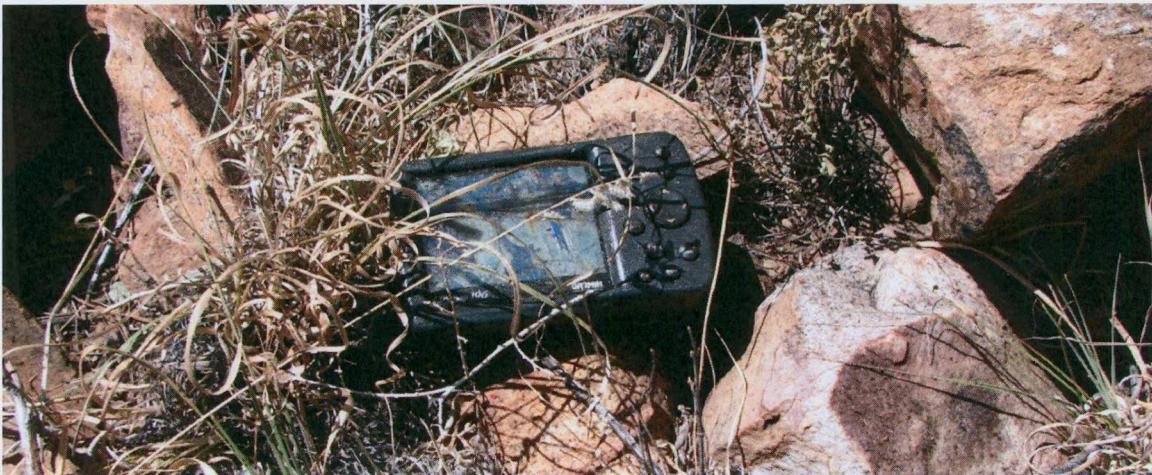
Image 3

1.11.2 The GPS (Garmin 196) of the helicopter was recovered and send for data retrieval. The flight data of the last flight was recovered and used for the reconstruction of the ill-fated flight.

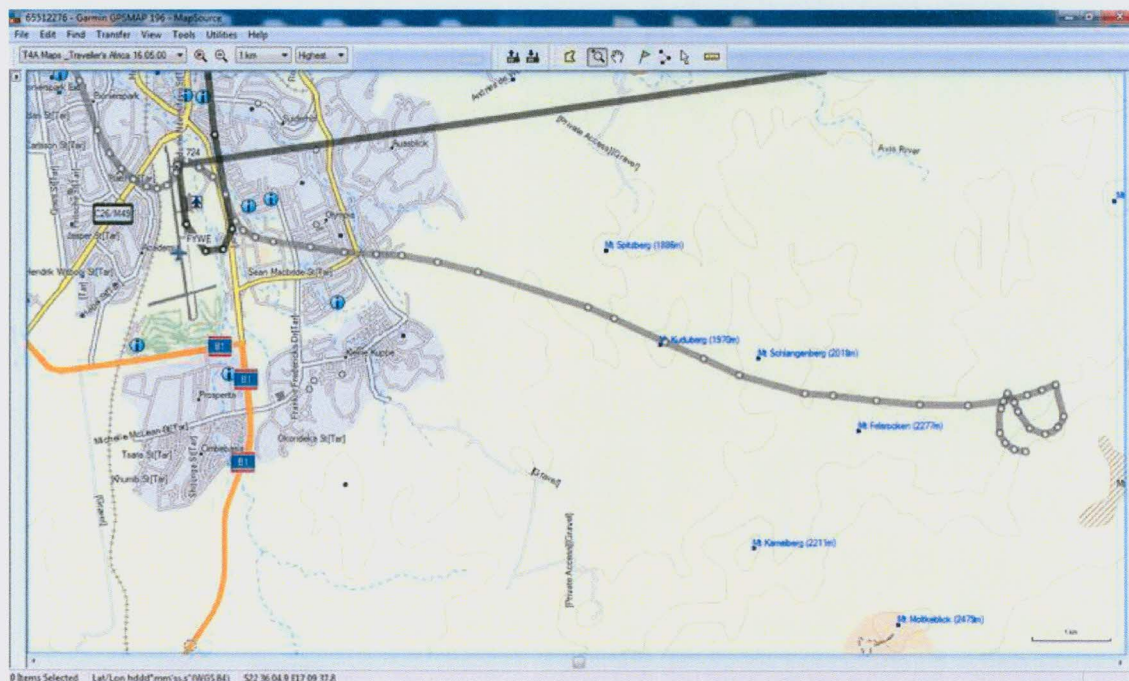
1.18.1 Download of helicopter flight path from takeoff to accident site.

Image 10 - Data extracted by official GARMIN agent situated in Namibia. (Radio Electronics)

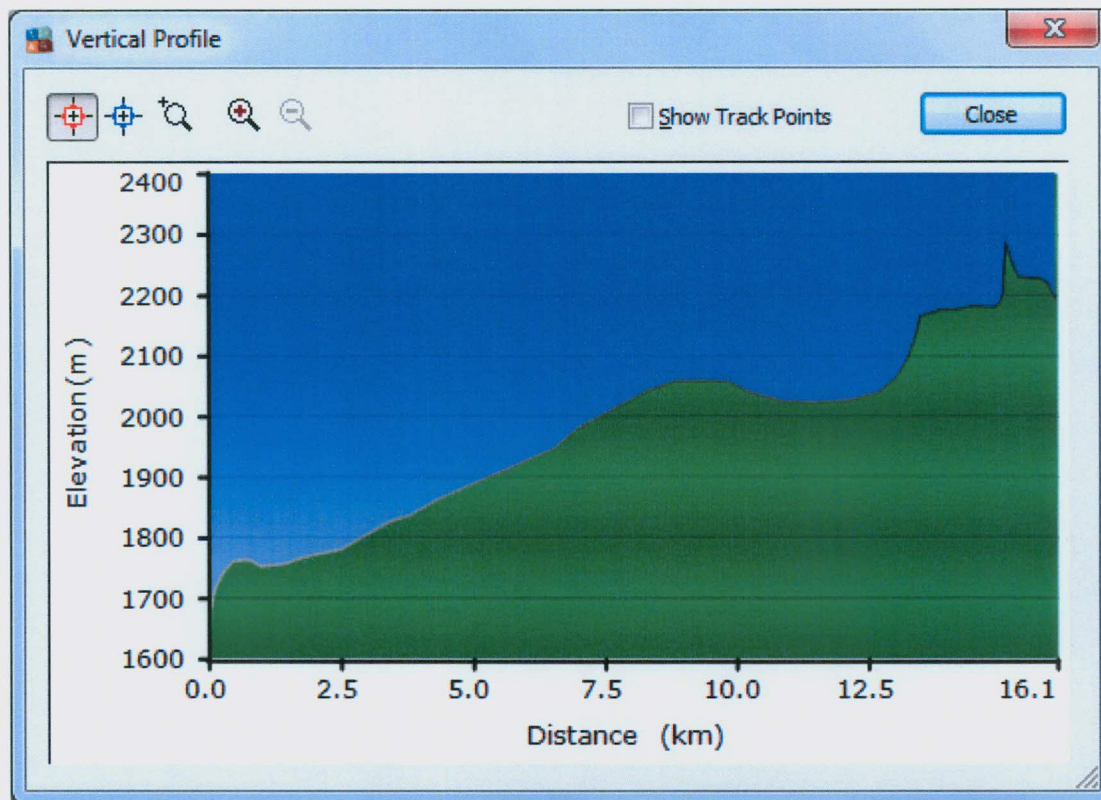
1.18.2 Download of vertical flight path of helicopter from takeoff to accident site.

Image 11 - Data extracted by official GARMIN agent situated in Namibia. (Radio Electronics)

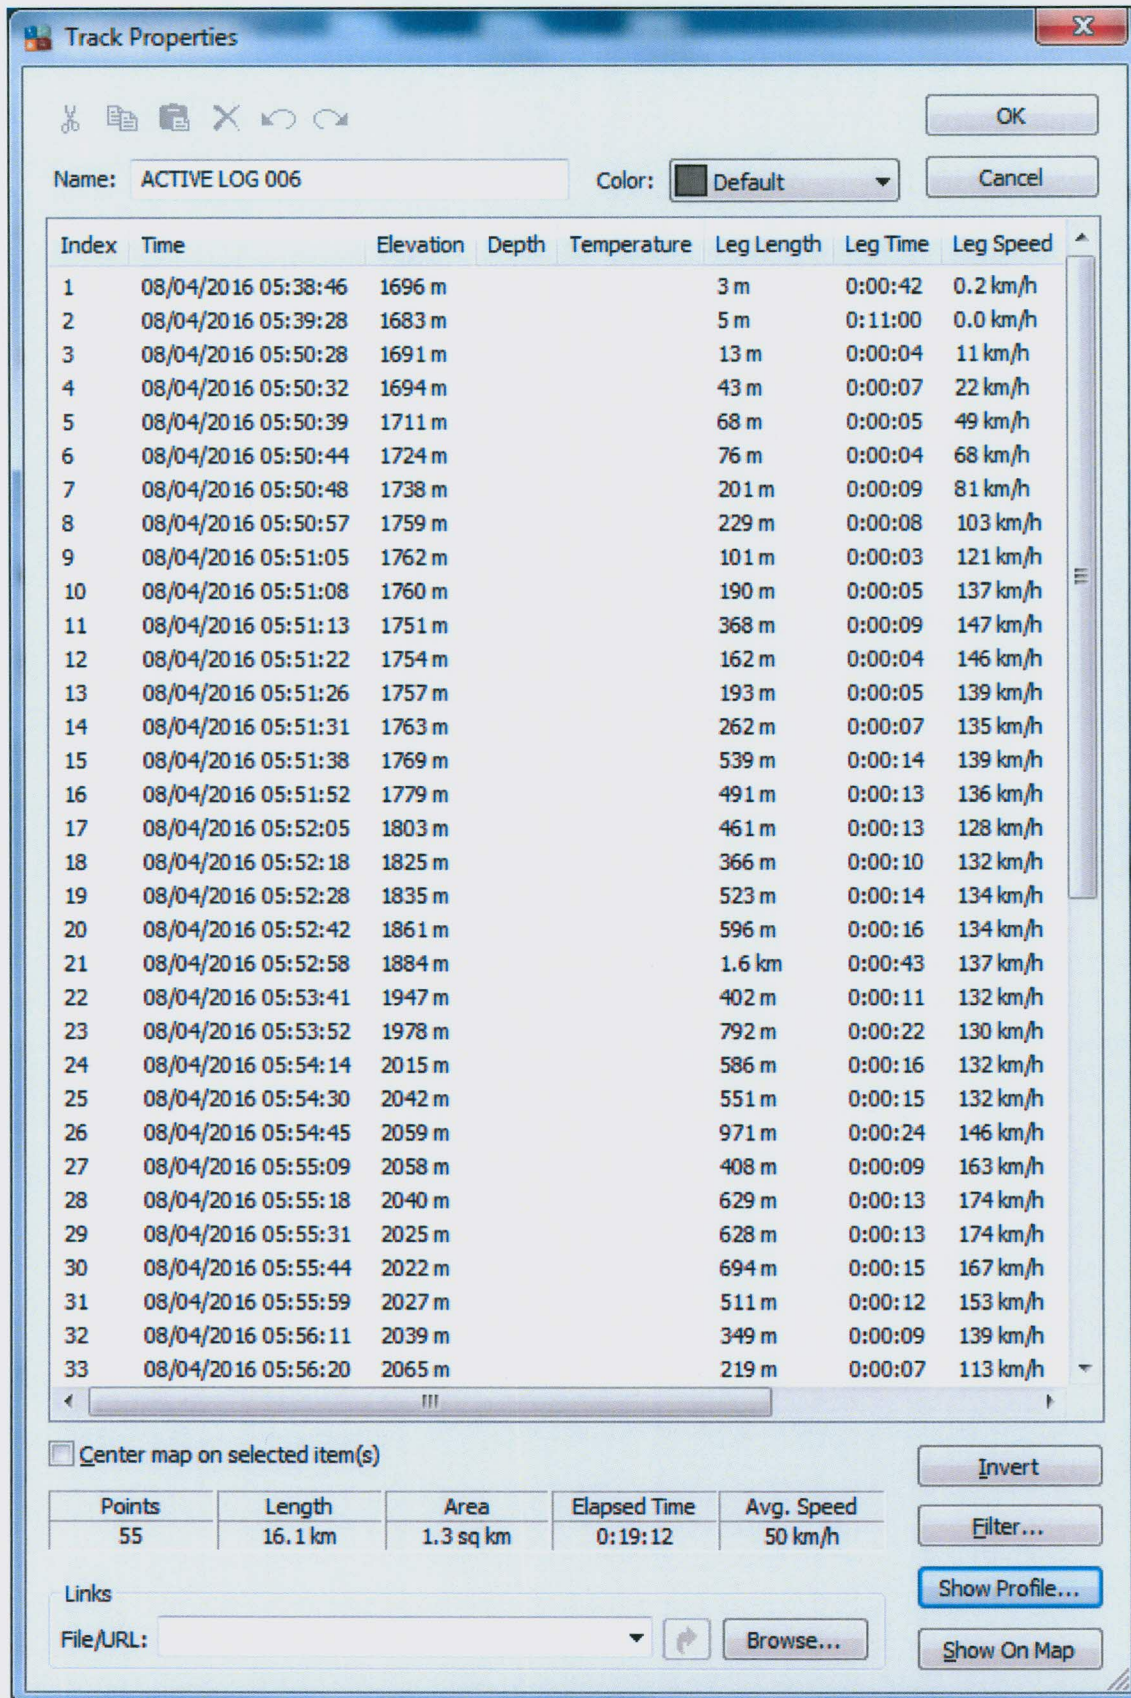
1.18.3 Download of flight data from GPS which indicate the time frame, speed ,height and directions flown by the helicopter for the flight from takeoff till the point of impact.

Image 12 – Data extracted by official GARMIN agent situated in Namibia. (Radio Electronics)

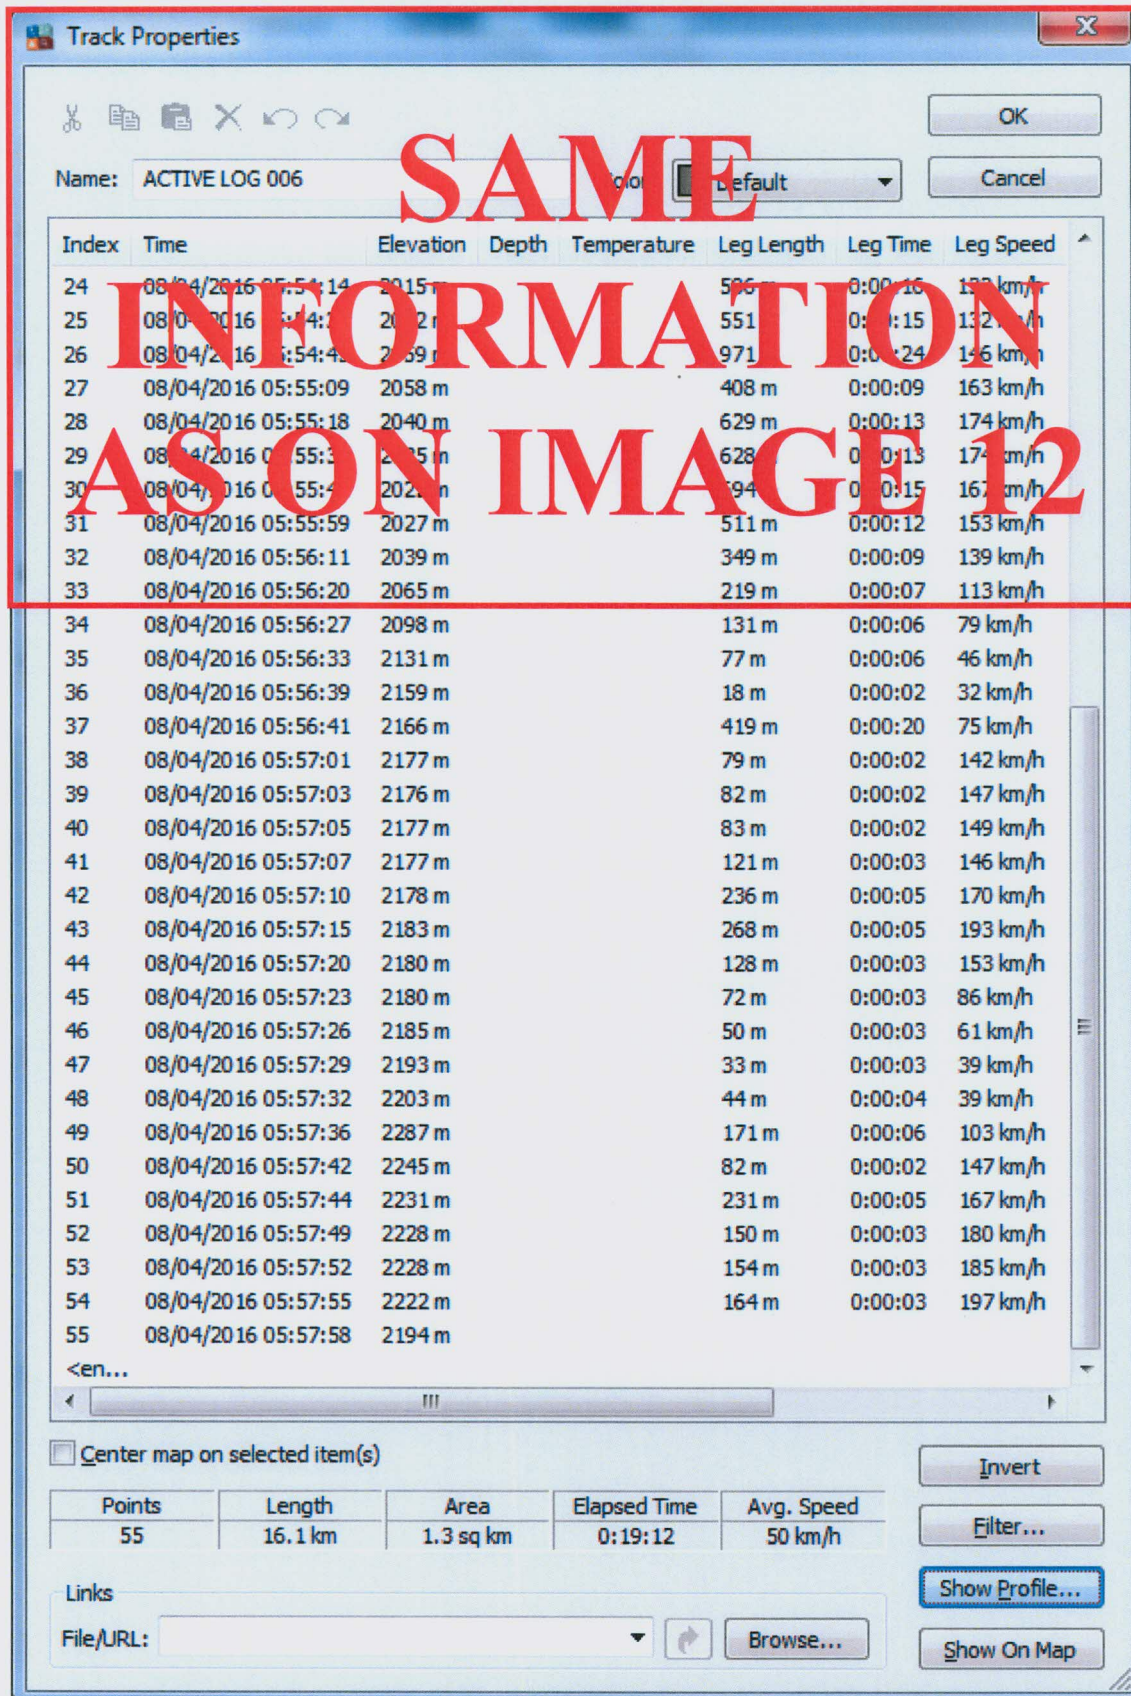
Image 13 - Data extracted by official GARMIN agent situated in Namibia. (Radio Electronics)
