**CIVIL AIRCRAFT ACCIDENT REPORT
ACCID/032420/01-01**

AIRCRAFT : V5-HOZ

LOCATION : TSUMEB AIRFIELD

DATE : 24 MARCH 2020

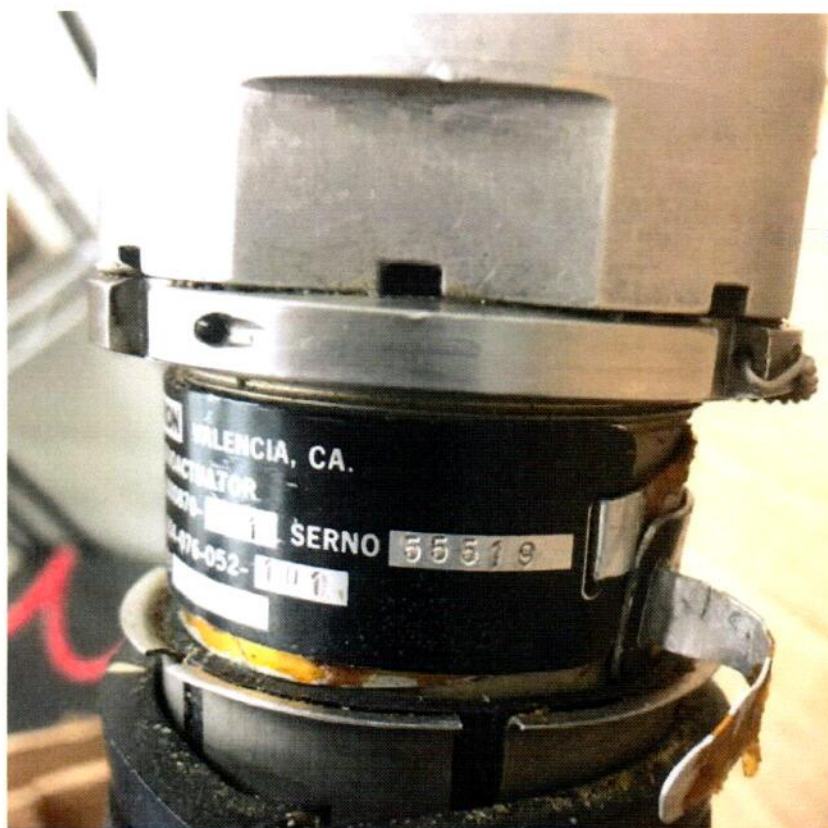
The Servo –actuator was tested according to the requirements of the assembly, test and inspection procedure. Although the unit failed leakage tests 60.5 and 60.7.2, it was found functional and performed as intended.

To further investigate the leakage, the unit was disassembled and the seals were inspected. The visual examination found the seals in good condition with no problems noted. However, an examination of the piston found a polished finish with no evidence of cross-hatching, which is a typical of a Woodward piston. It is suspected that the piston may have been replaced at some point by a third-party repair facility. An overly polished piston is most likely the cause of the leaking noted during test.

Servo Actuator PN 204-076-052-101 (Woodward PN 41000870-101), SN 55519 was functionally tested according to Woodward ATIP 41000870, Rev. AF, Sections 60.5 through 60.9. In addition, the Irreversible Valve Assembly was removed and tested according to ATIP42550-006, Rev. D, Sections 40 (see Data Sheets for details).
