# DIRECTORATE OF AIRCRAFT ACCIDENT INVESTIGATION CIVIL AIRCRAFT ACCIDENT REPORT ACCID/12518/01-01

AIRCRAFT : V5-HTM

LOCATION : OUTJO AIRFIELD
DATE : 25 JANUARY 2018

# DIRECTORATE OF AIRCRAFT ACCIDENT INVESTIGATIONS ACCIDENT REPORT – EXECUTIVE SUMMARY

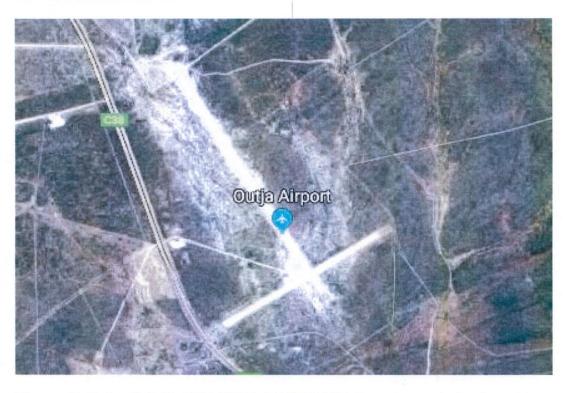
**Figure 3:** Outjo Airfield, 20°04′40″S 016°07′30″E, there is no navigation aids nor emergency services at the airfield.
