**Accident Reference: ACCID 013022/01-01**

## **Aircraft Accident Investigation Final Report**

**JABIRU 2 V5-UZI**

**DESCRIPTION OF OCCURRENCE:** (LOC-G) Loss of control on ground.

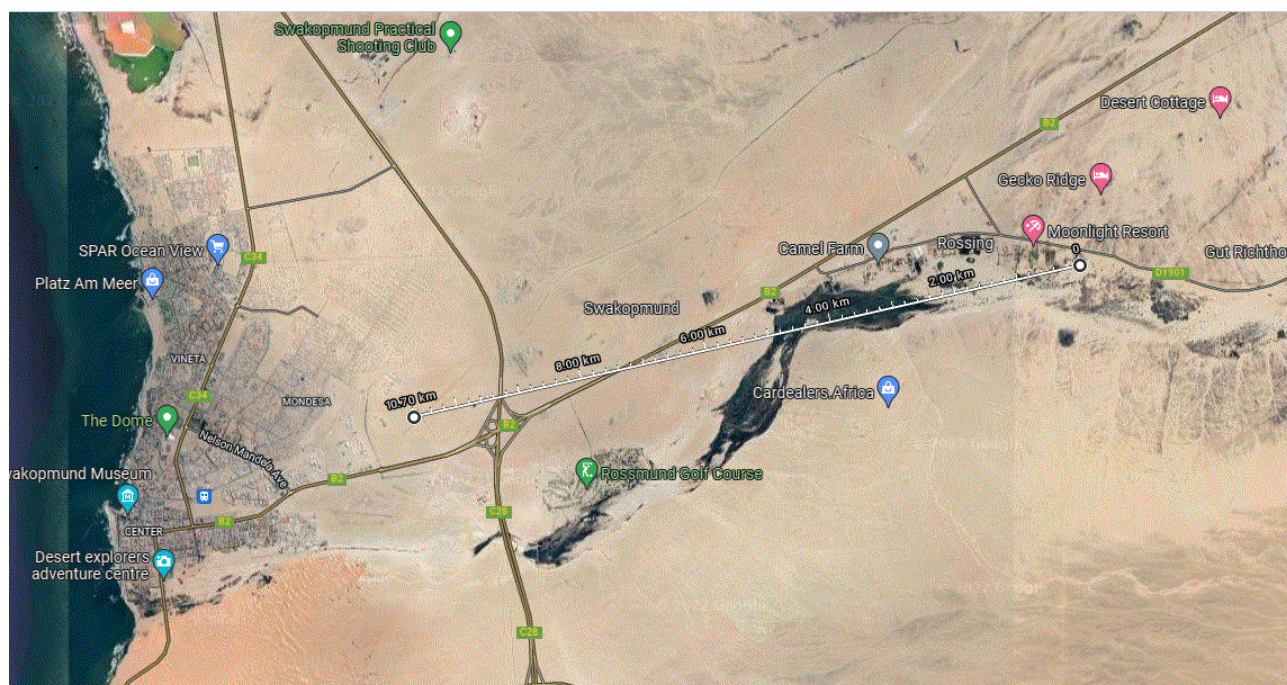
1.11 The accident occurred during daylight at Farm Farm Blakeway which is about 10km from Swakopmund airfield

Figure 4: Swakopmund airfield to accident site (google earth)
