Ministry of Works and Transport				INCID/04/2019/01-05	
	DIRECTORATE OF AIRCRAFT ACCIDENT INVESTIGATION INCIDENT REPORT – EXECUTIVE SUMMARY					
Aircraft Registration	V5-WAC	Date of Incident	20 th April 2019	Time of Incident	10:11 UTC	
Type of Aircraft	CESSNA 404	Type of Operation	Charter			
Pilot- In - command License Type	CPL	Age	23	License Valid	valid	
Pilot-In-command Flying Experience	Total Flying Hours	1500	Hours on Type	230		
Last point of departure	FYAR (Arandis airfield)					
Next point of intended landing	Mowe bay					
Location of the accident site with reference to easily defined geographical points (GPS readings if possible)						
S 22° 13' 14 & E 14° 14'39'						
Meteorological Information	Wind Direction: Northerly, Wind speed: 4-8 kt, Visibility: Good, Temperature: Unknown Cloud cover: OVC, Cloud base: CAVOK, Dew point: Unknown					
Number of people on board	1+8	No. of people injured	0	No. of people killed	0

AIRCRAFT INCIDENT REPORT

Name of Owner/Operator : Westair Aviation (Pty) Ltd
Manufacture : Cessna
Model : 404
Nationality : Namibian
Registration : V5 - WAC
Location : Arandis airfield
Date : 20th April 2019
Time : 10:11

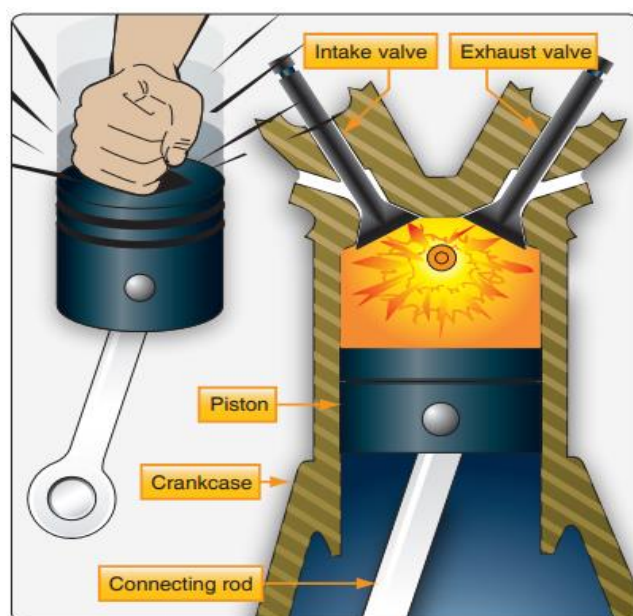
The effects of detonation are often not discovered until after teardown of the engine. When the engine is overhauled, however, the presence of severe detonation during its operation is indicated by dished piston heads, collapsed valve heads, broken ring lands, or eroded portions of valves, pistons, or cylinder heads (Aviation, 2018).

Figure 5. Detonation within a cylinder.

Prevention of detonation is critical and is a function of both the ground and the flight crew the flight crew to observe acceptable rpm and manifold pressure limits by continuously monitoring Cylinder head temperatures (CHT), the maintenance to ensure periodic bore scope inspections are done thoroughly, proper timing of the valves (opening and closing) cannot be over emphasized as failure
