Accident Reference: ACCID/110322/02-06

Aircraft Accident Investigation Final Report

CIRRUS SR22 ZS-PVW

Runway Excursion at Okahirongo river lodge Airstrip RWY 01

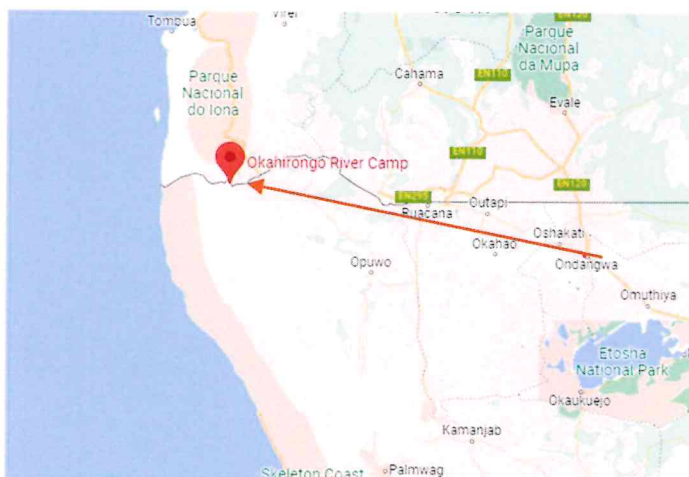
Figure 1: Red Arrow shows the route flown by the Aircraft.
