## **REPUBLIC OF NAMIBIA**

### **CIVIL AIRCRAFT INCIDENT REPORT**

INCID/111013/01-02

<b>OPERATION</b>	: Scheduled International Flight
<b>AIRCRAFT</b>	: ZS-SXY
<b>LOCATION</b>	: Hosea Kutako International Aerodrome
<b>DATE</b>	: 11 <sup>th</sup> October 2013

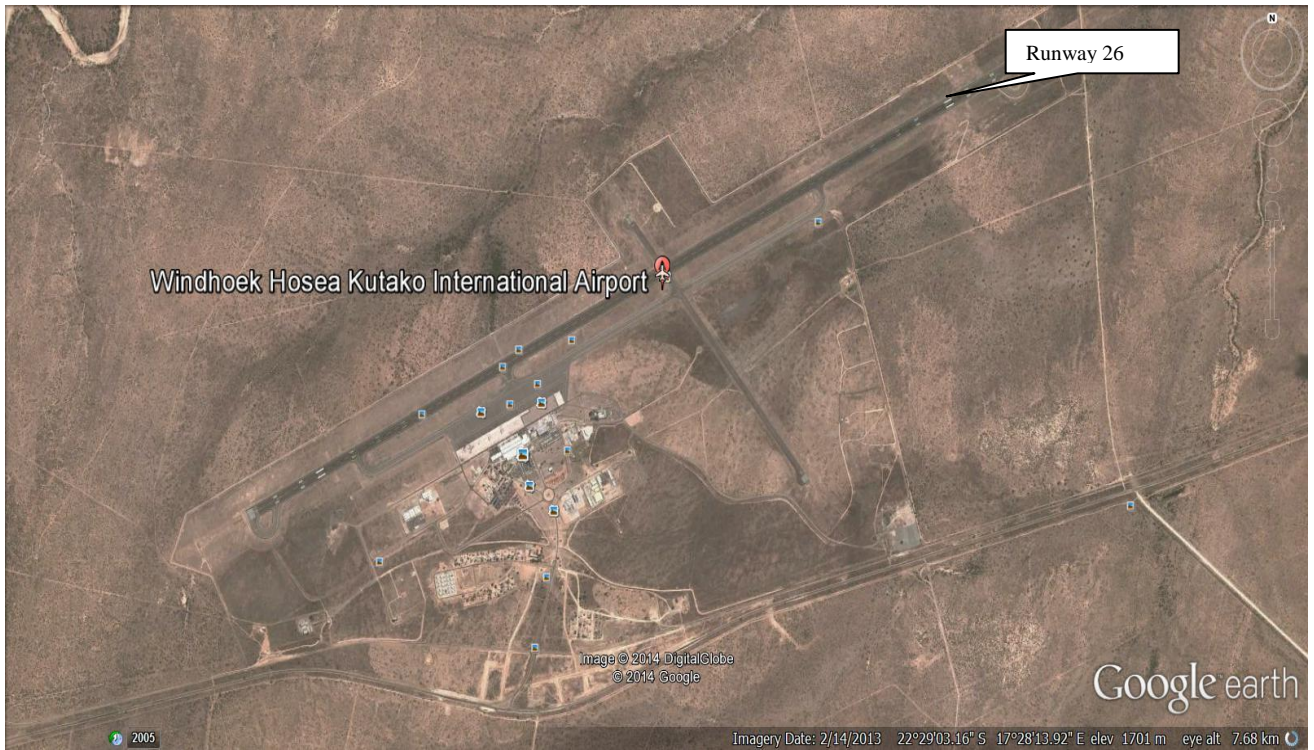
Figure 3: Hosea Kutako Airport layout

Appendix 2 shows a sketch of aircrafts at the apron relative to the intersection C and runway 26.
