**Directorate of Aircraft Accident and Incident
Investigations**

Aircraft Accident Investigation Final Report

CESSNA 206 V5-NSK

DESCRIPTION OF OCCURRENCE Runway Excursion

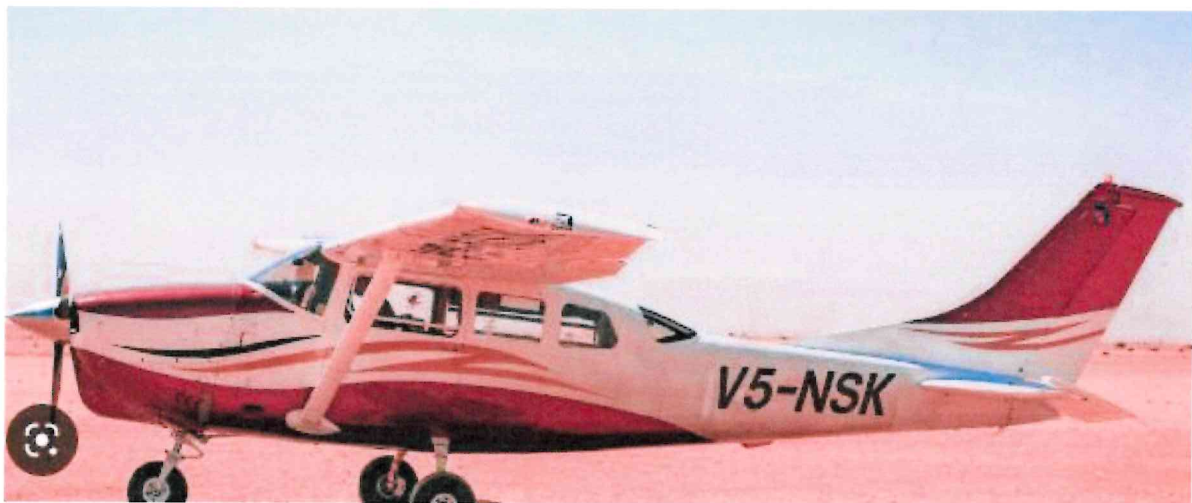
Figure 3: (FILE PHOTO)

The aircraft was equipped with a Robertson STOL system. The Robertson 'STOL' Operation is designed for experienced pilots who demand the utmost in performance in emergency conditions or austere fields, R/STOL combination of wing stall fences, leading-edge modifications, symmetrically drooped ailerons and automatic trim interconnect increases the aircraft's capabilities. The system reduces up to 47% shorter takeoff and landing distances, Improves high-density altitude performance etc ¹
