ENVIRONMENTAL FIELD SURVEY

UPGRADE OF THE RAILWAY LINE IN BETWEEN
KRANZBERG STATION TO TSUMEB AND OTAVI TO
GROOTFONTEIN

PHASE 1 – RAILWAY LINE BETWEEN KRANZBERG
STATION AND OTJIWARONGO TOWN

April 2022

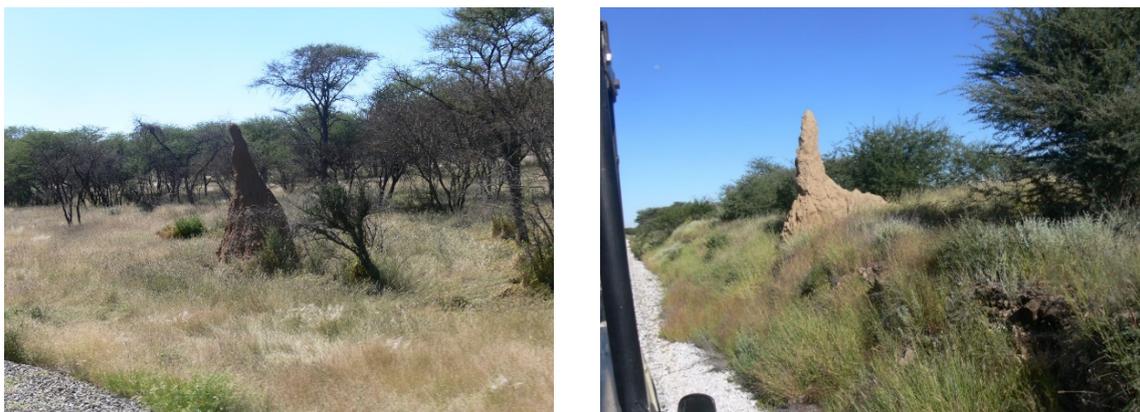
Termite activity only became evident in Section 2, north of Omaruru and is evident in ant hills next to the railway line and in the adjacent area.

Photo 3.4.5 – Ant hills indicate termite activity

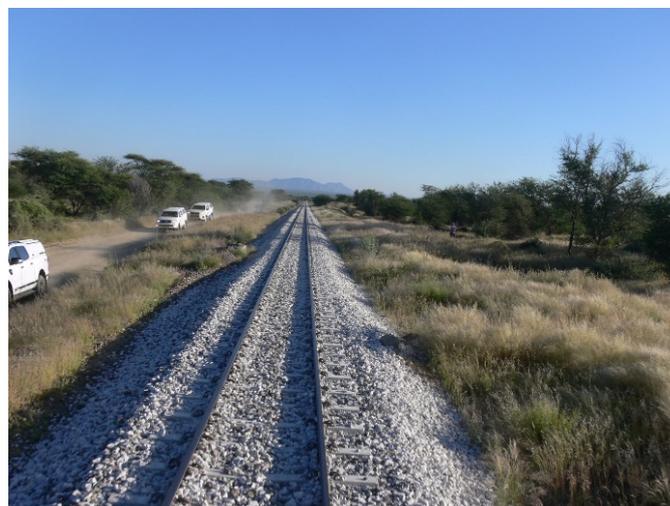
The woody biomass of the area is a natural resource that is harvested extensively for charcoal production and during the field survey local people gathering wood was also observed.

Photo 3.5.3 – Local people chopping wood in the servitude

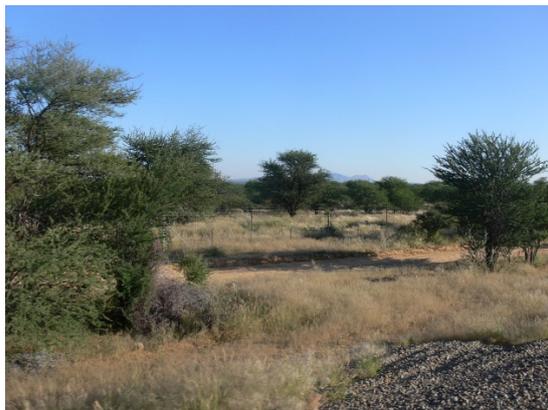
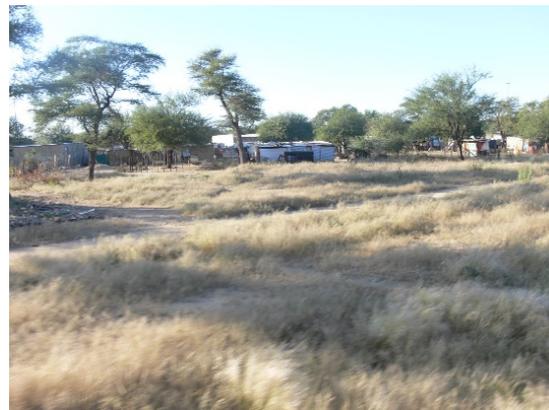
Closer to Omaruru Town the railway line deviates to the east towards a newly erected informal settlement that was not there previously when the initial plans were drawn up.

Photo 3.5.4 – Electrified game fence of an estate and an informal settlement south of Omaruru

This incidence was noted for possible re-alignment to prevent relocation of people.

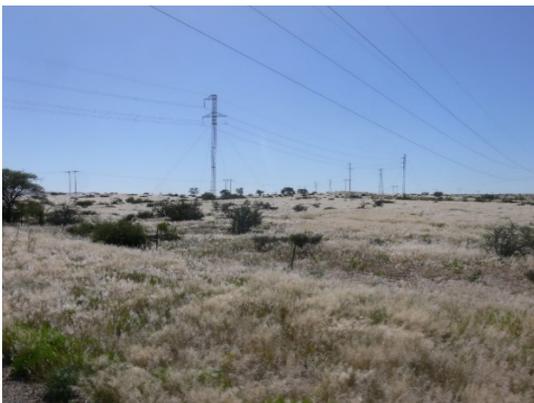
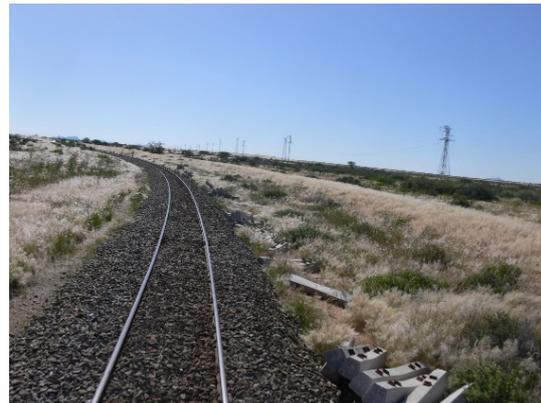
NamPower powerline runs parallel to the railway line between Karibib and Otjiwarongo and can be seen from the railway line for most of the way. Powerlines also cross the railway line at several points. *Powerline crossings were noted.*

Photo 3.7.3 – Powerlines cross the railway line near Kranzberg and runs // east of the line in Section 1

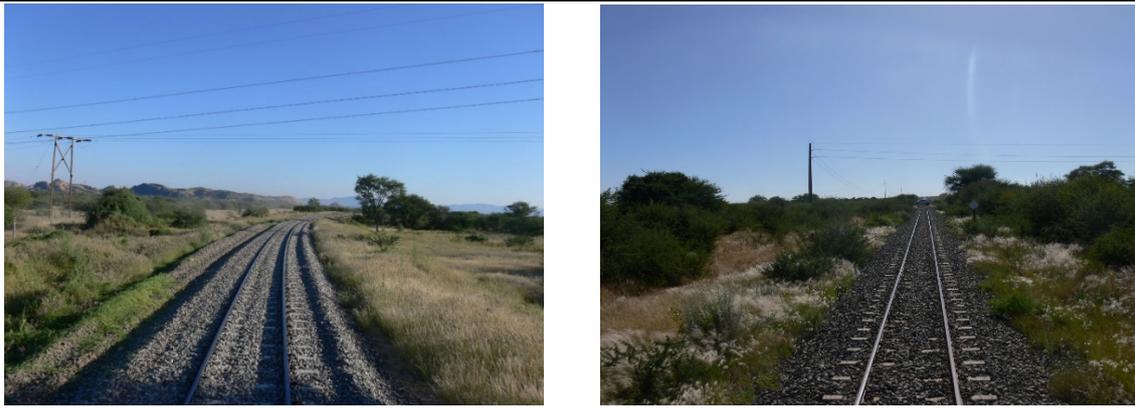
Photo 3.7.4 – Powerline crossing north of Norman Siding and south of Parasis Siding

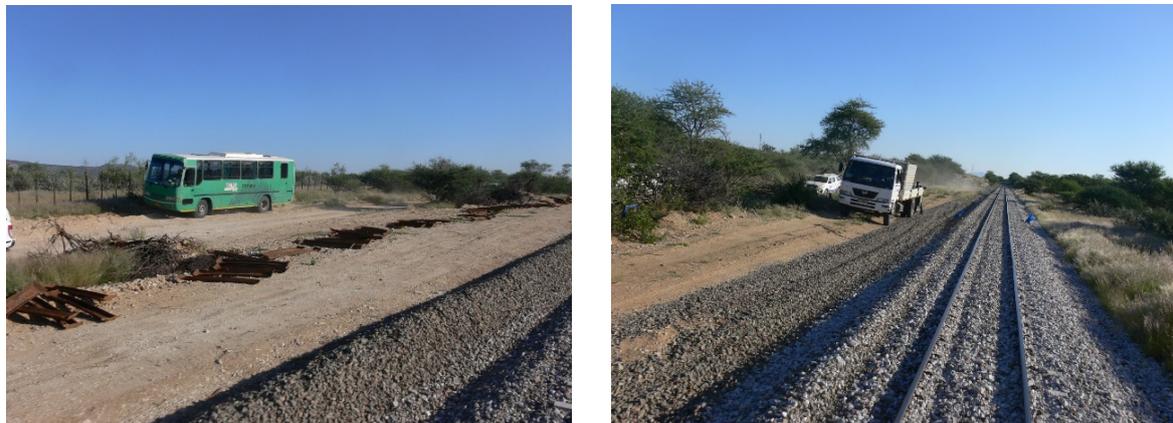
Maintenance and minor construction activities are on-going on the existing railway line. The railroad currently poses a threat to Health and Safety, because of its dilapidated condition in some areas.

Photo 3.8.4 – Maintenance staff are being transported to site by bus and trucks are used to transport maintenance material.
