REPUBLIC OF NAMIBIA
MINISTRY OF WORKS AND TRANSPORT

Accident Reference: ACCID/05032024-01-01

Aircraft Accident Investigation Interim Report

Reims Cessna F406 Caravan II aircraft: V5-ASB

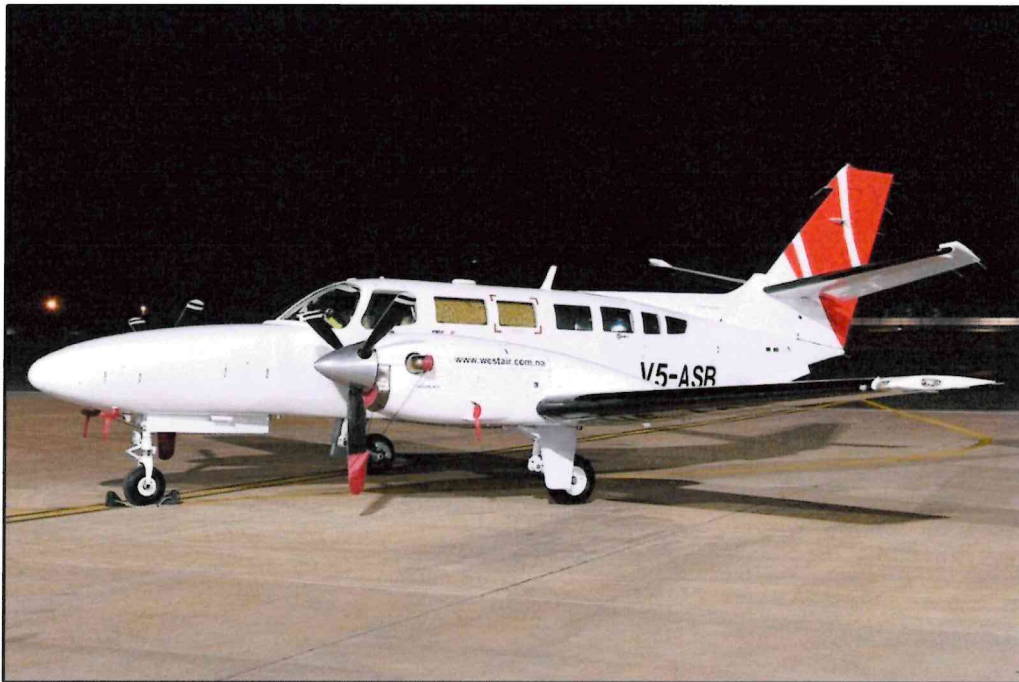
Figure 1: The Reims Cessna 406 aircraft V5-ASB accident aircraft (source: Operator)

V5-ASB Reims Cessna F406 Caravan II 406-0031 (S/N)
